**REPORT ON
INITIAL PERIODIC STRUCTURAL STABILITY ASSESSMENT
POND 004
NEW MADRID POWER PLANT
NEW MADRID, MISSOURI**

by Haley & Aldrich, Inc.
Cleveland, Ohio

for Associated Electric Cooperative, Inc.
New Madrid, Missouri

File No. 40616-300
October 2016

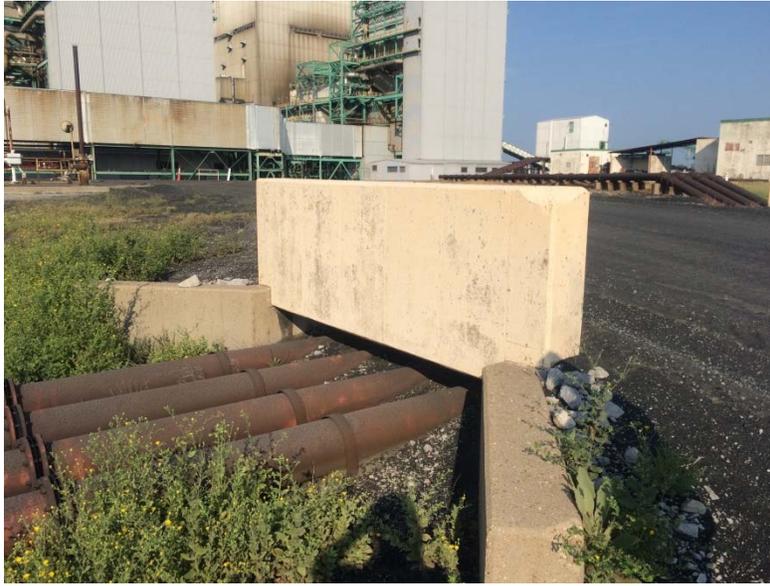
Four (4) 10 in. pipes discharge CCR and water into Pond 004. There were no leaks or defects observed in the discharge pipes that required repair.

Photograph No. 1
Slag Dewatering Pond Dam (004 Pond)
Four inlet pipes with headwall

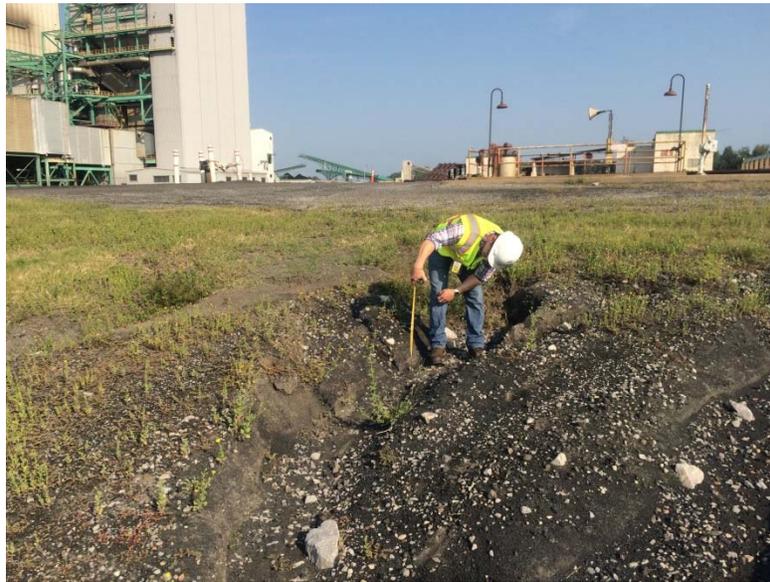
Photograph No. 2
Slag Dewatering Pond Dam (004 Pond)
Minor rutting and erosion in upstream slope

- Cut/mow the embankments and routinely mow the embankment slopes (upstream and downstream) and downstream areas to maintain vegetation at a height of 6 in. or less.
- Repair minor ruts and erosion at the Pond 004 dikes and crest.
- Conduct a video inspection of outlet pipe from the drop inlet structure at a time that is reasonable based on operation of the impoundment.

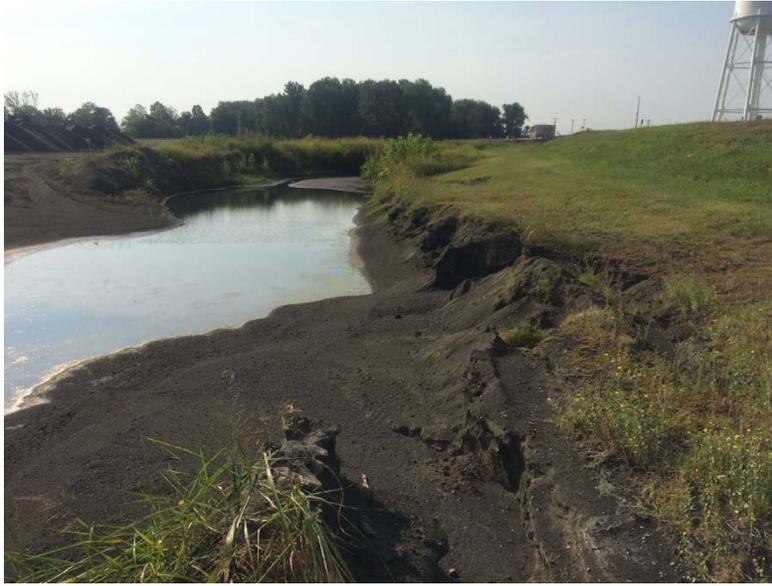
Photograph No. 3
Slag Dewatering Pond Dam (004 Pond)
Upstream slope of western embankment

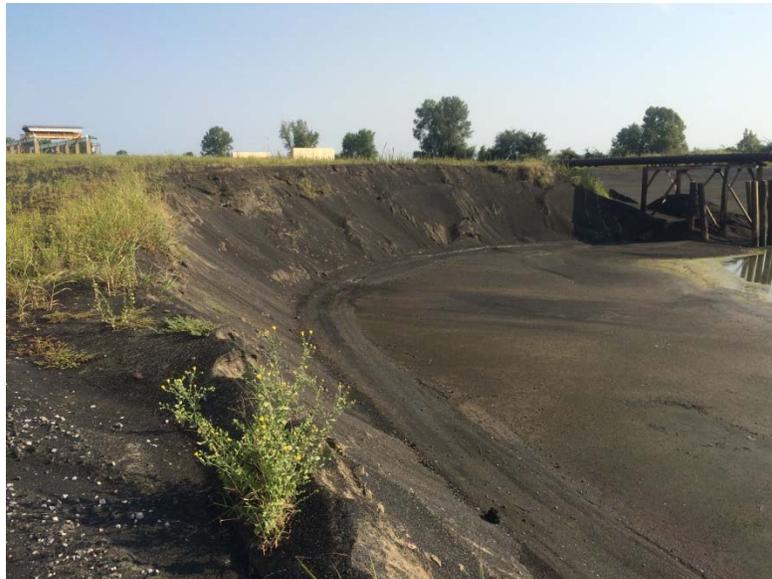
Photograph No. 4
Slag Dewatering Pond Dam (004 Pond)
Upstream slope of northern embankment

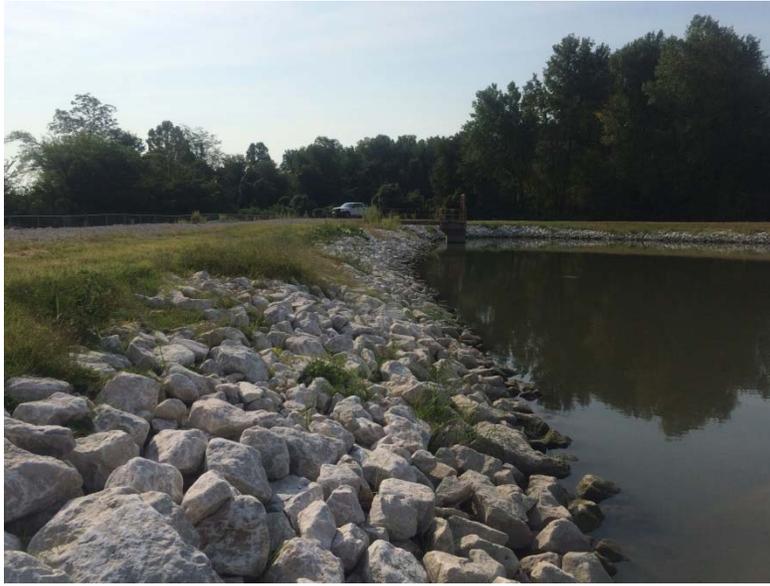
Photograph No. 5
Slag Dewatering Pond Dam (004 Pond)
Upstream slope of eastern embankment with riprap and vegetation

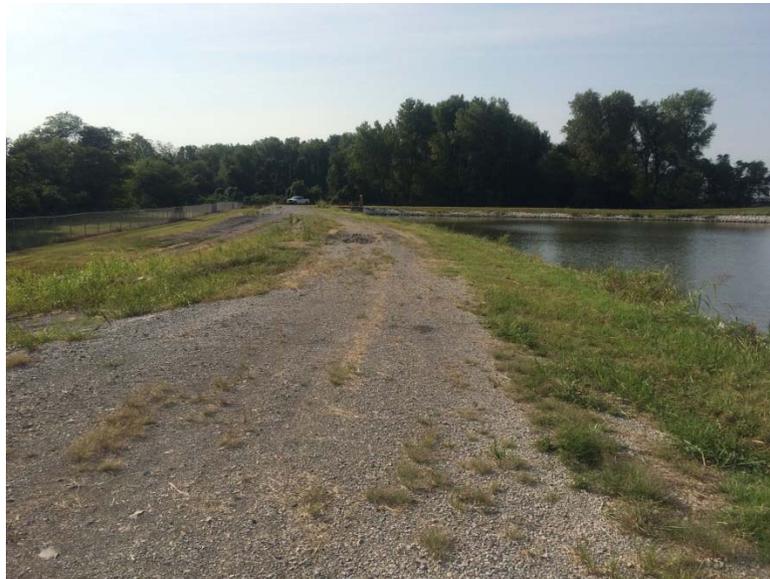
Photograph No. 6
Slag Dewatering Pond Dam (004 Pond)
Crest of eastern embankment

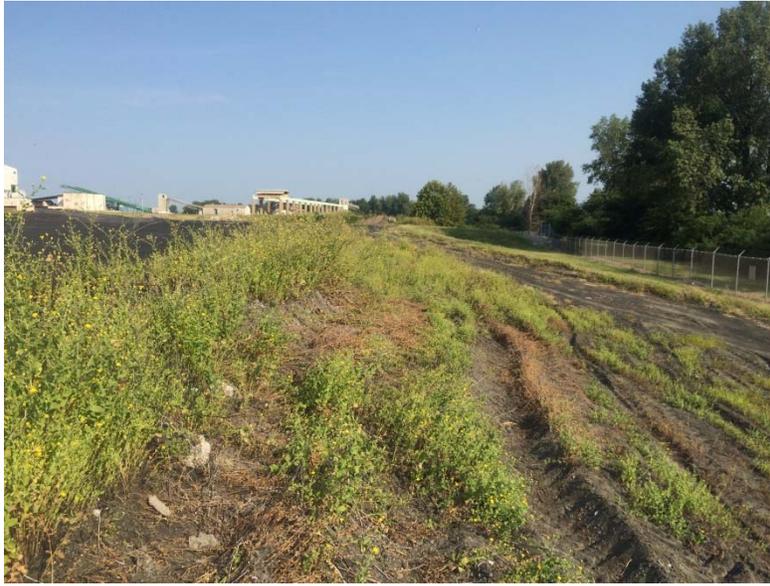
Photograph No. 7
Slag Dewatering Pond Dam (004 Pond)
Downstream slope of eastern embankment with ruts and uneven surface

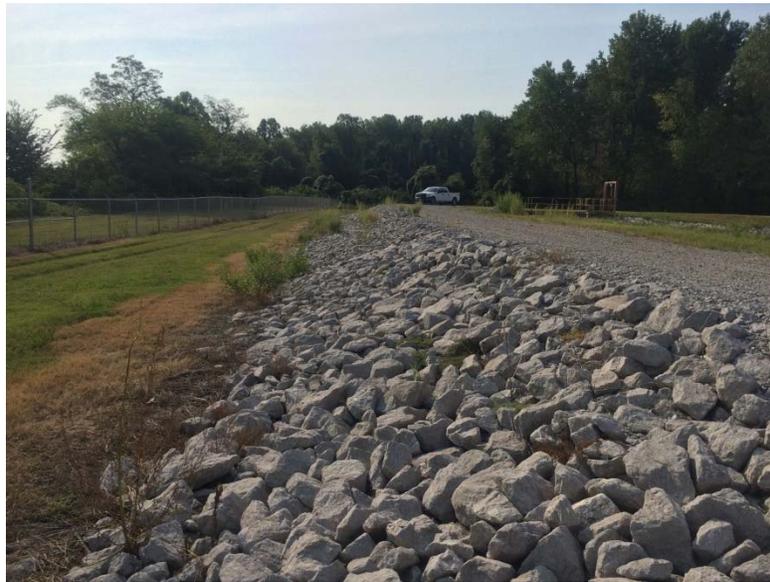
Photograph No. 8
Slag Dewatering Pond Dam (004 Pond)
Downstream slope of eastern embankment with riprap

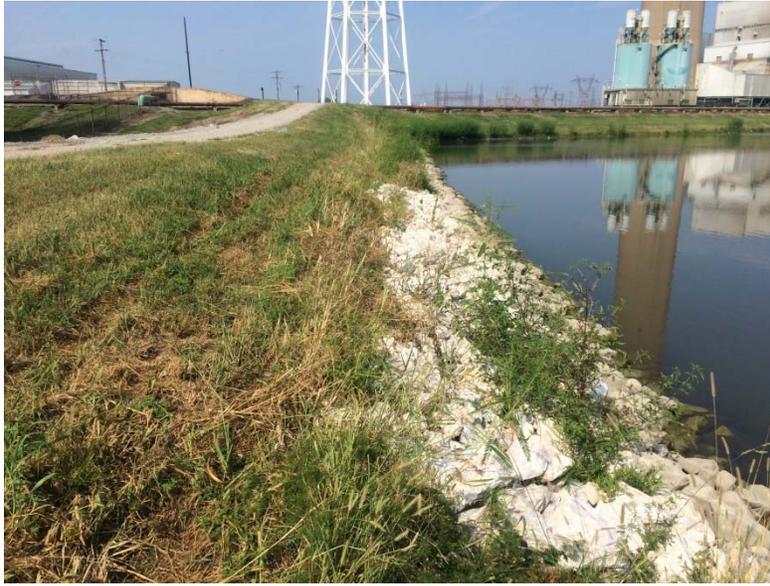
Photograph No. 9
Slag Dewatering Pond Dam (004 Pond)
Upstream slope with riprap and vegetation

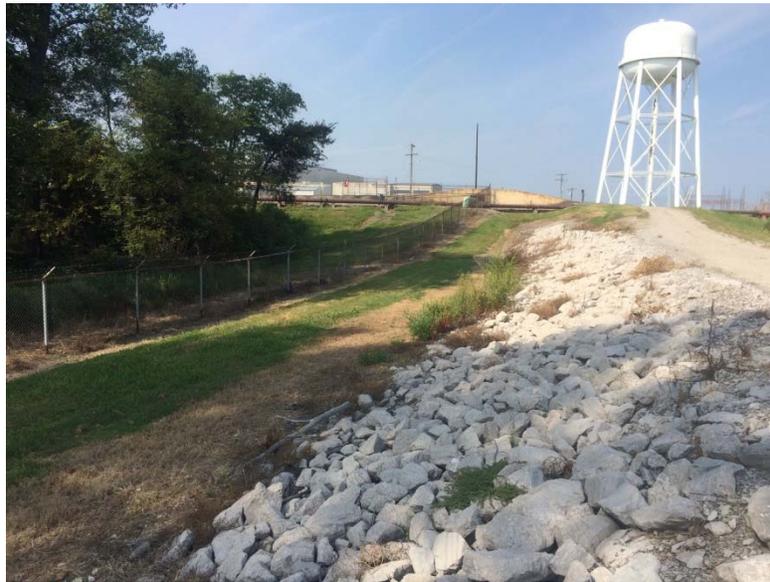
Photograph No. 10
Slag Dewatering Pond Dam (004 Pond)
Downstream slope with Mississippi River Levee in Background

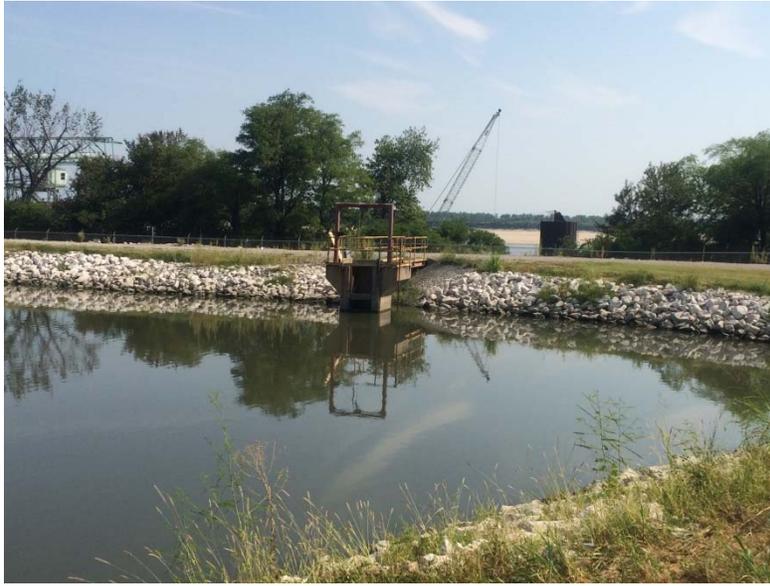
The concrete drop inlet spillway appeared to have minor, isolated, concrete chips and weathering. Minor, surficial rusting was observed on the stoplog removal winch and frame. Deficiencies in the discharge headwall and drainage pipe were not observed.

Photograph No. 11
Slag Dewatering Pond Dam (004 Pond)
Concrete drop inlet spillway with stoplogs
Mississippi River in background

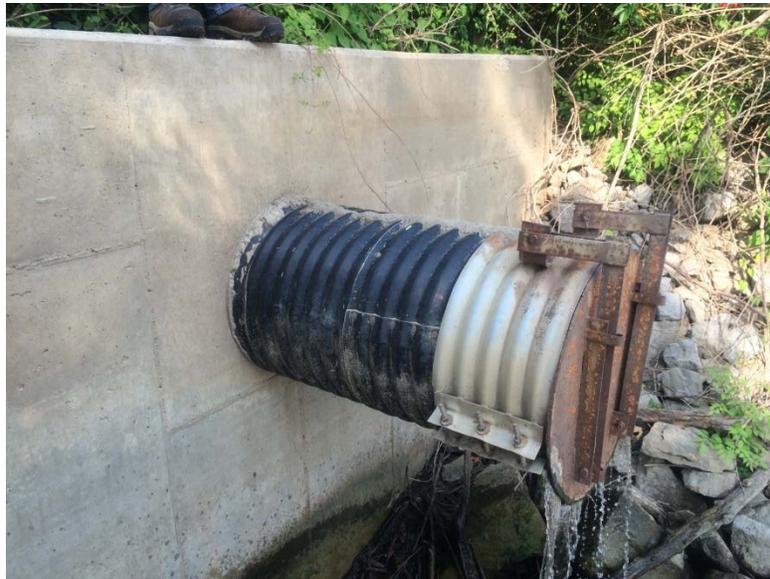
Only limited portions of the intake and outlet structures were visible during our inspection. Regarding the 18-in. corrugated metal pipe, the pipe is buried below the dike and only the downstream end of the pipe is visible. The visible portion of the pipe appeared sound and during our inspection, we observed no signs that would indicate seepage or internal erosion along the length of the pipe where it penetrates the east dike. The headwall was in good condition as well.

Photograph No. 12
Slag Dewatering Pond Dam (004 Pond)
Discharge pipe to Mississippi River with backflow preventer
