REPORT ON
INITIAL PERIODIC STRUCTURAL STABILITY ASSESSMENT
INACTIVE LINED POND
NEW MADRID POWER PLANT
NEW MADRID, MISSOURI

by Haley & Aldrich, Inc.
Cleveland, Ohio

for Associated Electric Cooperative, Inc.
New Madrid, Missouri

File No. 129342-015
April 2018

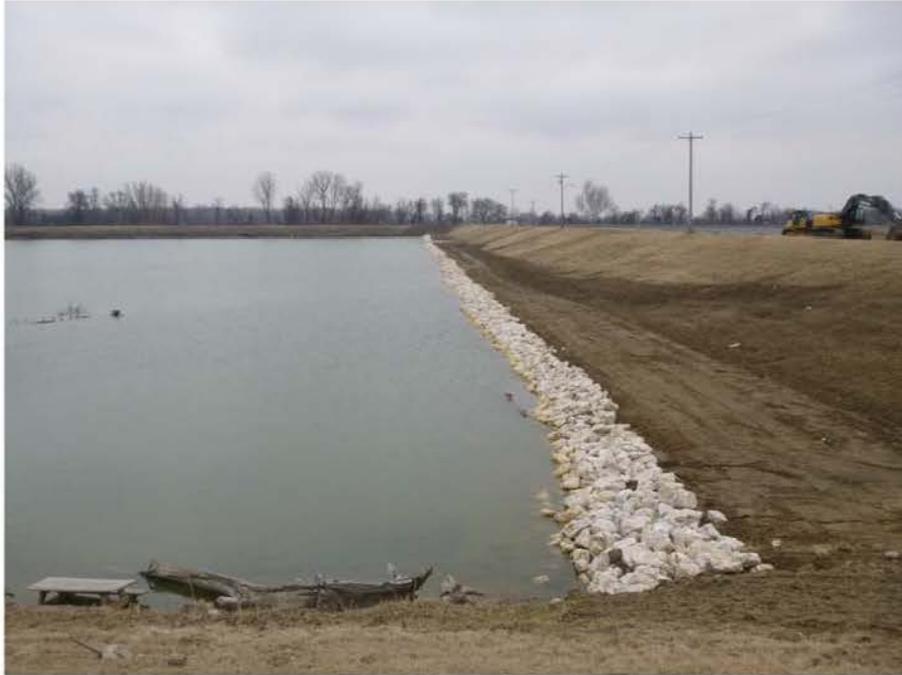
Photo 01:

On the eastern embankment, the downstream slope has historically exhibited significant surficial sloughing, and these were remedied in 2012 through installation of plate-piles along this slope. Plate-piles were not visible from the surface. During our inspection, we observed that an approximately 15-foot-wide bench has been constructed at the lower part of the downstream slope (where it reaches approximately the Raw Water Pond water level elevation) using rip-rap, and this bench was covered with a compacted soil layer. Rip-rap is present along the contact between the downstream slope/bench and the water level in the Raw Water Pond. Due to repairs and re-grading along the downstream slope of eastern embankment, we observed that parts of the downstream slope of eastern embankment have not been seeded as of the date of the inspection. Minor erosion rills (less than 6 inches in depth) were observed on the unseeded portions of the slope.

View of repaired downstream slope of eastern embankment (view towards South).

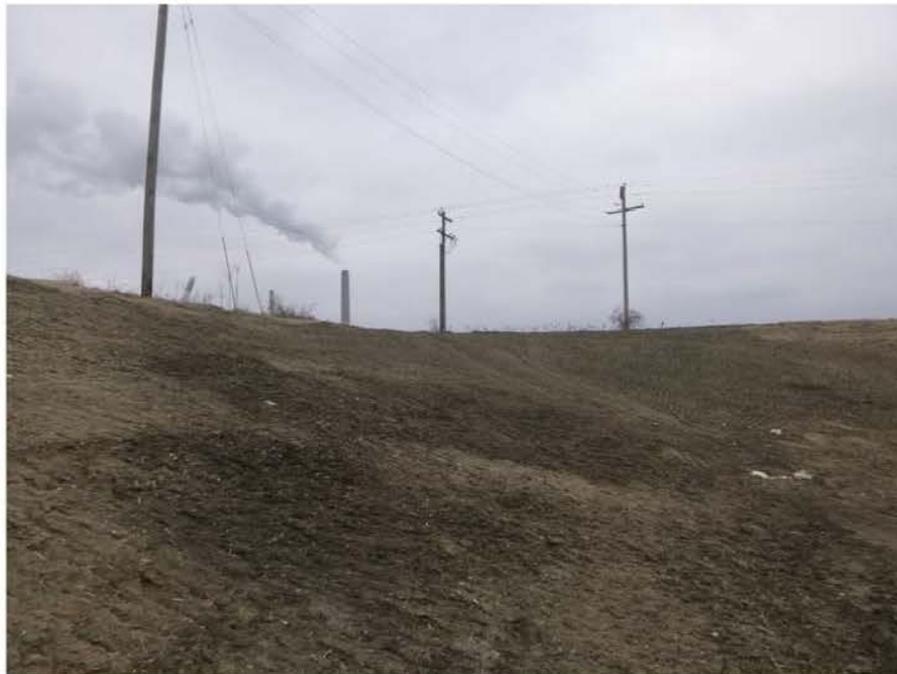
Photo 02:

An unseeded portion of the downstream slope of eastern embankment (view towards northern abutment area).

- Mow grass exceeding 6 inches in height on downstream slopes of eastern, southern and western embankments, and mow/cut vegetation exceeding 6 inches in height on the upstream and downstream sides of the crest of eastern embankment and downstream side of crest of western embankment.
- Repair minor ruts and erosion along the gravel access road on the crest of southern embankment.
- Seed unseeded areas of downstream slope of eastern embankment to establish vegetation.
- Re-work depressed area in the downstream toe area of southern embankment so that water will not continue to pond at the toe after a rainfall event. Property boundaries may need to be evaluated to allow for this activity to be completed.

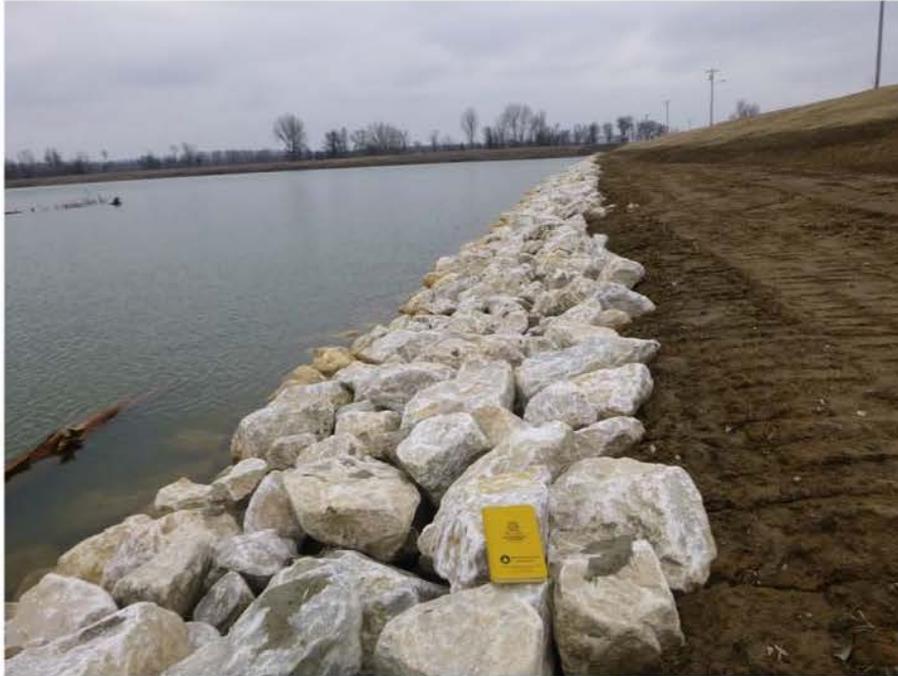
Photo 03:

Rip-rap placed on lower part of downstream slope of eastern embankment.

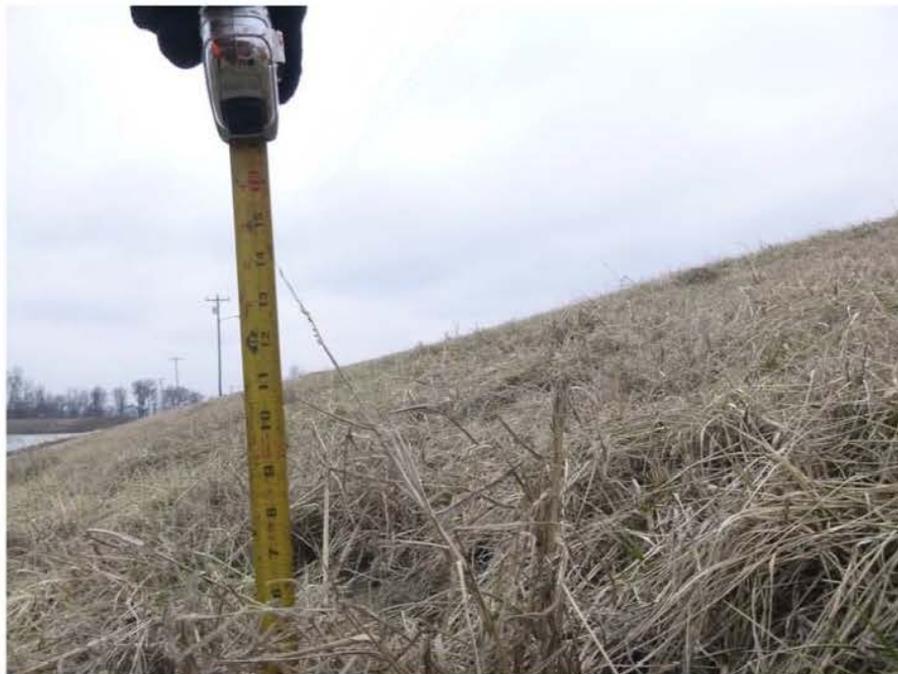
Photo 04:

Throughout much of the vegetated portions of the downstream slope of eastern embankment, we observed grass taller than 6 inches.

Grassy vegetation taller than 6 inches on downstream slope of eastern embankment.

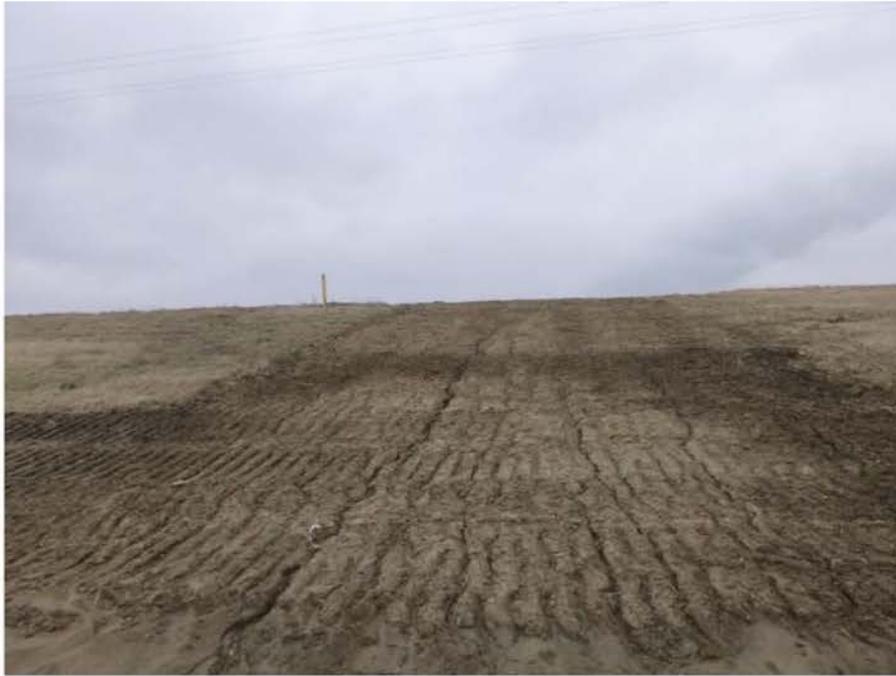
Photo 05:

View of erosion rills (less than 6 inches deep) at an unseeded portion of downstream slope of eastern embankment.

Shallow erosion rills that were observed on the downstream slope of eastern embankment should be monitored until seeding in these areas are completed.

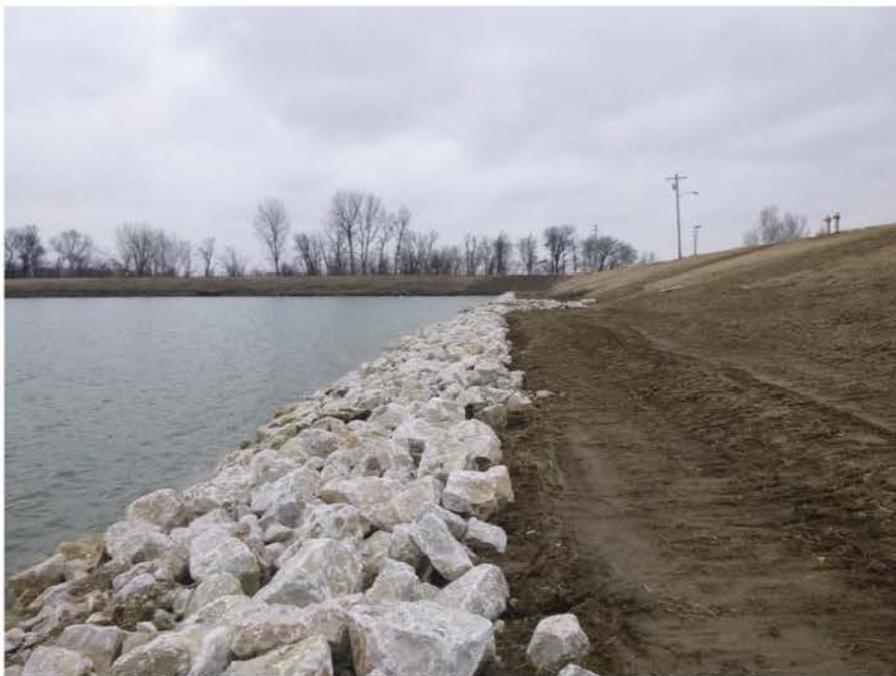
Photo 06:

View of filled portion and rip-rap along downstream slope of eastern embankment.

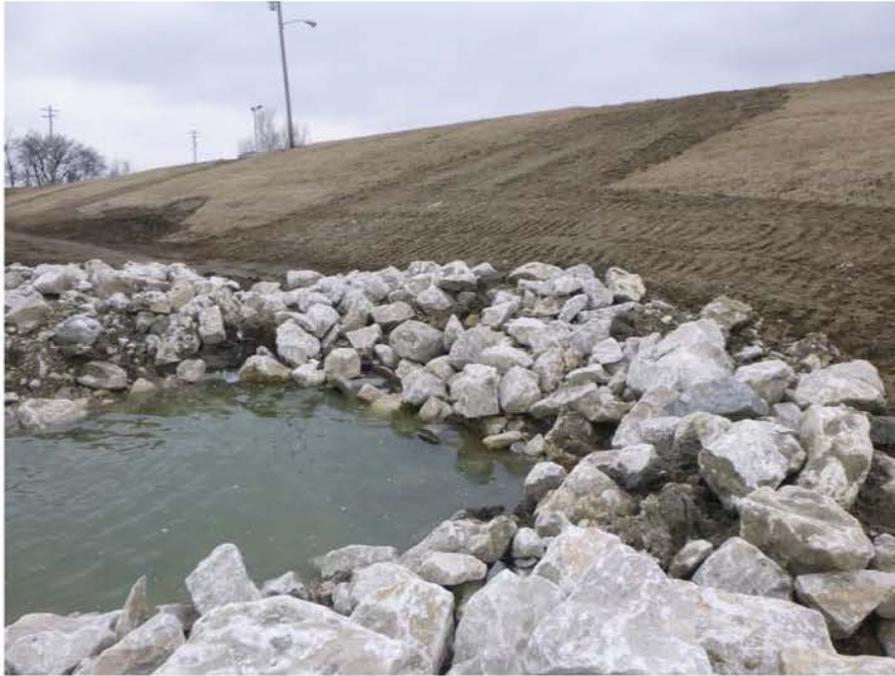
Photo 07:

Two 18-inch pipes pass through the eastern embankment. Only the discharge/outfall part of the pipes were partially visible on the downstream side of eastern embankment (i.e. Raw Water Pond side). Along the alignment of these two buried pipes, no settlement of ground surface was observed on the crest, upstream slope, and downstream slope of eastern embankment.

View of the two conduit pipes running from Lined Pond to Raw Water Pond through the eastern embankment, exposed on the Raw Water Pond side.

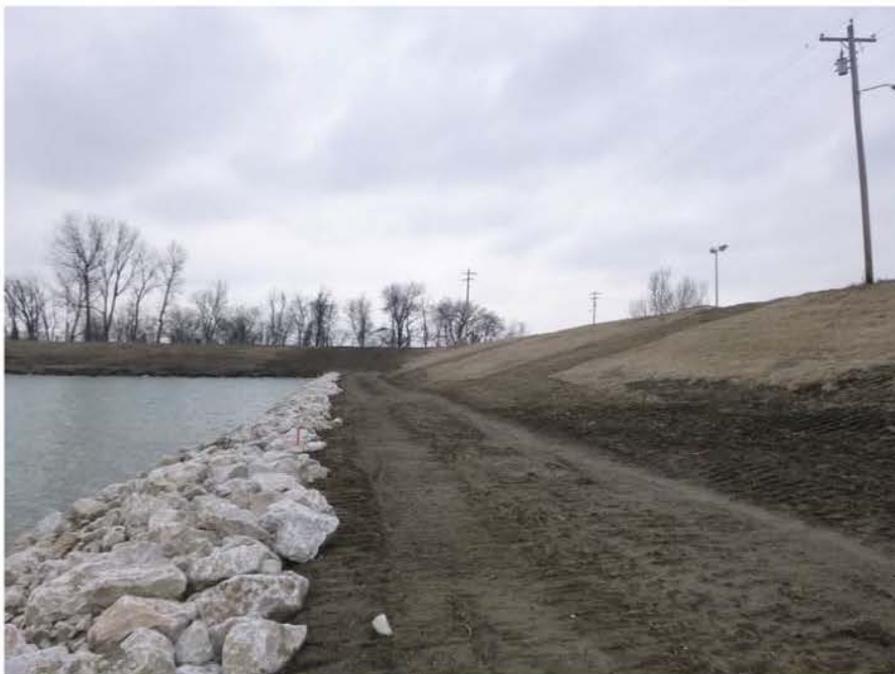
Photo 08:

View of some of the unseeded areas along the downstream slope of eastern embankment (view towards South).

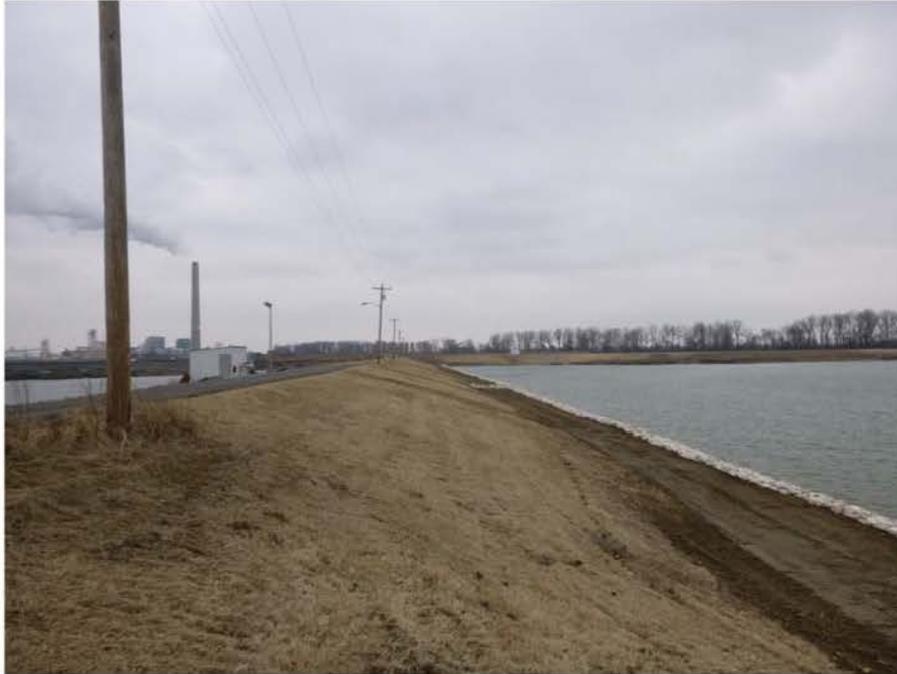
Photo 09:

At the southern end of the downstream slope of eastern embankment, we observed sloughing which formed an irregularity on the slope surface. The irregularity formed by sloughing is approximately

15 feet long, 2 feet wide and 1 feet deep. This sloughing was observed within the grassed portion of the slope and did not appear to affect the immediate structural stability of the eastern embankment. However, we recommend that AECI monitor this area for potential further movements and undertake appropriate repairs if movements are observed.

View of downstream slope of eastern embankment from the south end. A linear slough on the grassed portion of the slope is visible in the lower right part of the photograph.

The linear manifestation of a slough observed on the downstream slope of eastern embankment should be monitored for potential future movements and repairs should be made if further movements are observed.

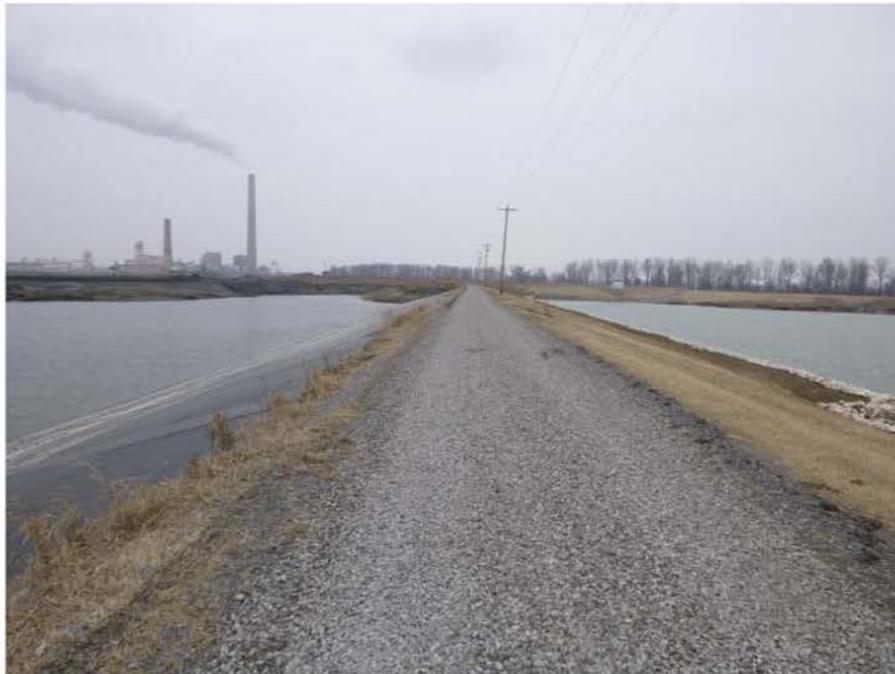
Photo 10:

Crest of eastern embankment (view towards North).

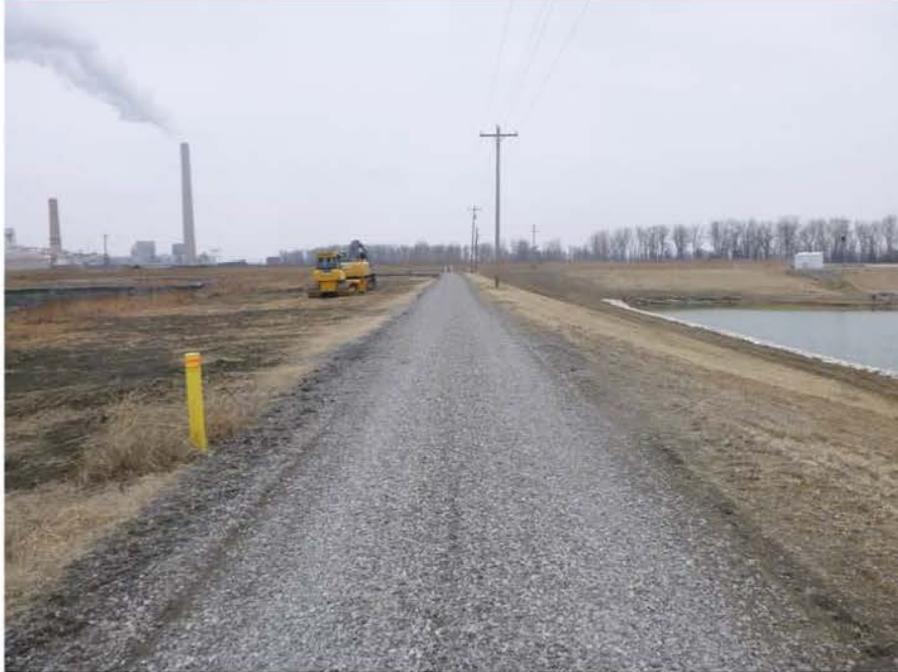
Photo 11:

Northern half of the crest of eastern embankment (view towards North).

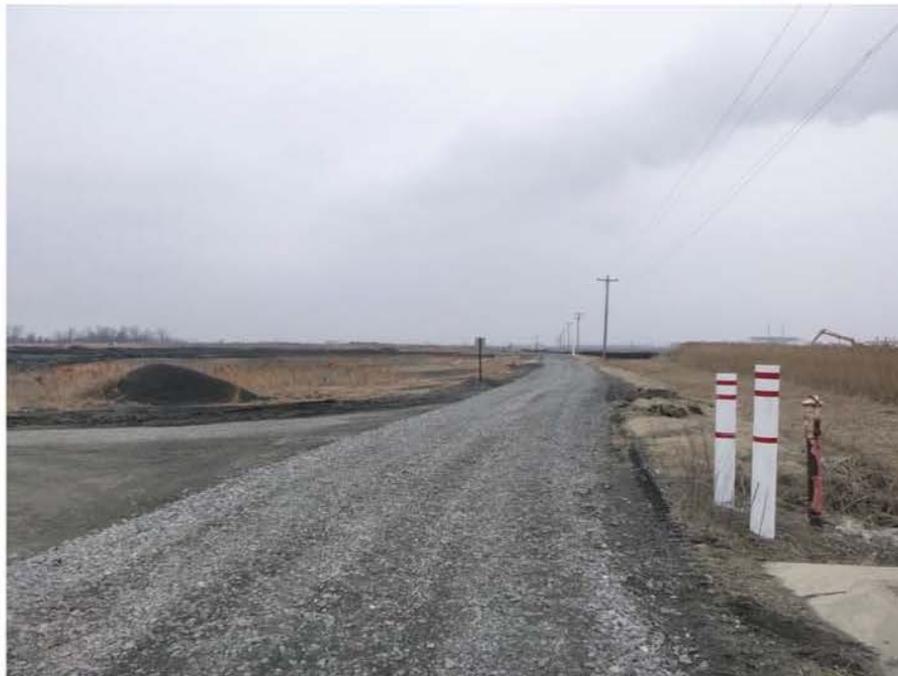
Photo 12:

Crest of northern embankment (view towards West).

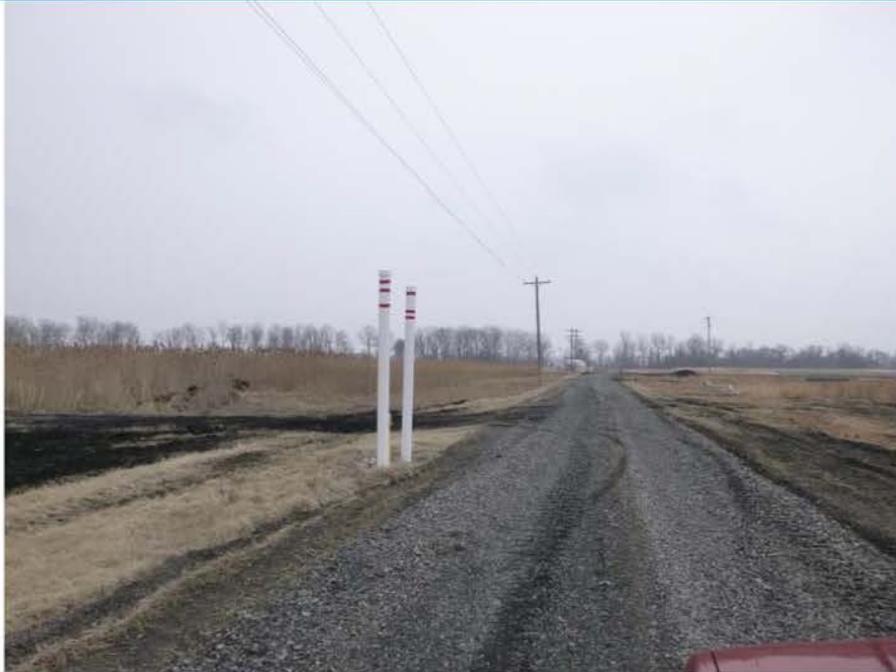
Photo 13:
Crest of northern embankment (view towards East).

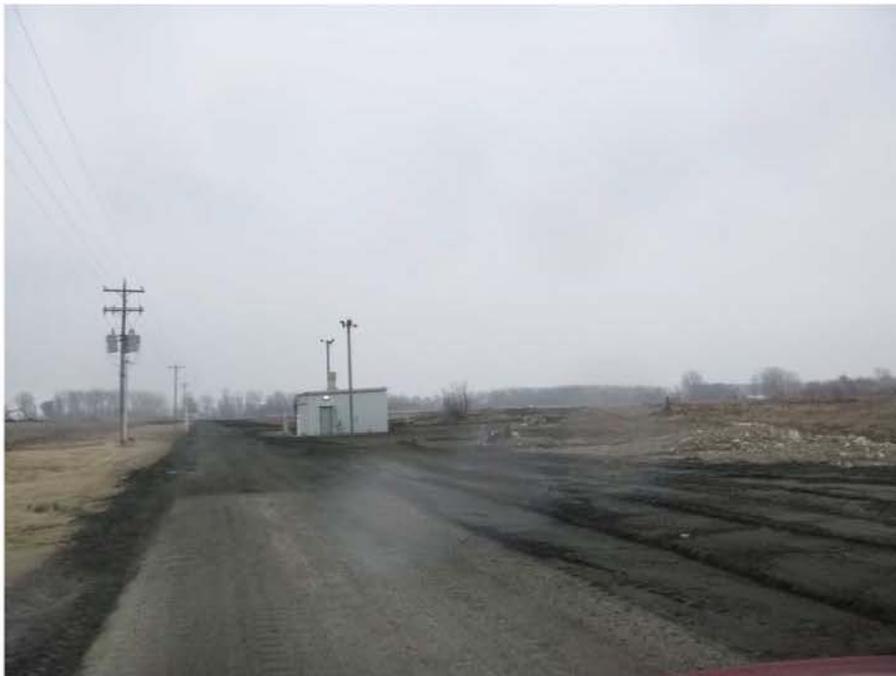
Photo 14:
Crest of northern embankment as seen in the vicinity of air compressor building (view towards East).

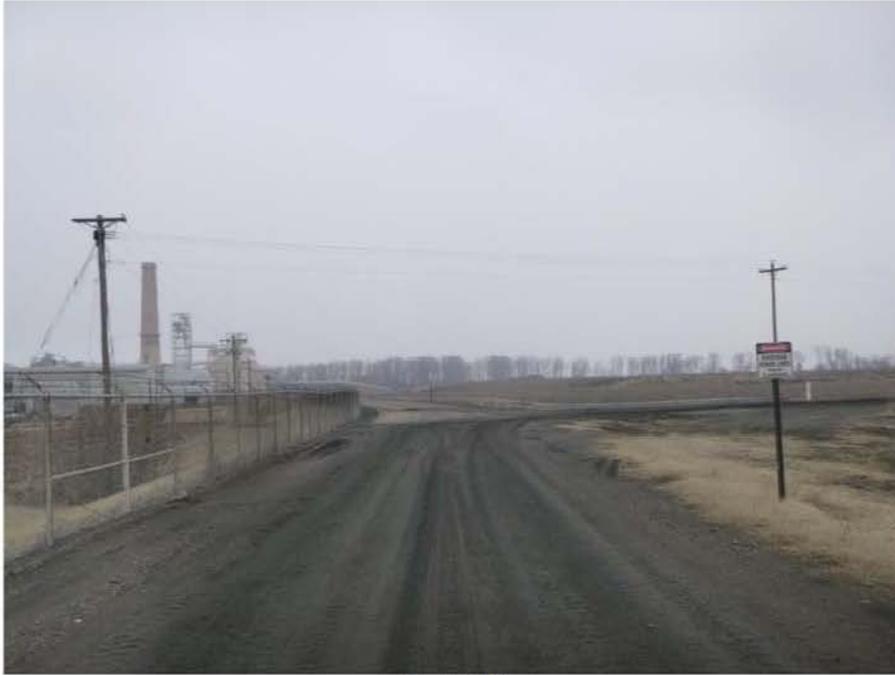
Photo 15:

Crest of western embankment (i.e. US Army Corps of Engineers levee) near northern abutment (view towards North).

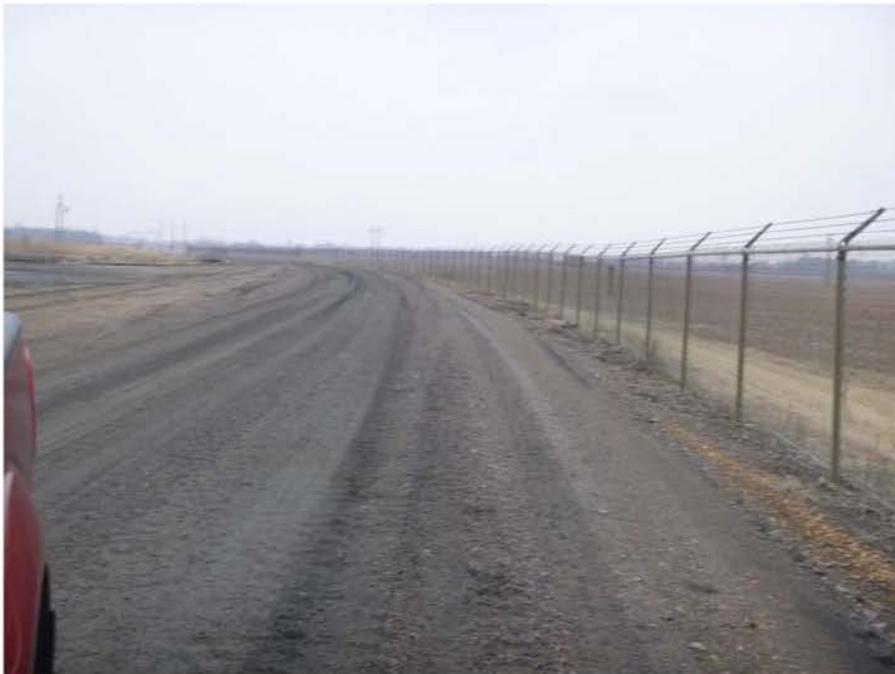
Photo 16:

Crest of western embankment (i.e. US Army Corps of Engineers levee) (view towards South).

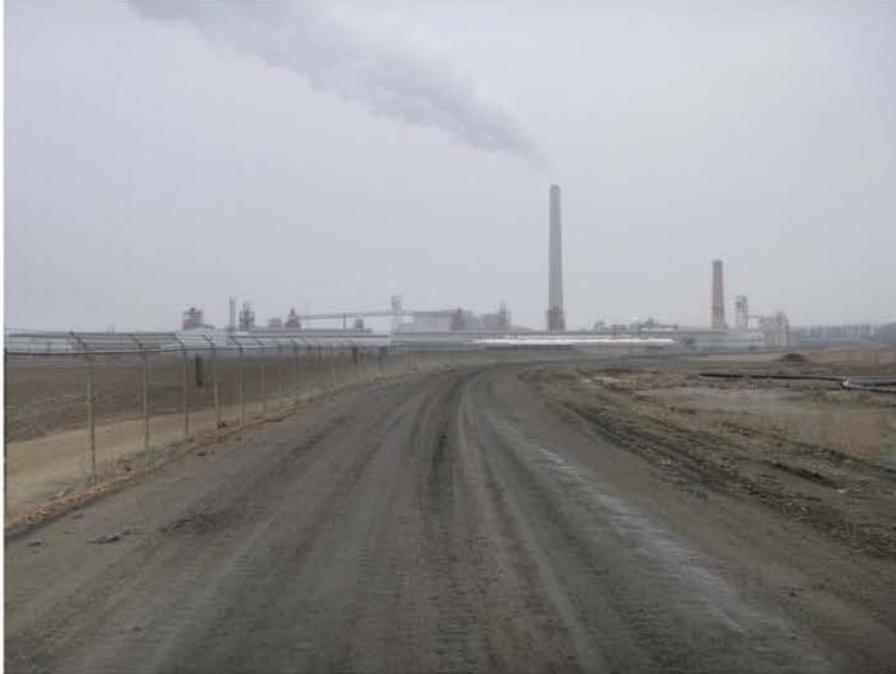
Photo 17:

Crest of western embankment (i.e. US Army Corps of Engineers levee) (view towards North).

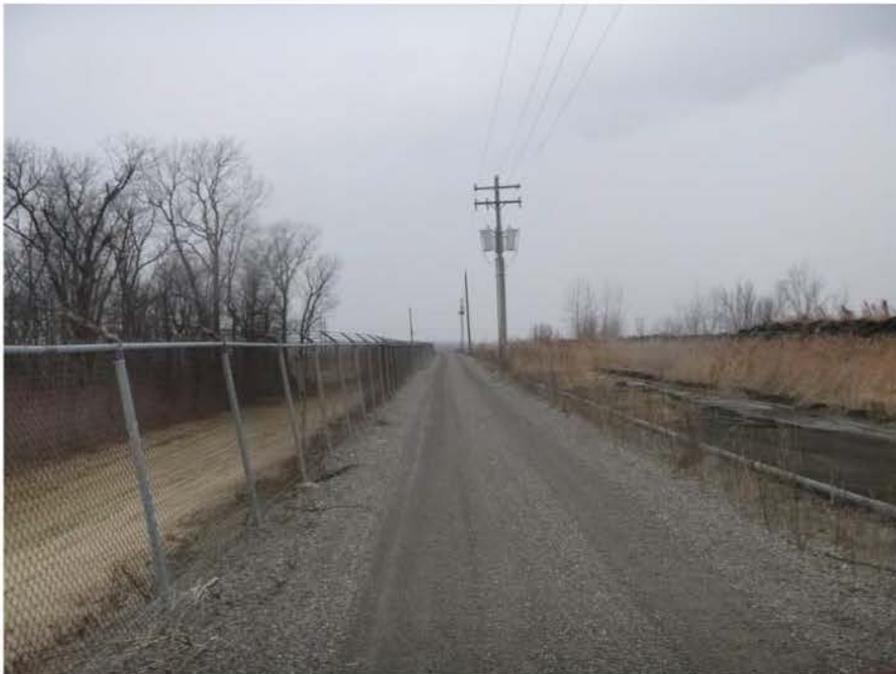
Photo 18

Crest of southern embankment (view towards West).

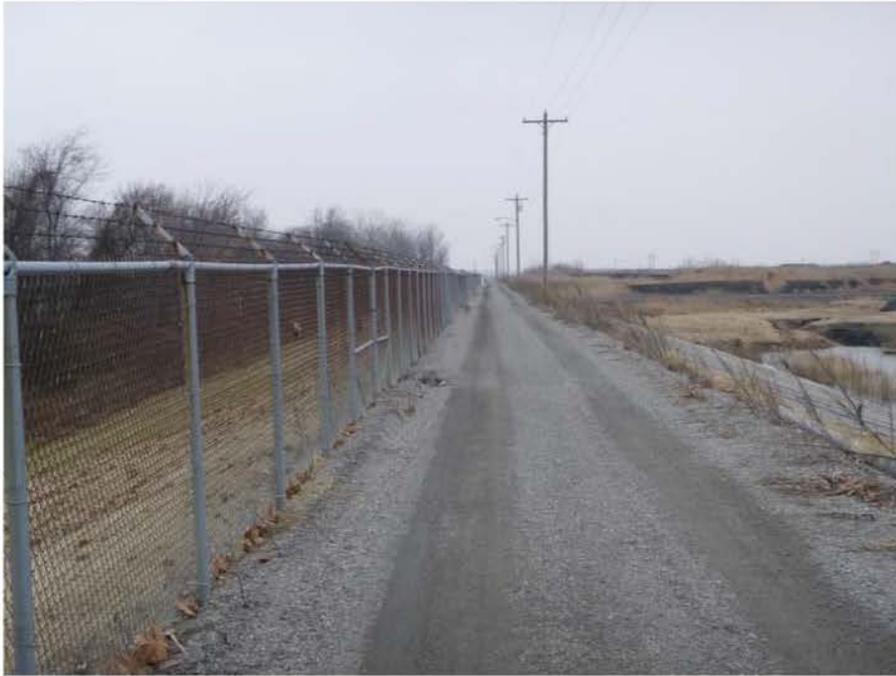
Photo 19:
Crest of southern embankment (view towards West).

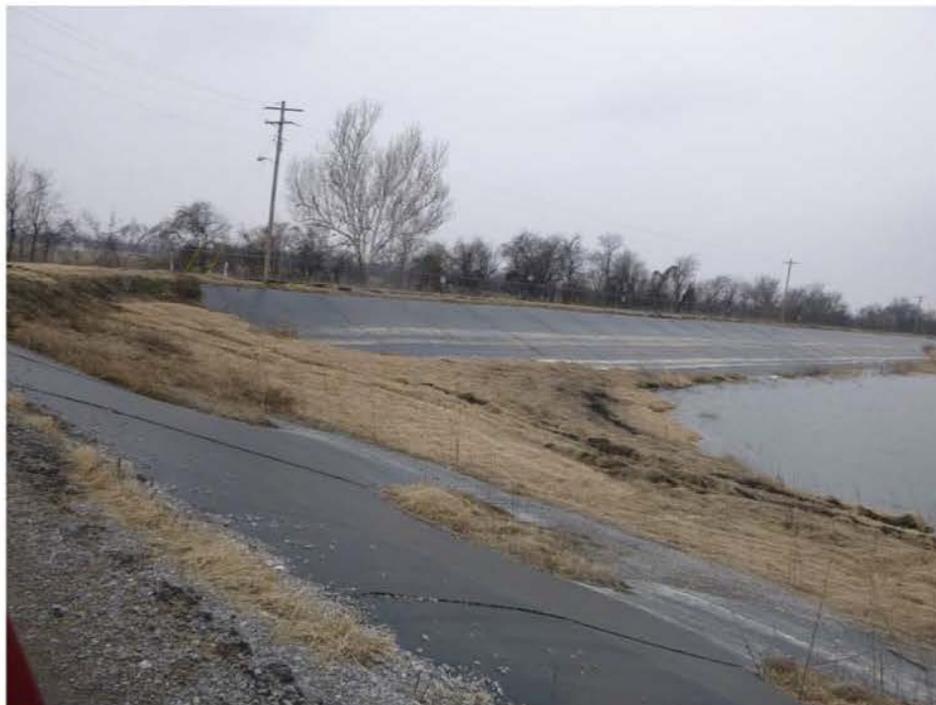
Upstream slope of the dike is only visible at the southeastern part of the Lined Pond. At this area, the liner installed on the upstream slope is exposed without protection. It is understood that an attempt was made to place protective soil cover over the liner at the southwest corner of the pond, however this effort was not continued throughout the entire exposed area since placed soil did not stay stable on the smooth liner inclined at an approximately 3H:1V slope. At the time of our inspection, exposed portions of upstream slope with the liner appeared stable and no defects were visible on the liner.

Photo 20:
Exposed liner on upstream slope of eastern and southern embankments (view towards Southwest).

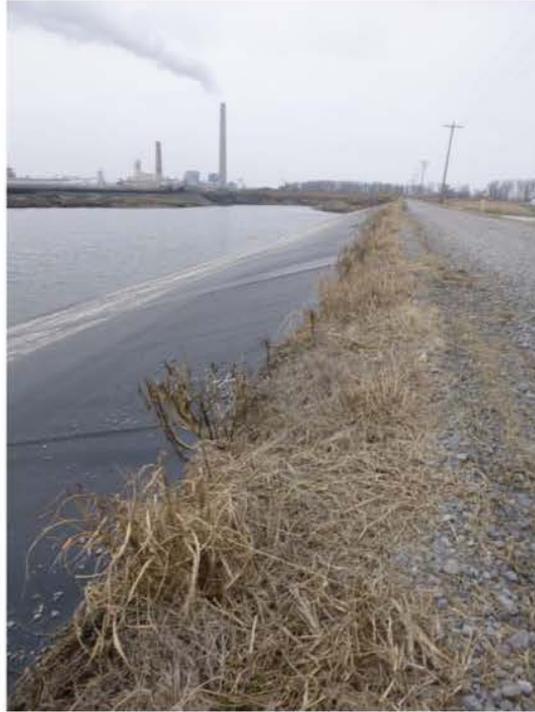
Photo 21:

Exposed liner on upstream slope of eastern embankment (view towards North).

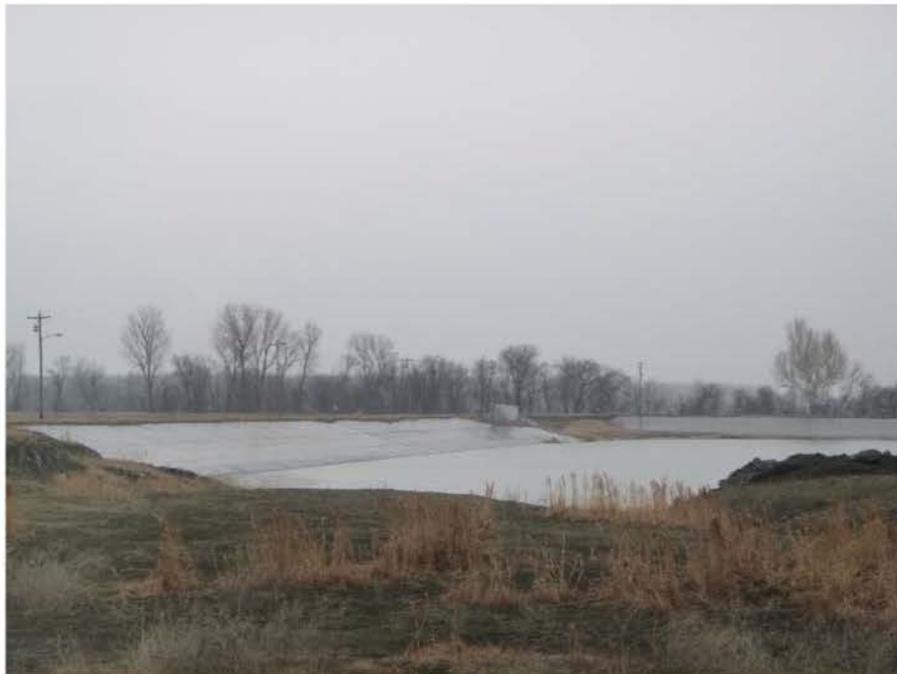
Photo 22:

Exposed liner on upstream slope of eastern and southern embankments (view towards Southeast).

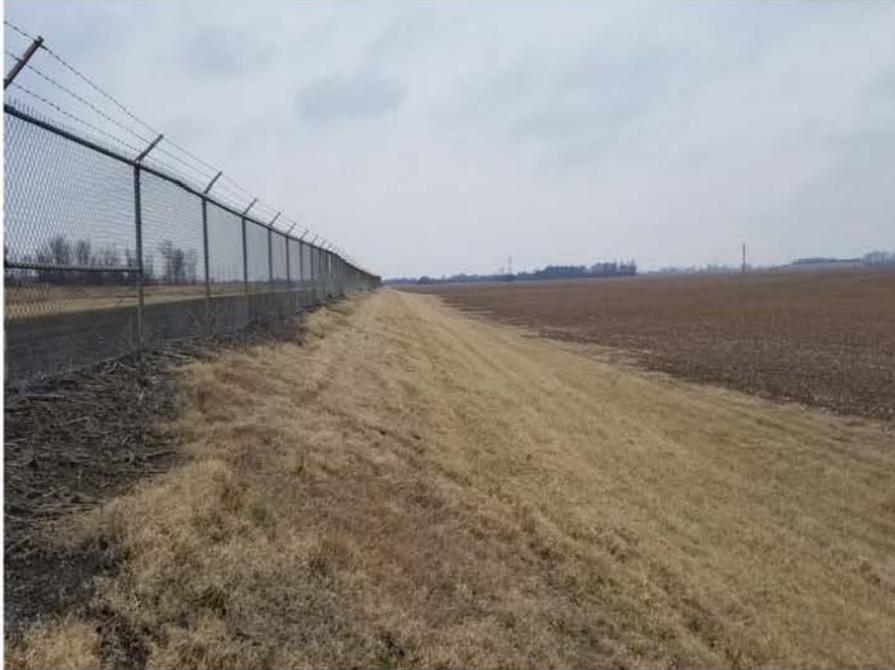
Photo 23:

Downstream slope of western embankment (i.e. US Army Corps of Engineers levee) (view towards South).

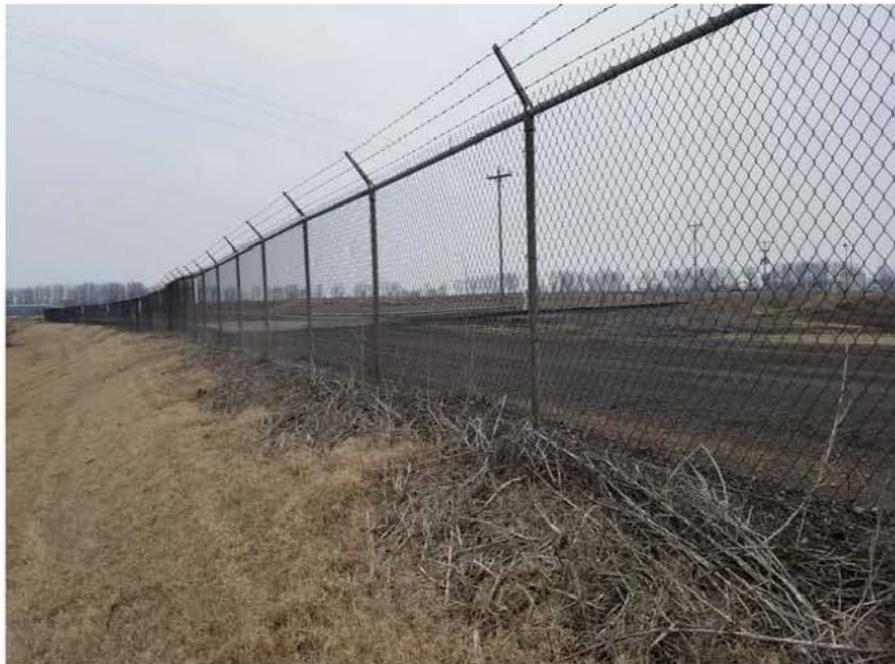
Photo 24:

Bushes (up to 1 to 2 feet tall) along the upper portion of the upstream slope of western embankment (i.e. US Army Corps of Engineers levee).

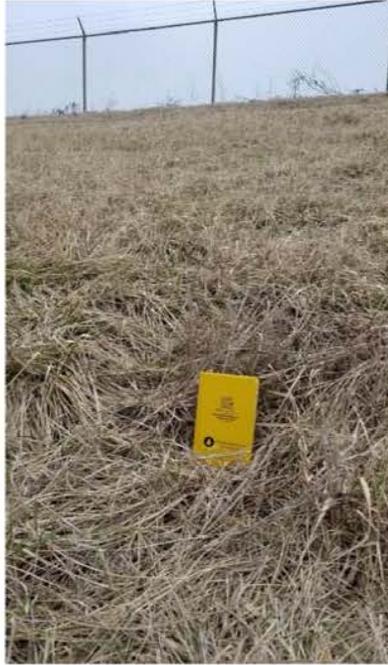
Photo 25:

Downstream slopes of southern and western embankments were observed to be in good condition, with no unusual movements or seepage. Similar to downstream slope of eastern embankment. Grassy vegetation covering the downstream slopes of southern and western embankments were mostly taller than 6 inches during our inspection.

Grassy vegetation (taller than 6 inches) on downstream slope of western embankment (i.e. US Army Corps of Engineers levee).

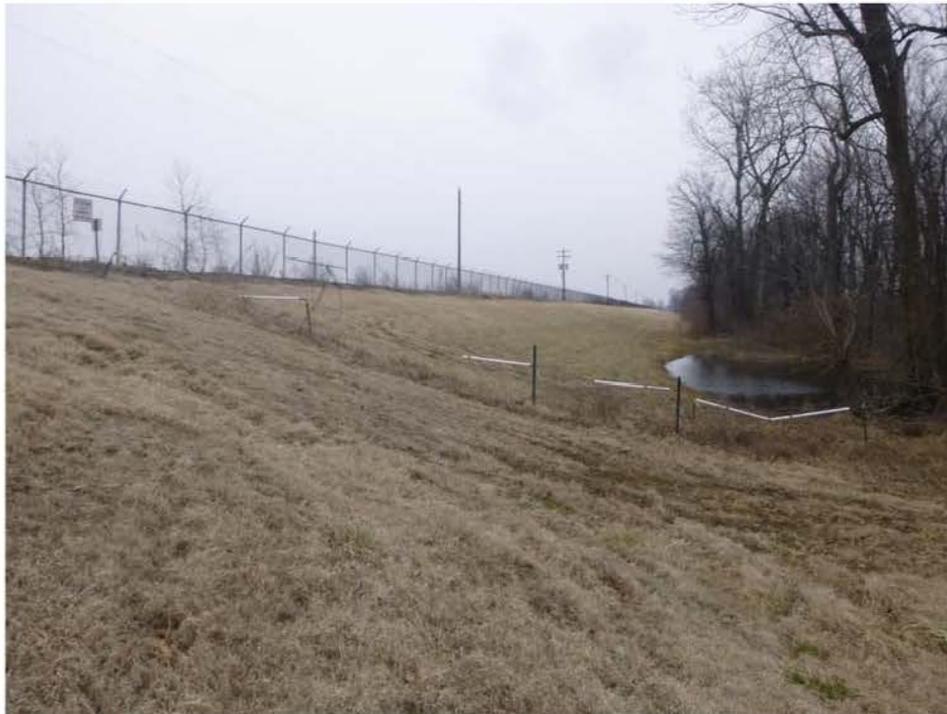
Photo 26

Downstream slope of southern embankment (view towards East).

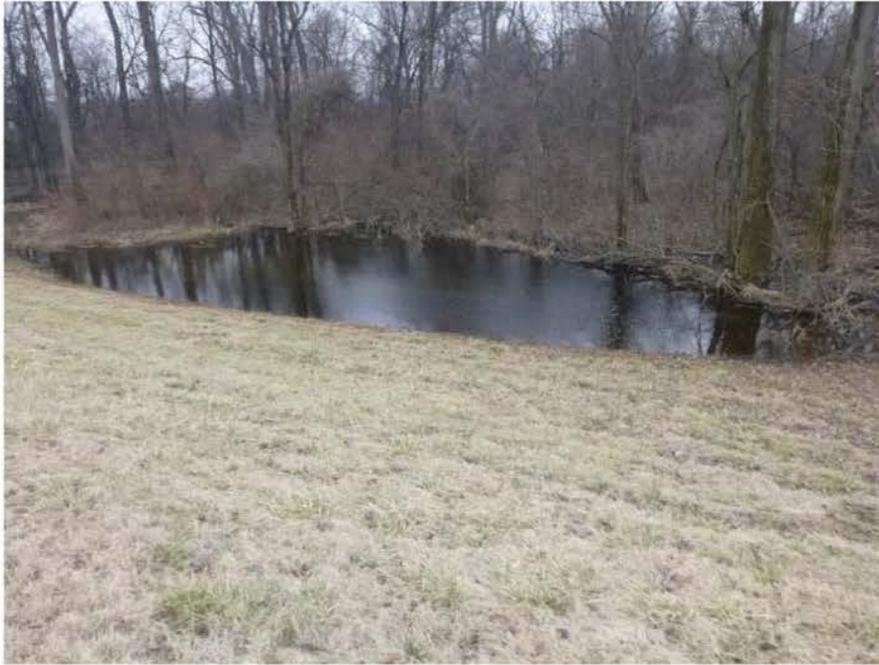
Photo 27:

Downstream area along the southern embankment consists of a zone of dense, rooted vegetation with heights exceeding several feet and trees with flat, open farming field further south. An area of ponded water at the downstream toe area, at the western end of the southern embankment, was observed during our inspection. The ponded water appeared to have accumulated due to recent rainfall. No other ponded water or seepage was observed in the downstream area of southern embankment.

Ponded water in downstream toe area of southern embankment, at the western end of the embankment.

The ponded water area in the downstream toe area of the southern slope, that formed directly adjacent to toe of the embankment, should be repaired so that water will not pond in this area.

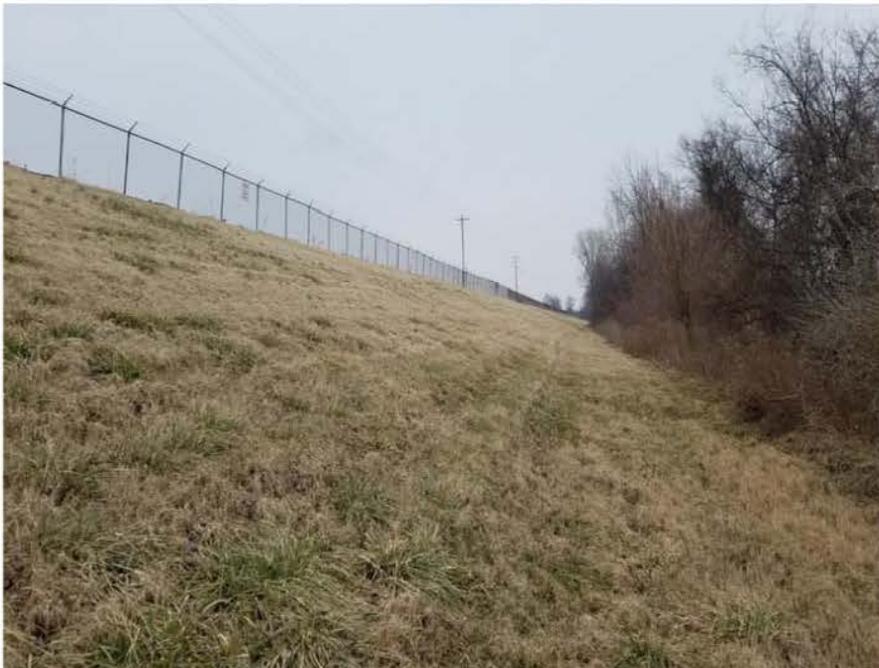
Photo 28:

Downstream slope of southern embankment (view towards East).

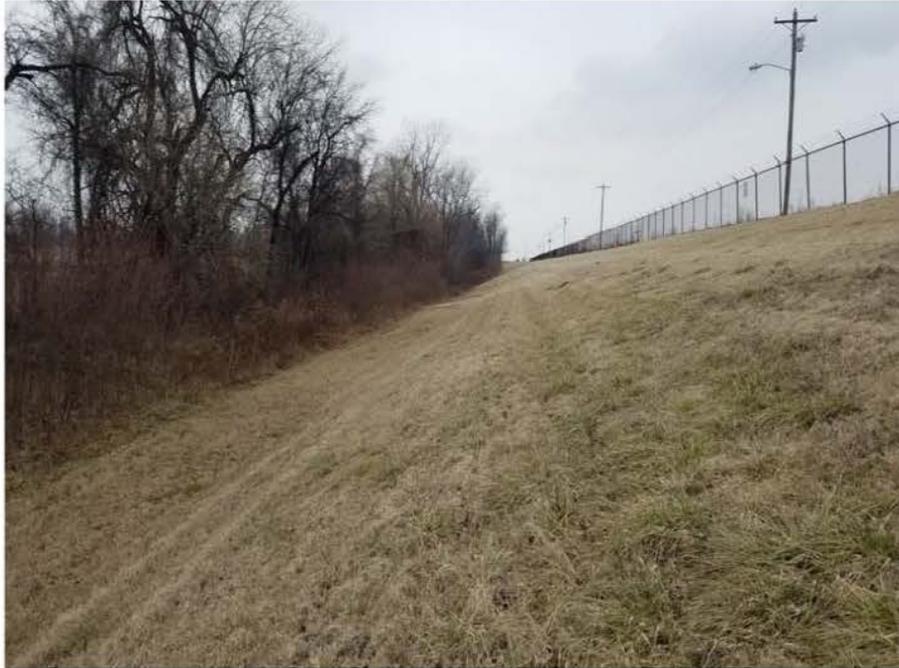
Photo 29:

Downstream slope of southern embankment (view towards West).

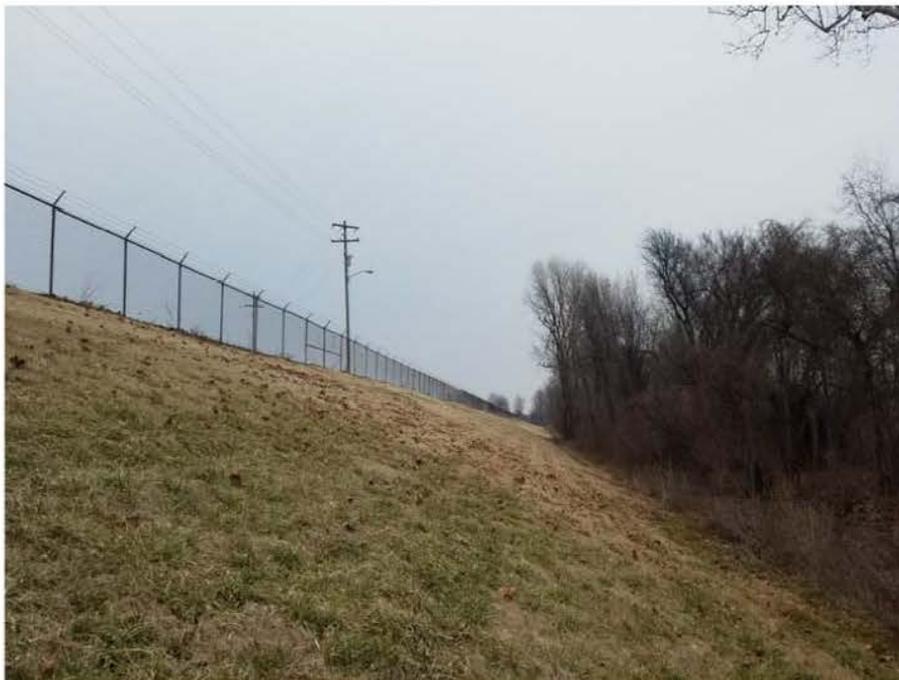
Photo 30:

Downstream slope of southern embankment (view towards East).
