REPORT ON
PERIODIC STRUCTURAL STABILITY ASSESSMENT
POND 001 – CELL 001
THOMAS HILL ENERGY CENTER
CLIFTON HILL, MISSOURI

by Haley & Aldrich, Inc.
Cleveland, Ohio

for Associated Electric Cooperative, Inc.
Clifton Hill, Missouri

File No. 128064-022
October 2021

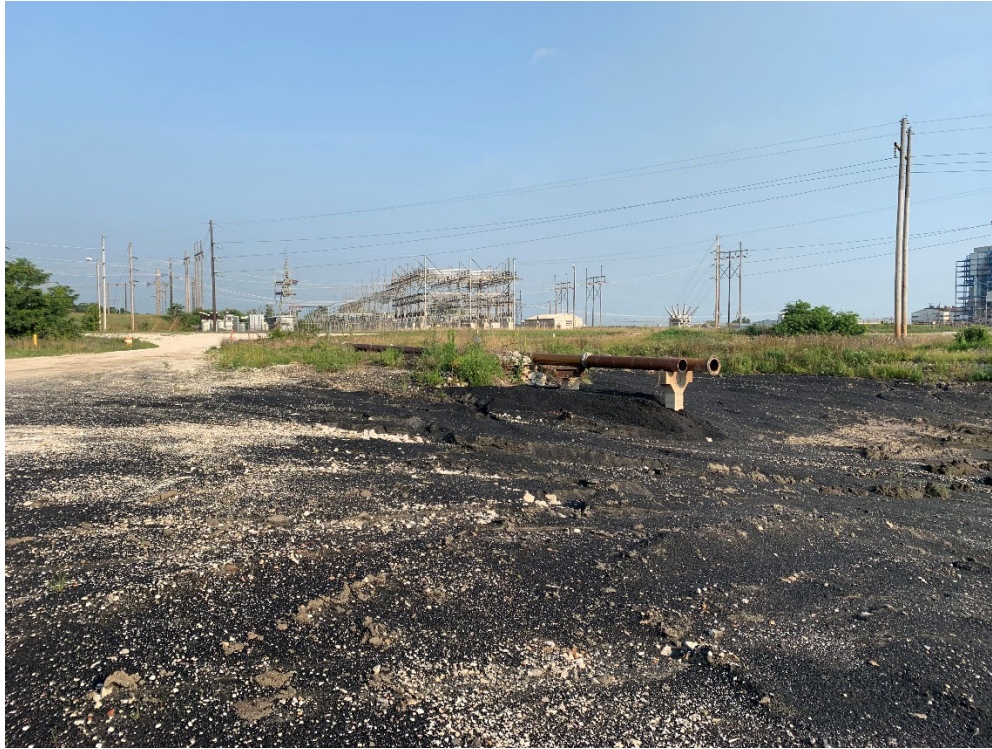
Photo No. 1
Overview historic inlet pipe southwest corner of pond

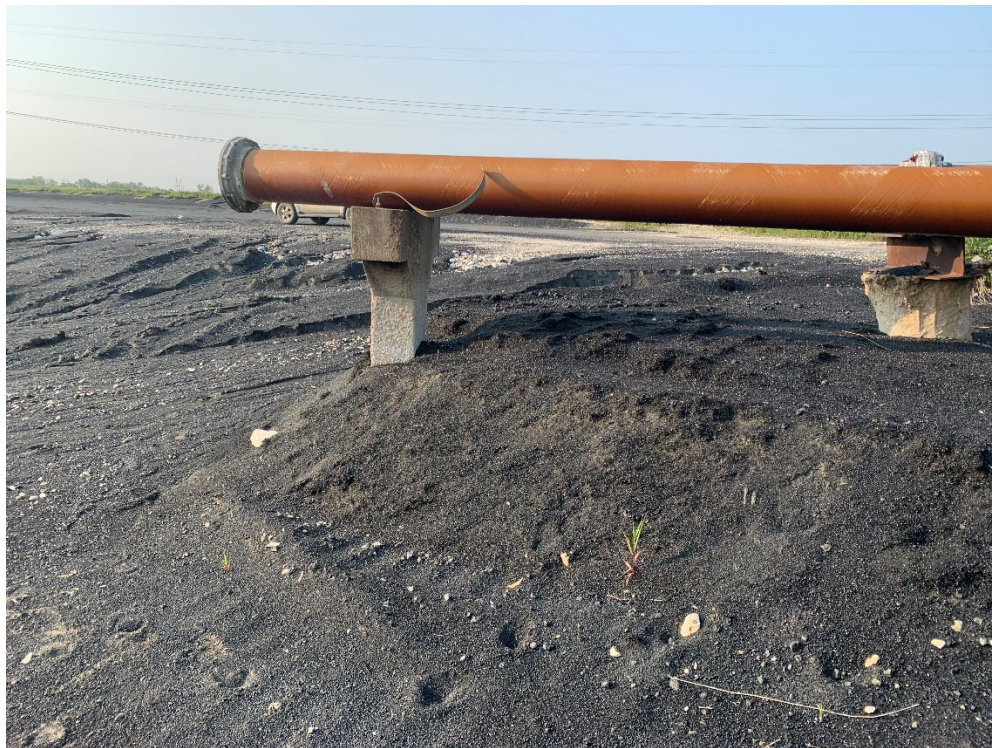
Photo No. 2
Historic inlet pipe southwest corner of pond facing south

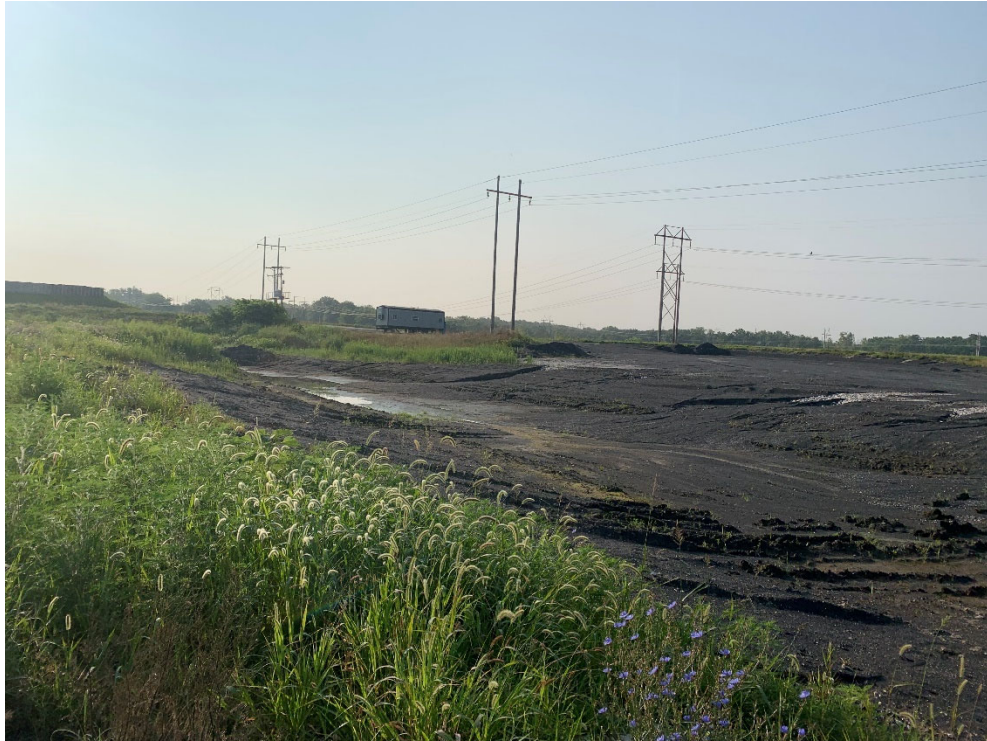
Photo No. 3

Overview of south side of pond from southwest corner of finger dike

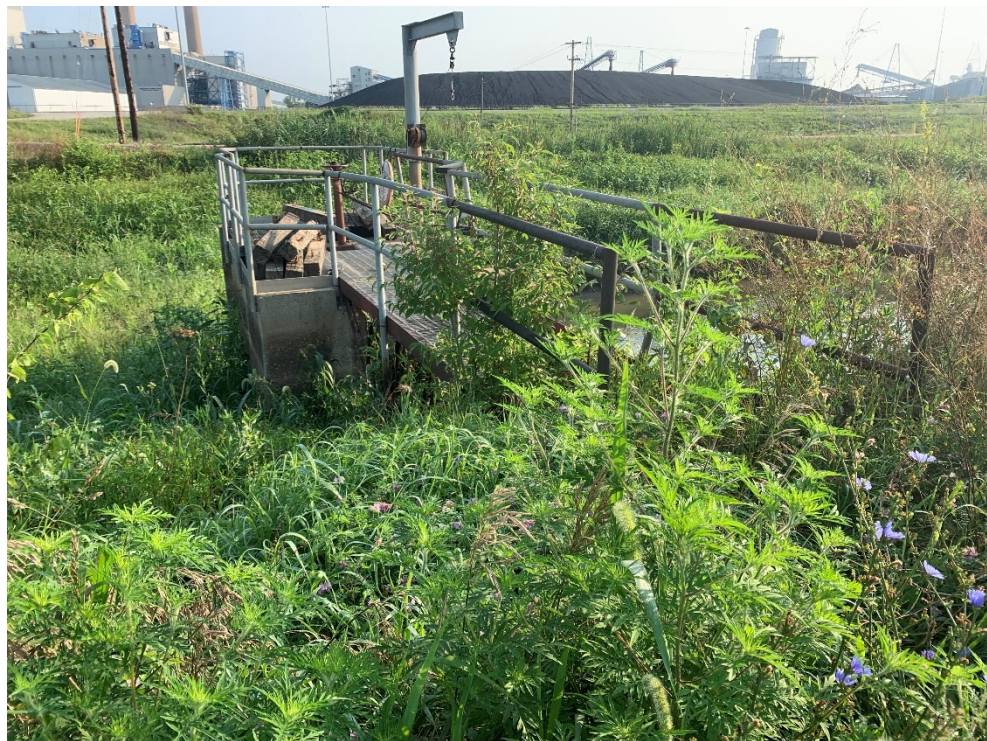
Photo No. 4

The walkway leading to the structure was overgrown with tall grasses and shrubs. The decant structure has some surface pitting on the concrete and surface rust on some of the metal components but was judged to be in good condition overall.

Tall vegetation around outlet control structure

2. Tall vegetation – Cut vegetation and maintain at the required maximum height per the regulations. Maintain in a manner to reduce and control woody vegetation.

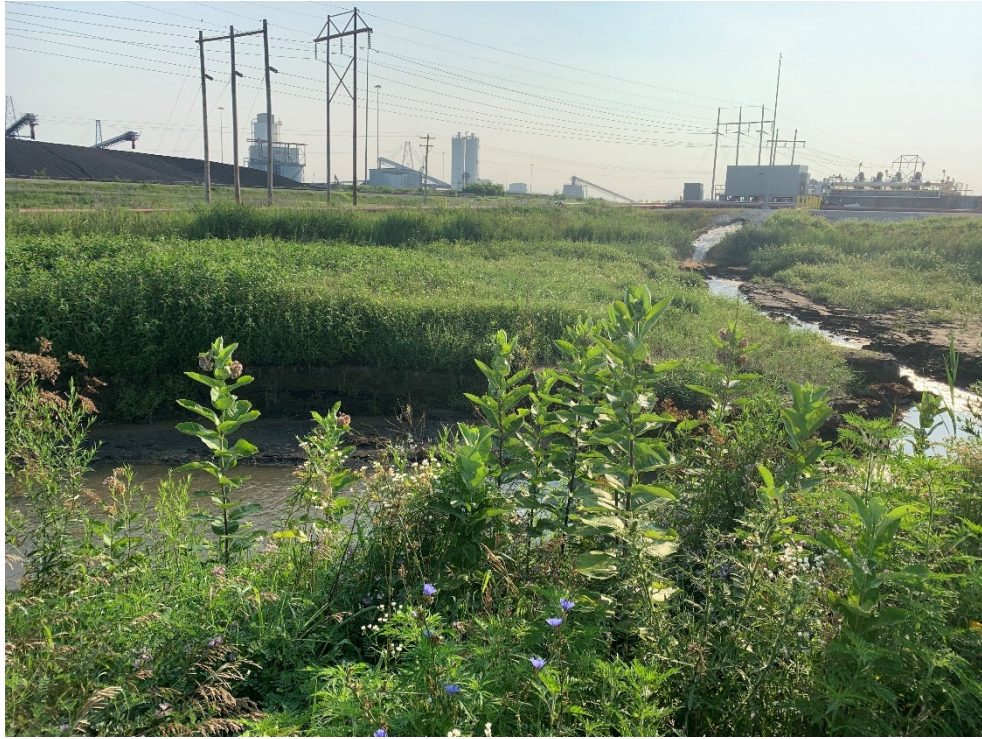
Photo No. 5

Tall vegetation in foreground at northeast corner of finger dike
Inlet pipe from CDT in background

1. Tall vegetation – Cut vegetation and maintain at the required maximum height per the regulations. Maintain in a manner to reduce and control woody vegetation.

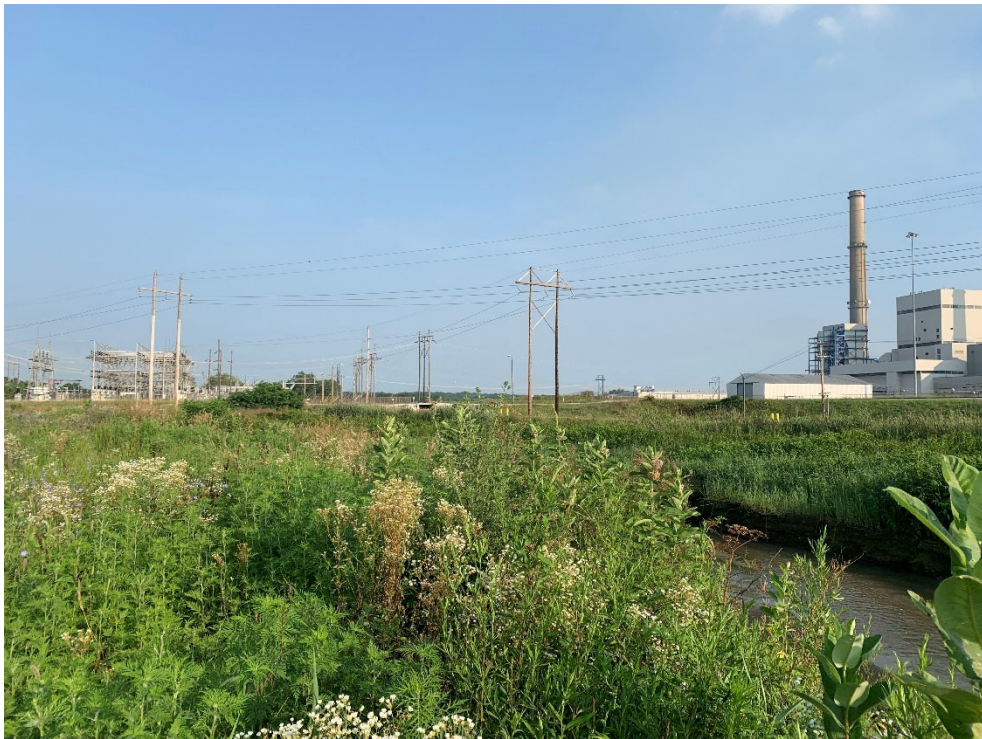
Photo No. 6

Tall vegetation along finger dike north embankment

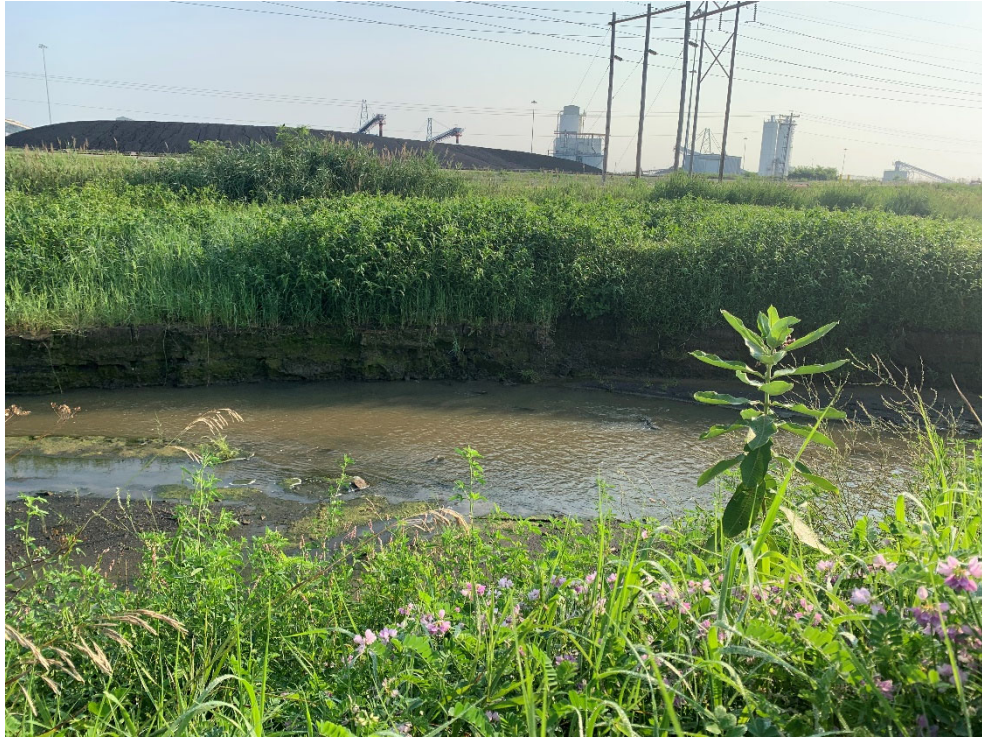
Photo No. 7
Tall vegetation on north upstream slope of pond

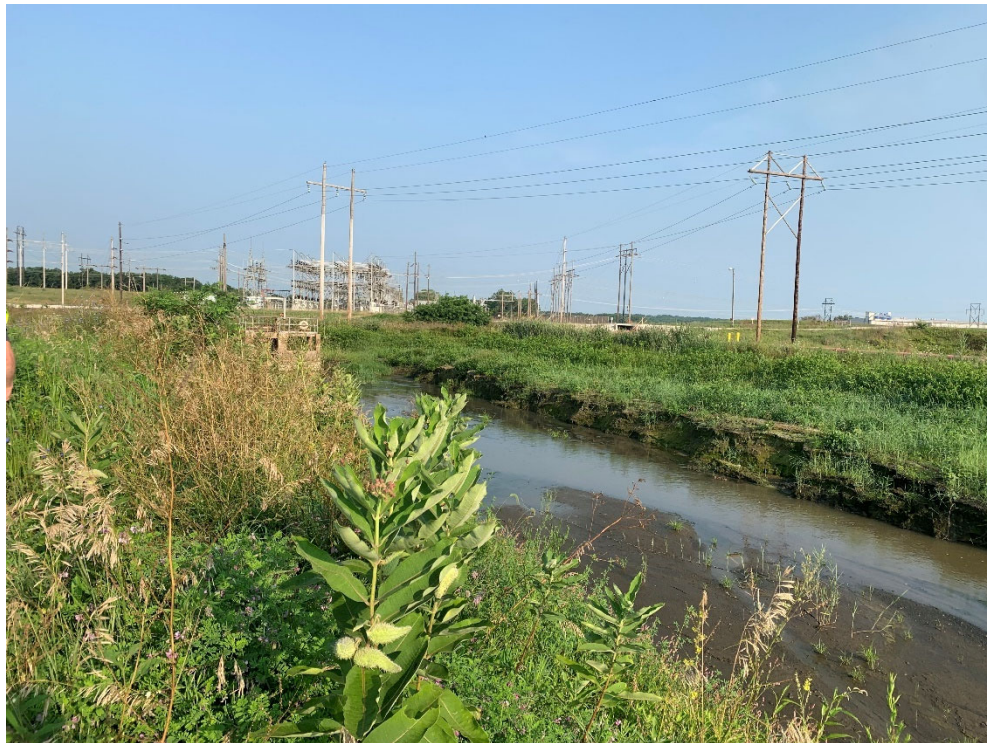
Photograph No. 8
Overview of north side of pond from northeast corner of finger dike

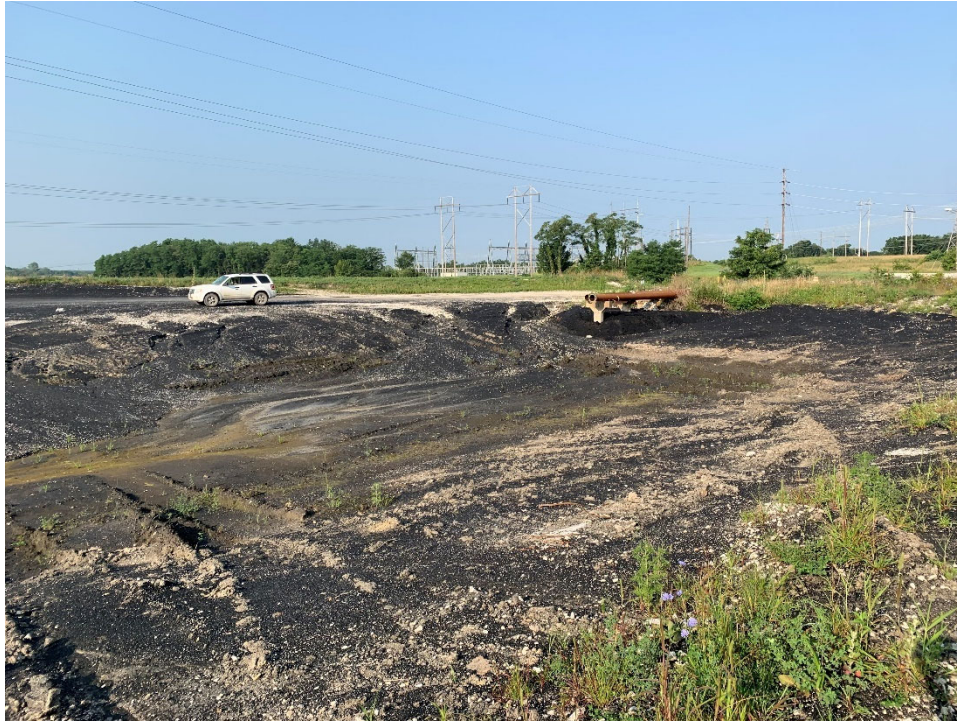
Photo No. 9
Overview of CCR removal from southwest corner of pond

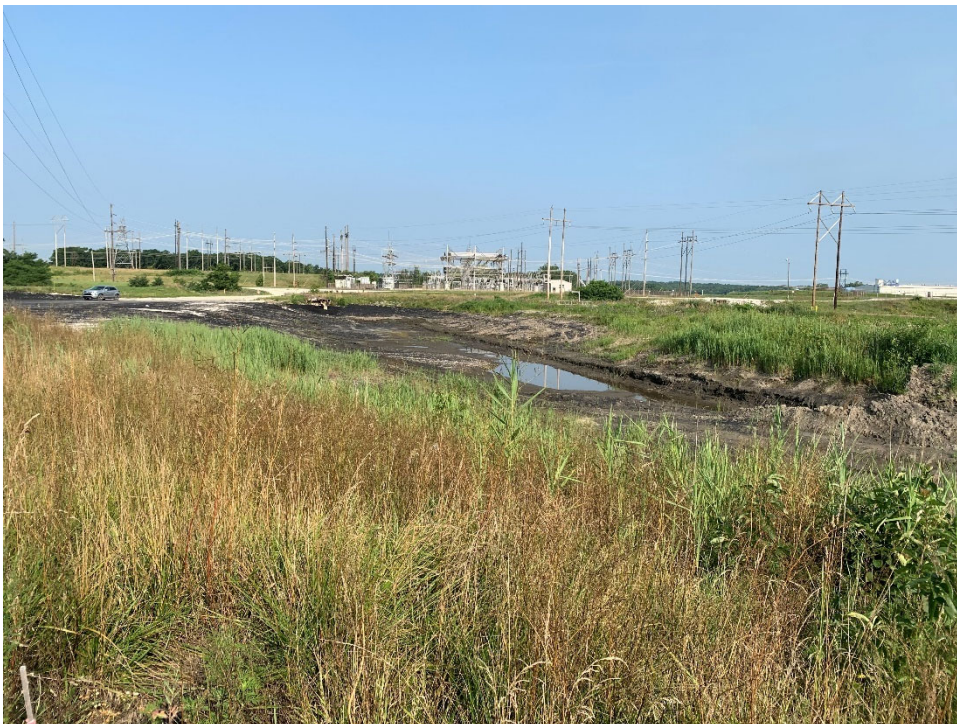
Photo No. 10
Tall vegetation along southeast upstream embankment

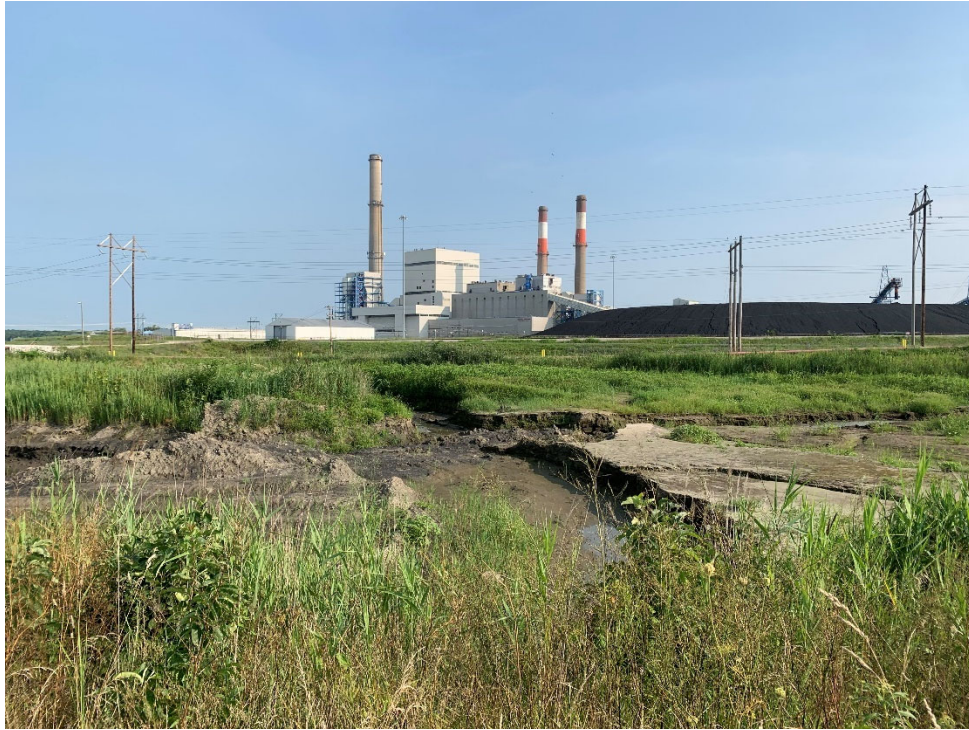
Photo No. 11
Overview of east side of pond and end of finger dike from south embankment

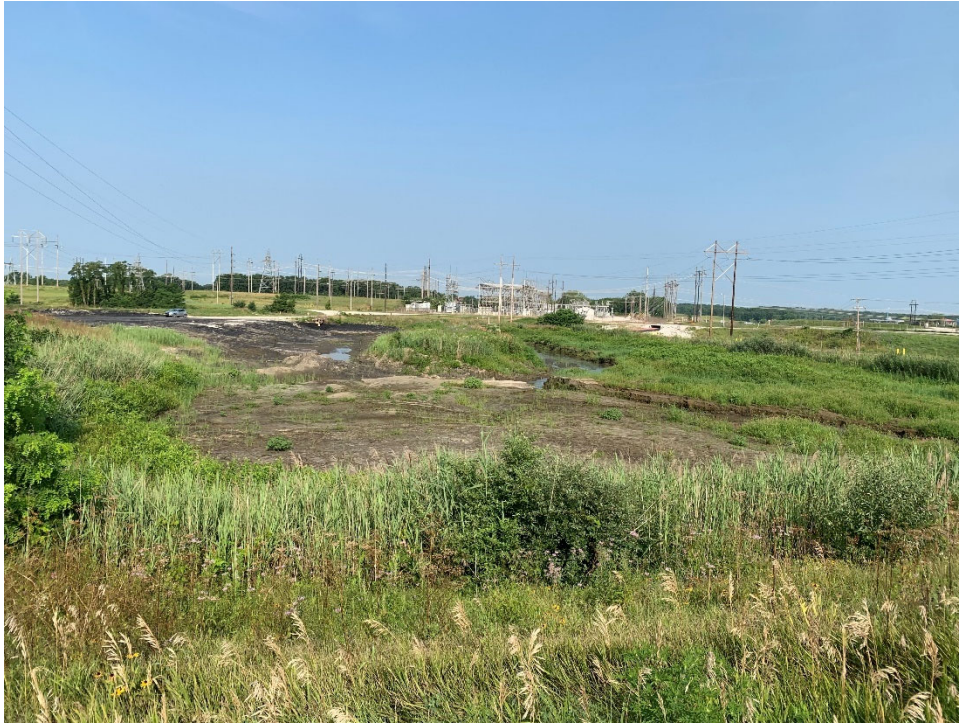
Photo No. 13
Overview of pond from east embankment

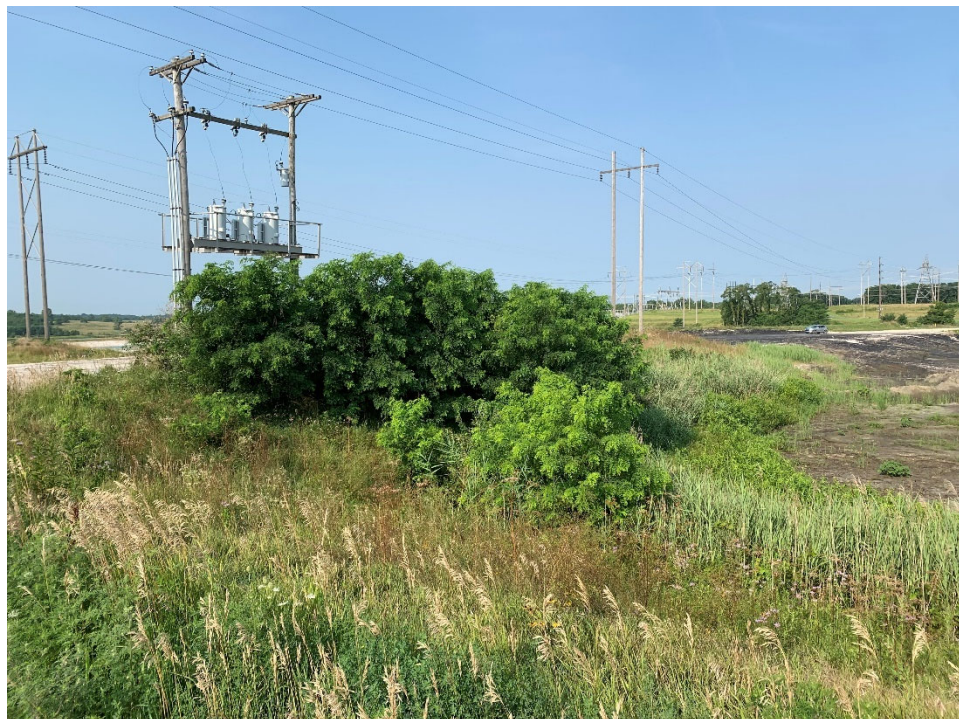
Photo No. 14
Tall woody vegetation in southeast embankment

5. Woody Vegetation – Remove woody vegetation encroaching on embankments to prevent degradation of the embankment.
6. Tall vegetation – Cut vegetation and maintain at the required maximum height per the regulations. Maintain in a manner to reduce and control woody vegetation.

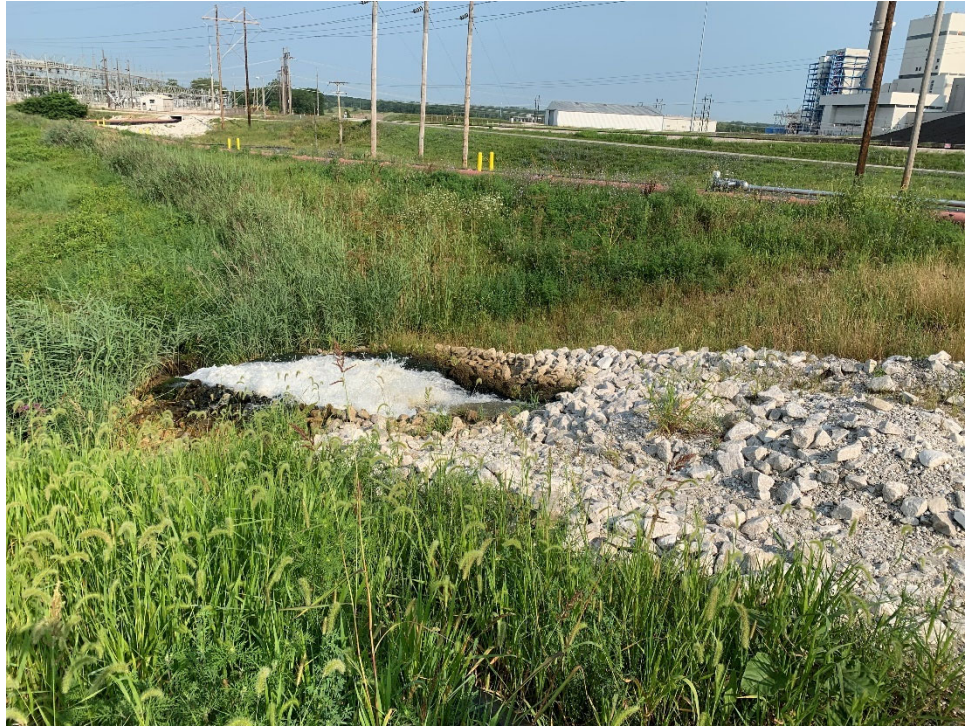
Photo No. 15
Discharge pipes from CDT at northeast corner of Cell 001

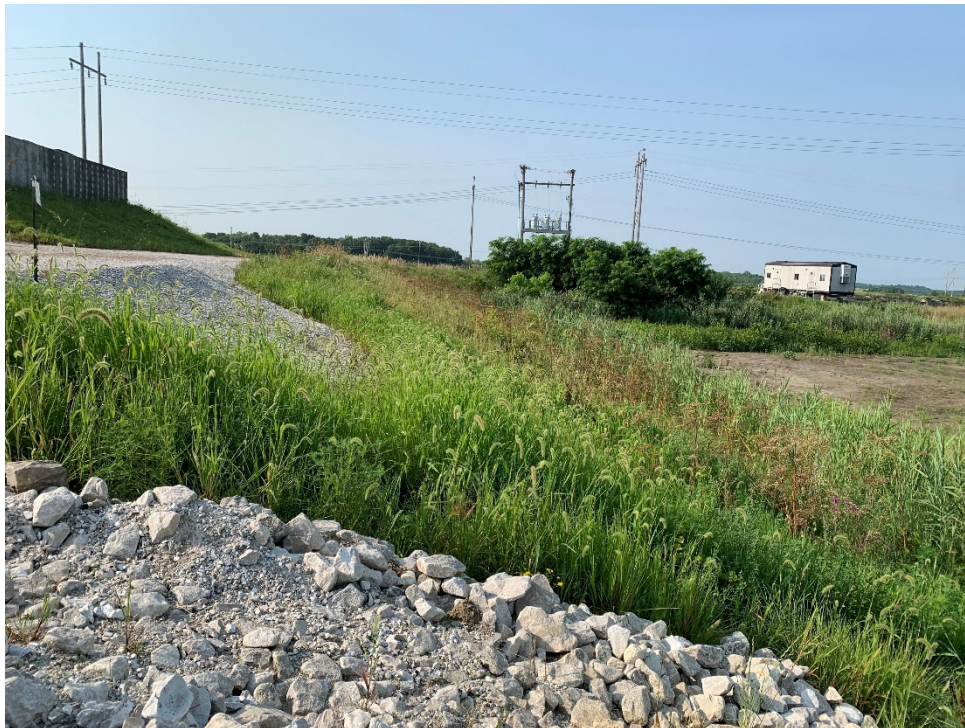
Photo No. 16
Vegetation exceeding 1 ft along east upstream embankment

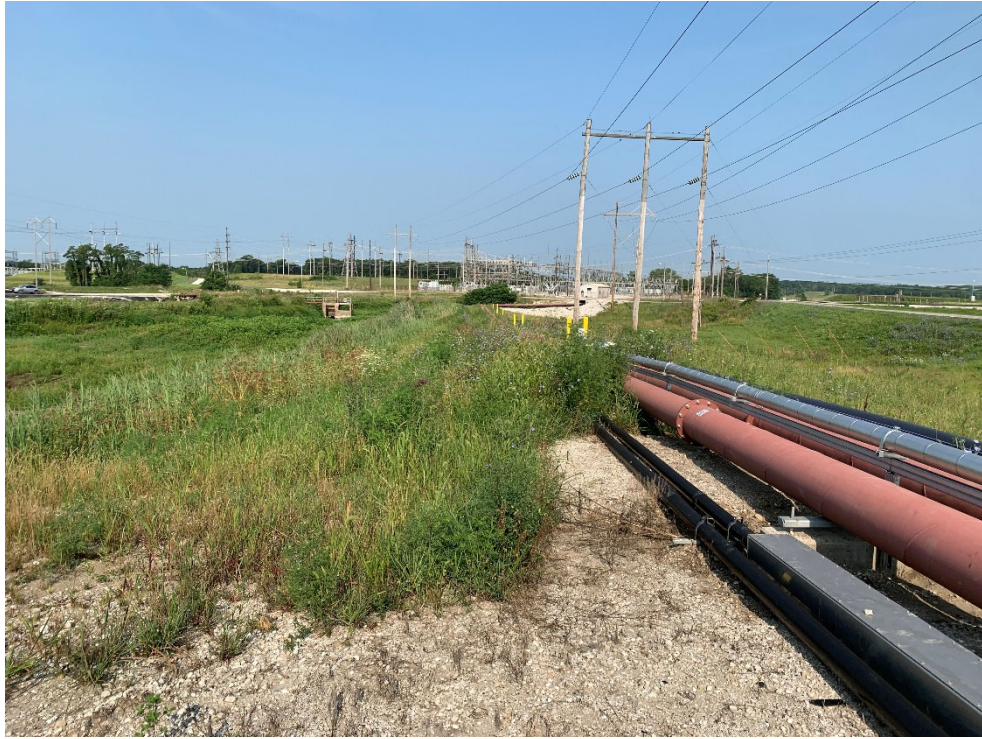
Photo No. 17
Above ground utility lines along top of north embankment

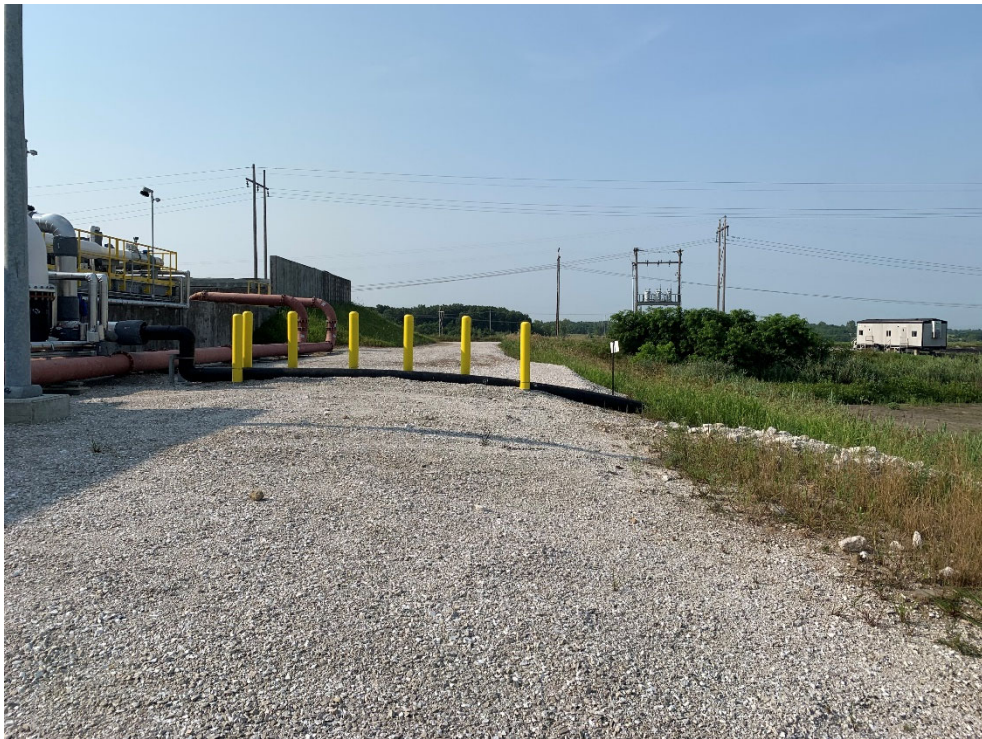
Photo No. 18
Aggregate top of east embankment

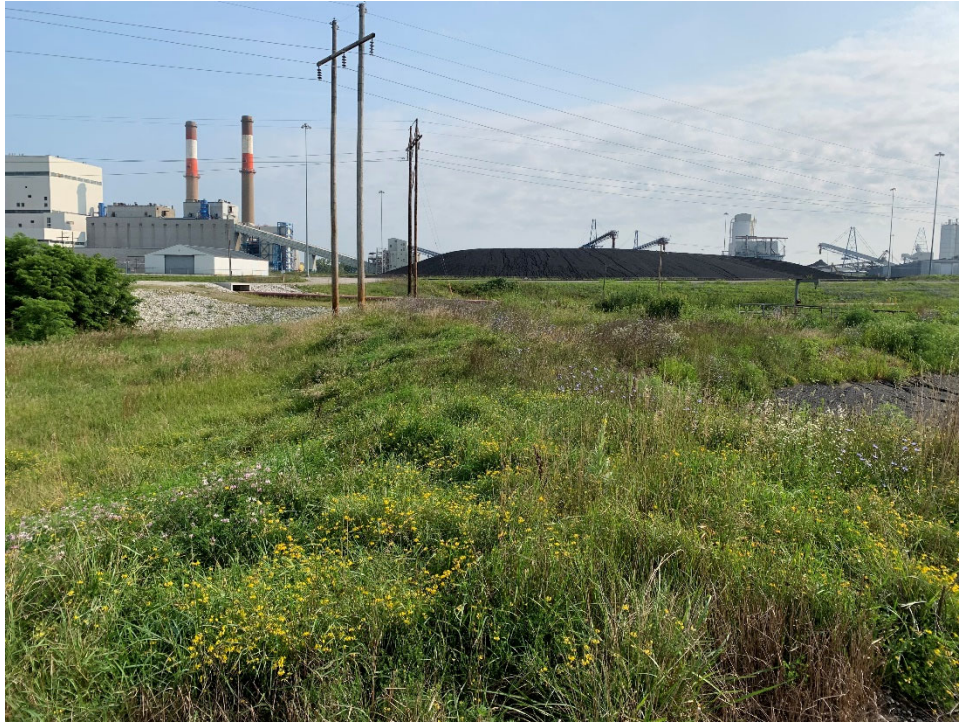
Photo No. 19

Vegetation greater than 1 ft along west embankment downstream slope

4. Tall vegetation – Cut vegetation and maintain at the required maximum height per the regulations. Maintain in a manner to reduce and control woody vegetation.

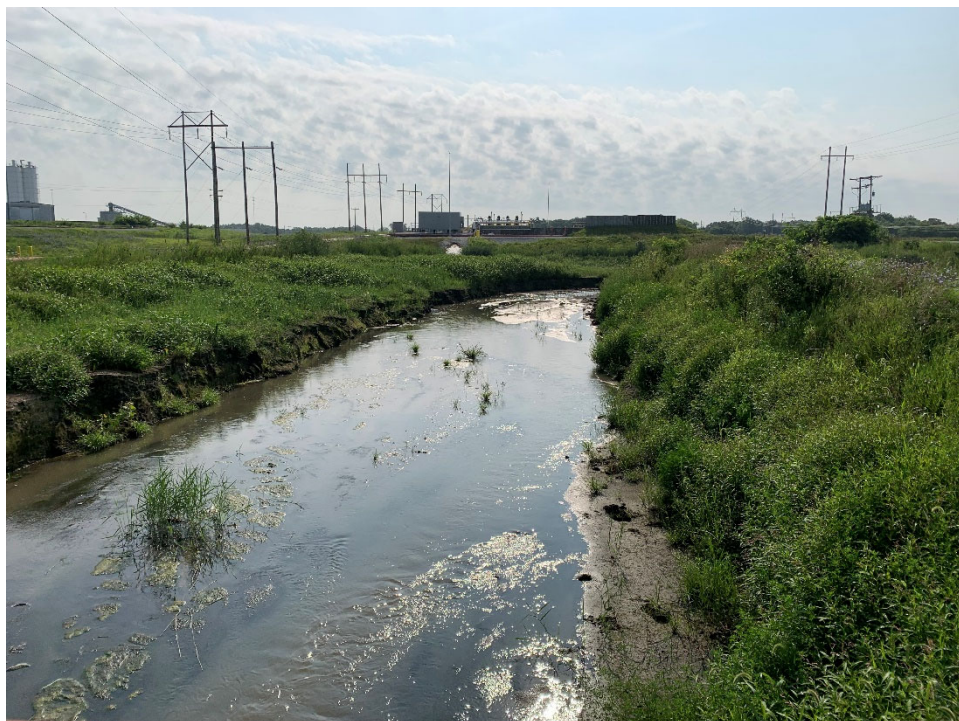
Photo No. 20

Tall vegetation along north slope of finger dike
View from outlet control structure facing east

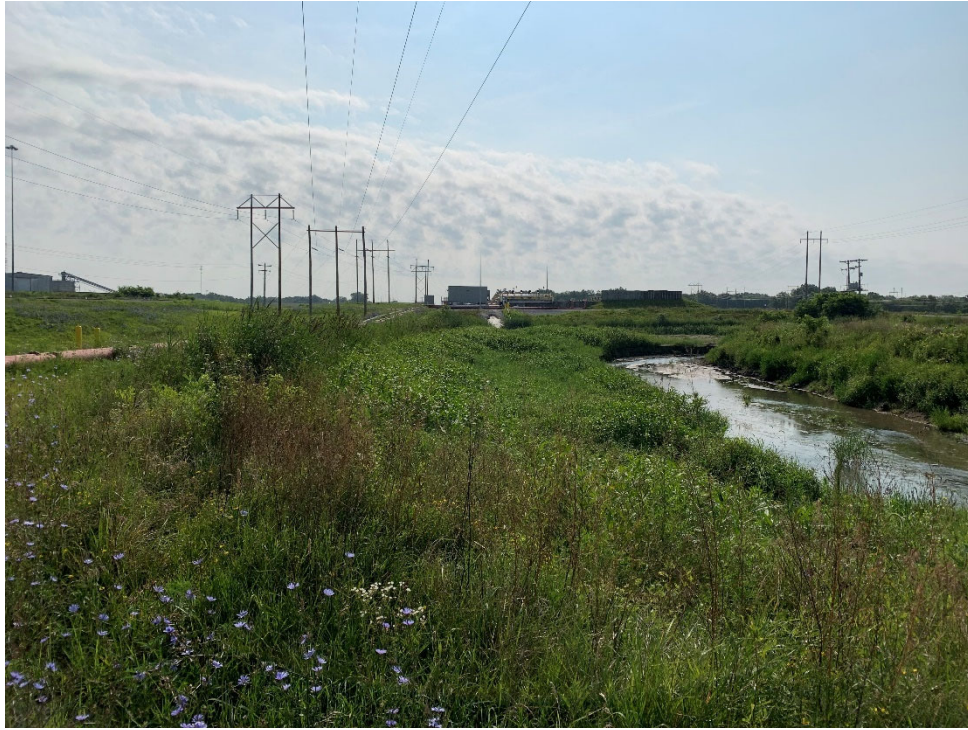
Photo No. 21
Tall vegetation along north upstream embankment

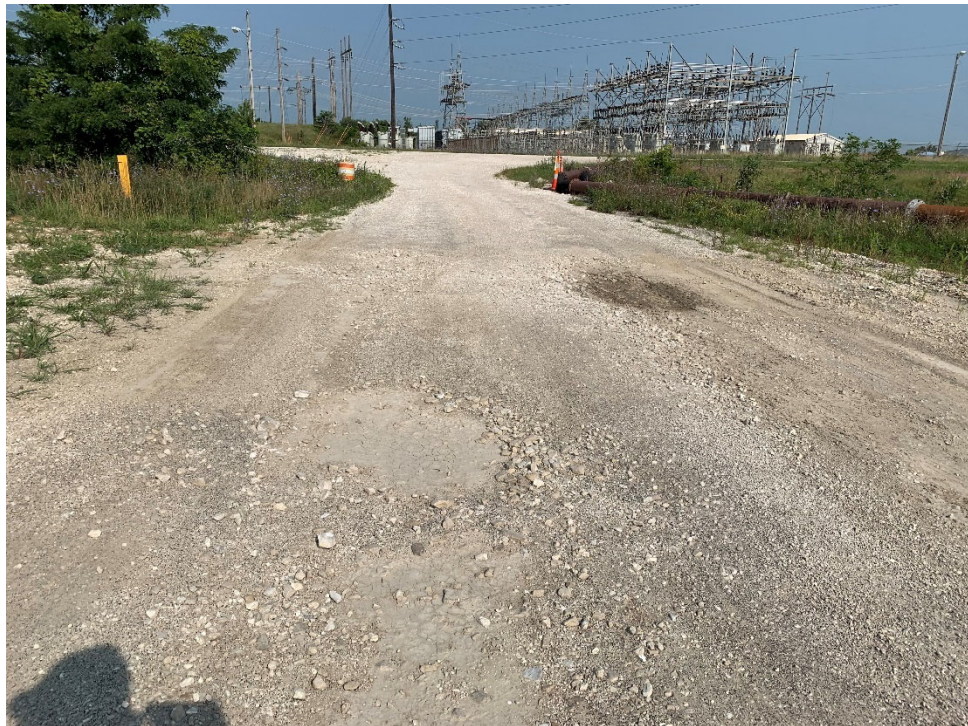
Photo No. 22
Aggregate road rutting and potholes

3. Ruts and Puddles – Monitor the area and fill eroded areas with additional aggregate material to prevent further degradation of the surface if necessary.

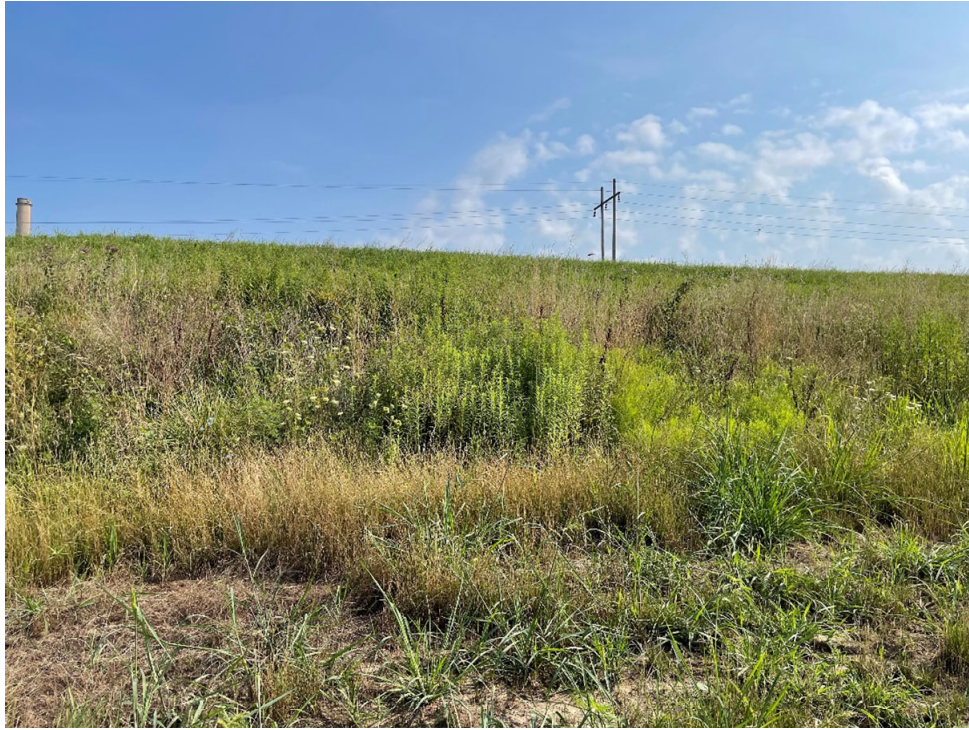
Photo No. 23
Typical vegetation on embankment downstream slope

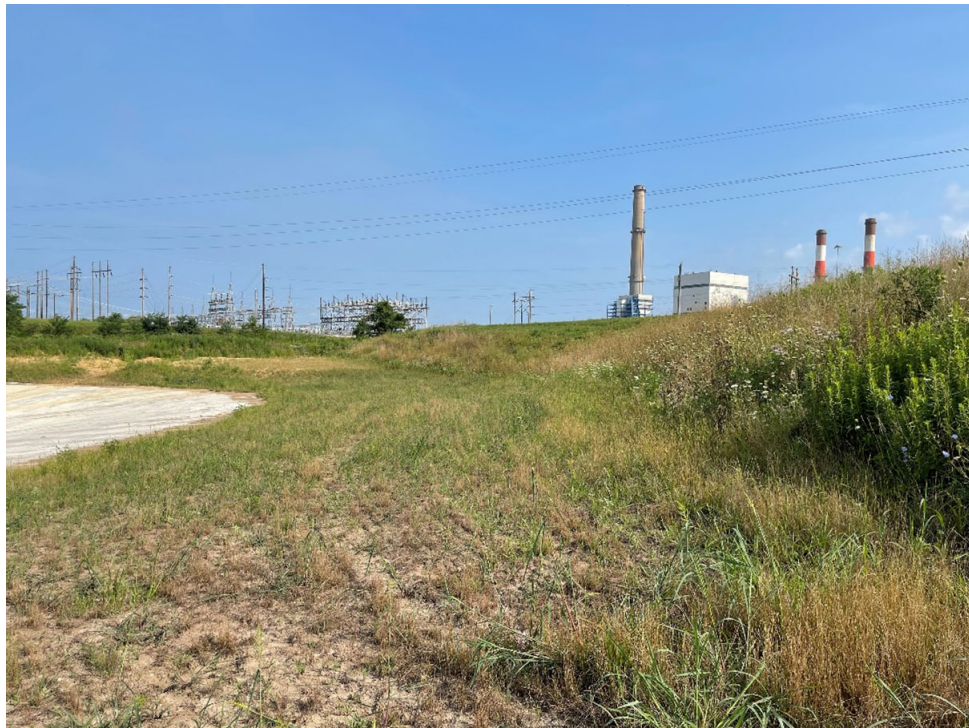
Photo No. 24
Embankment downstream area
Cell 002 at left
