Associated Electric Cooperative, Inc.  
New Madrid Power Plant  
New Madrid County, Missouri

Subject: Initial Annual CCR Landfill PE Inspection  
Utility Waste Landfill  
New Madrid Power Plant  
New Madrid County, MO

**REPORT ON**  
**INITIAL ANNUAL CCR LANDFILL PE INSPECTION**  
**UTILITY WASTE LANDFILL**  
**NEW MADRID POWER PLANT**  
**NEW MADRID COUNTY, MISSOURI**

File No. 40616-107  
January 2016

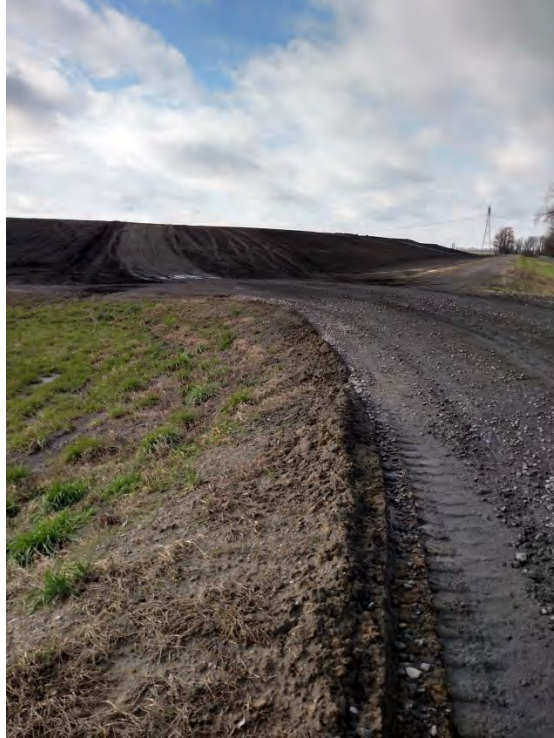
Photograph No. 1  
AECI UWL Inspection  
Haul road approaching northeast landfill corner

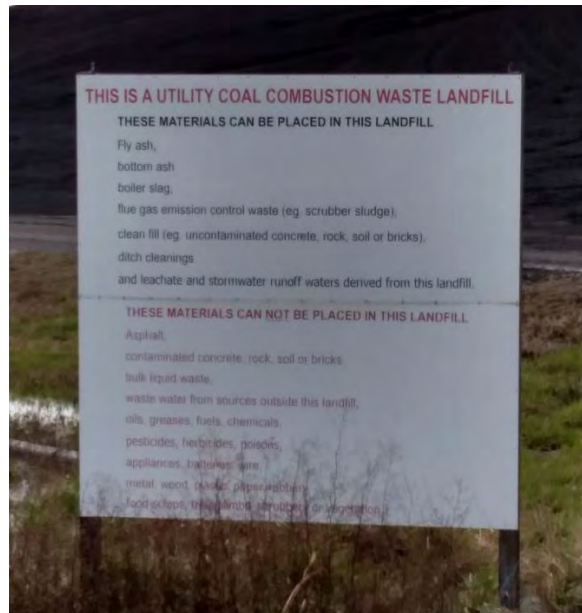
Photograph No. 2  
AECI UWL Inspection  
Sign posted along haul road northeast of landfill

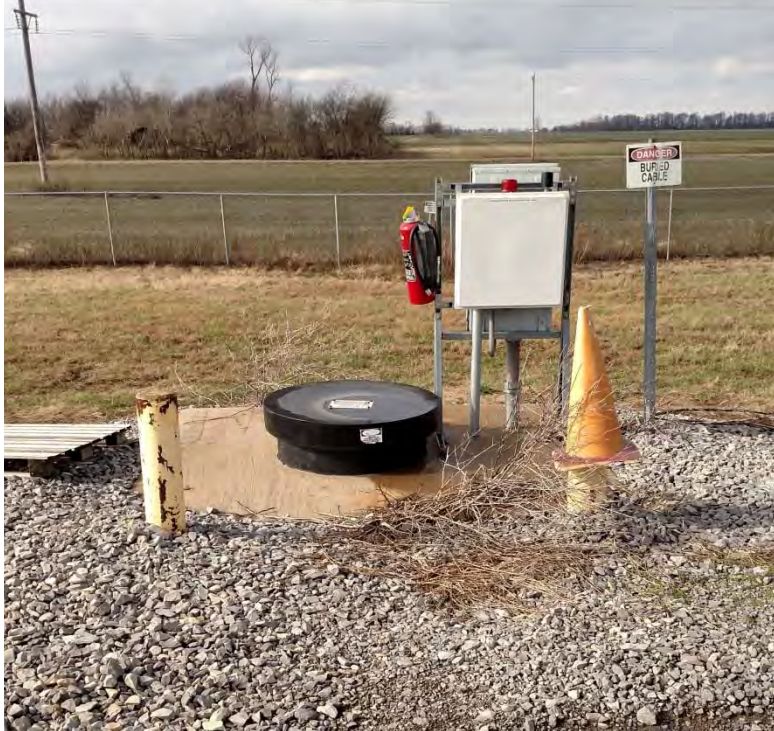
Photograph No. 3  
AECI UWL Inspection  
Inspection leachate collection manhole cover and electrical control box for pump

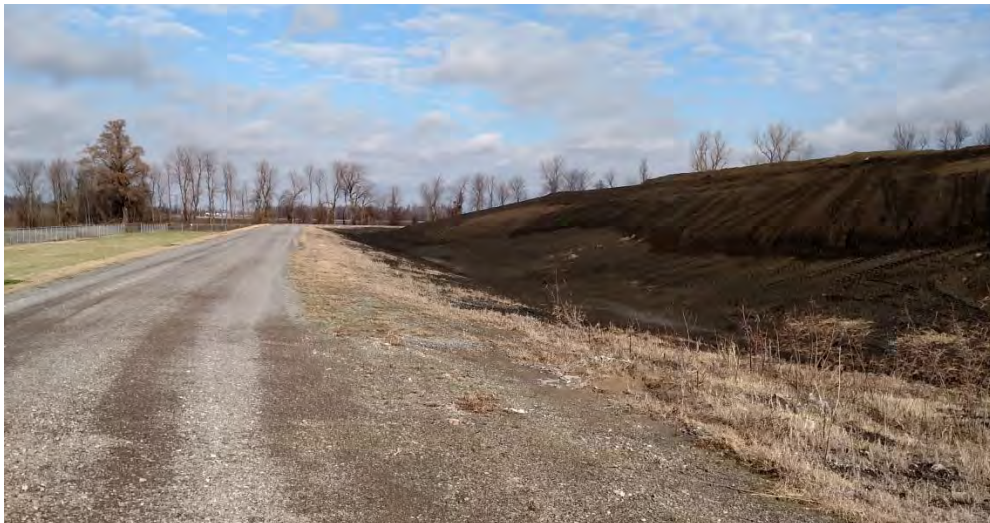
Small erosion rills, less than 6-inches deep, and several erosion rills between 6 and 12-inches deep were observed in several locations on the landfill side slopes. Erosion rills less than 6-inches deep are not an immediate concern but should be monitored regularly by AECl personnel. When erosion rills exceed 12-inches deep, AECl should consider repairing the area and make modifications as needed to prevent future erosion. Based on discussion with plant personnel, the side slopes are maintained and fine graded with a dozer periodically to repair erosion rills. Typical maintenance is conducted on the side slopes once CCR's in the perimeter ditches and along the side slopes are dry enough to perform the grading. At the time of this inspection, intermediate soil cover had not been placed on any of the landfill side slopes or landfill top.

Photograph No. 4  
AECI UWL Inspection  
Western landfill face and perimeter berm/road

- Consistent with current AECI maintenance and operation procedures, erosion rills should be monitored along landfill side slopes and maintenance should be conducted to repair areas where erosion rills greater than 12 inches become apparent. We recommend that AECI evaluate causes of erosion (e.g. stormwater flow paths) and determine if measures or re-direction of that flow path are appropriate to limit the erosion development.

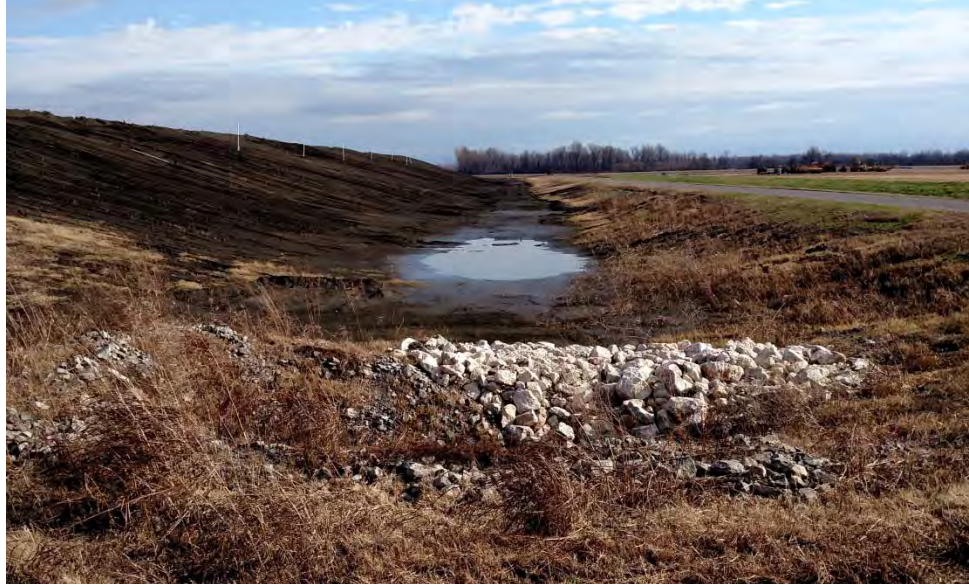
Photograph No. 5  
AECI UWL Inspection  
Southern landfill face and rock protection at stormwater pipe

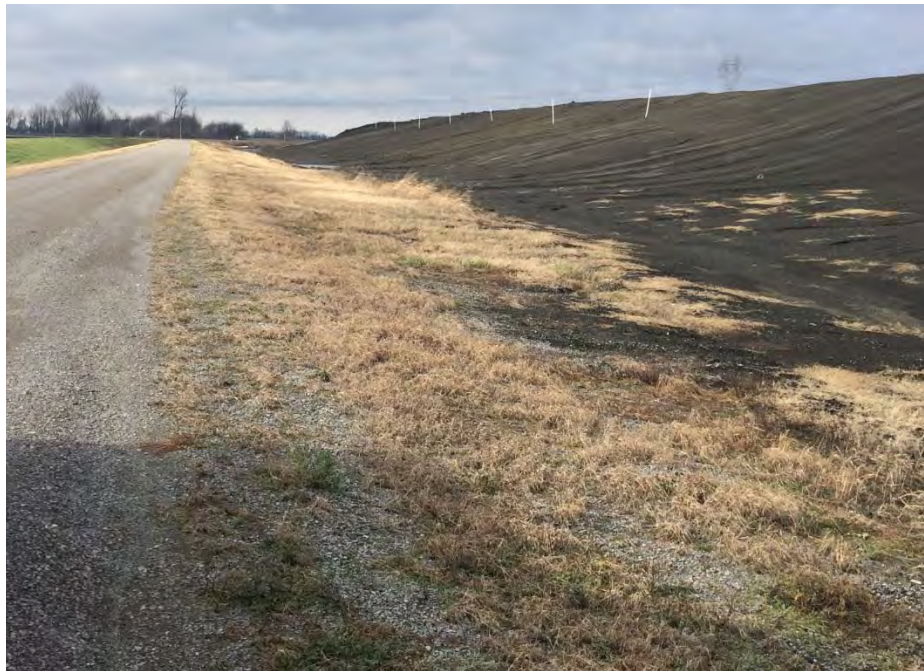
Photograph No. 6  
AECI UWL Inspection  
Southern landfill face and perimeter berm/road

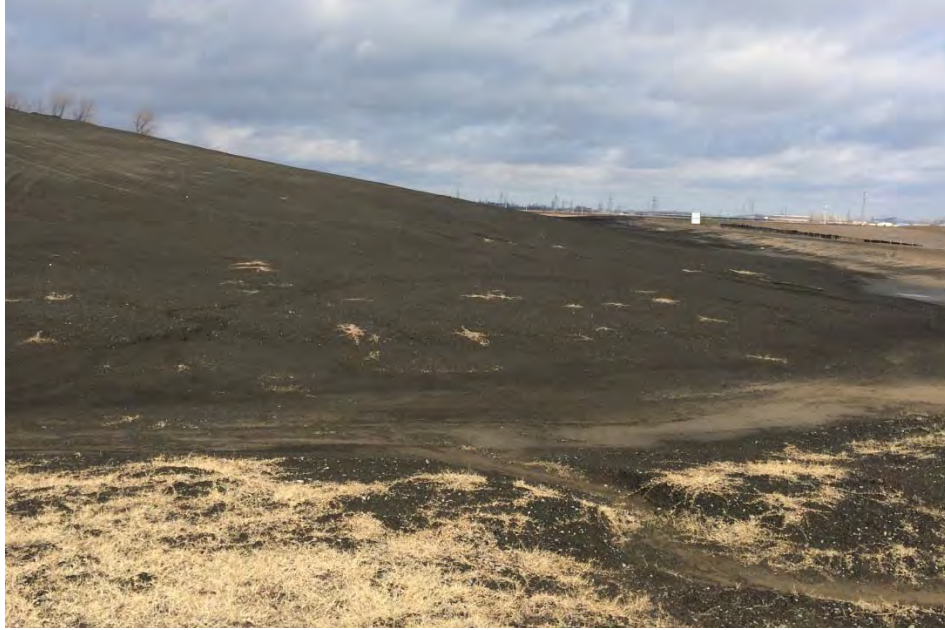
Photograph No. 7  
AECI UWL Inspection  
Eastern landfill face

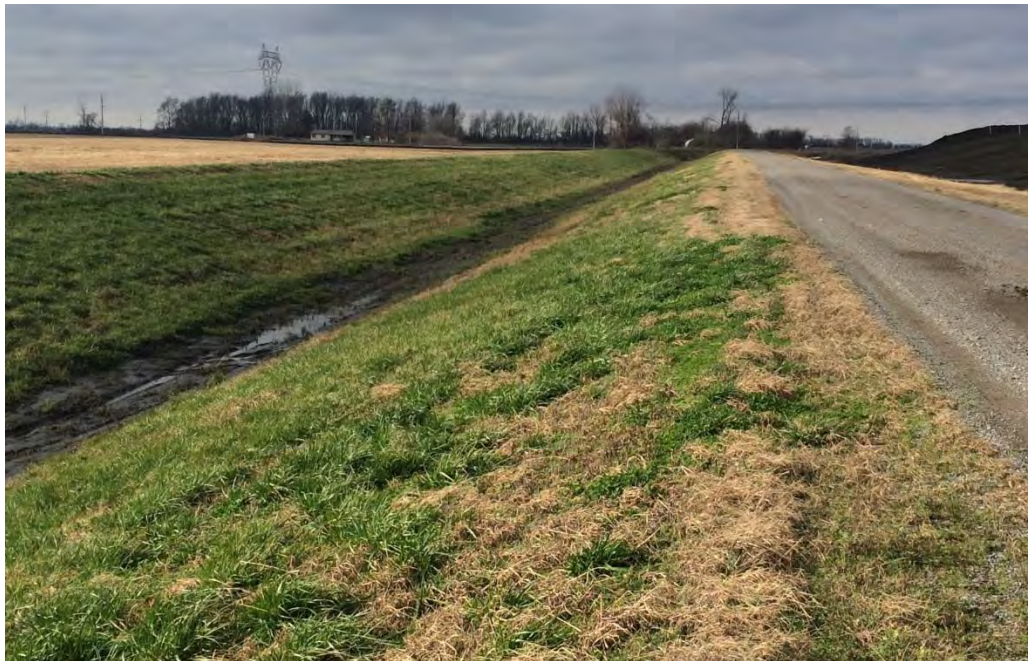
Photograph No. 8  
AECI UWL Inspection  
Stormwater drainage ditch

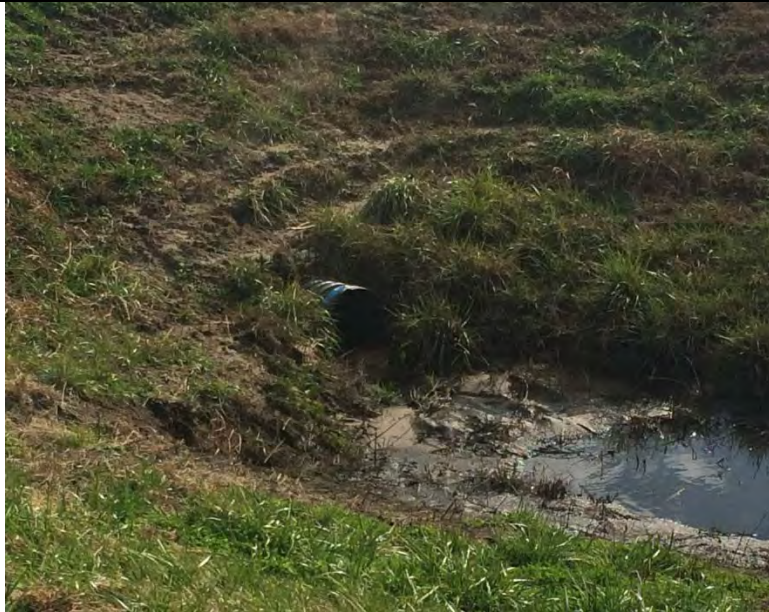
Photograph No. 9  
AECI UWL Inspection  
Stormwater pipe from drainage ditch to sedimentation pond

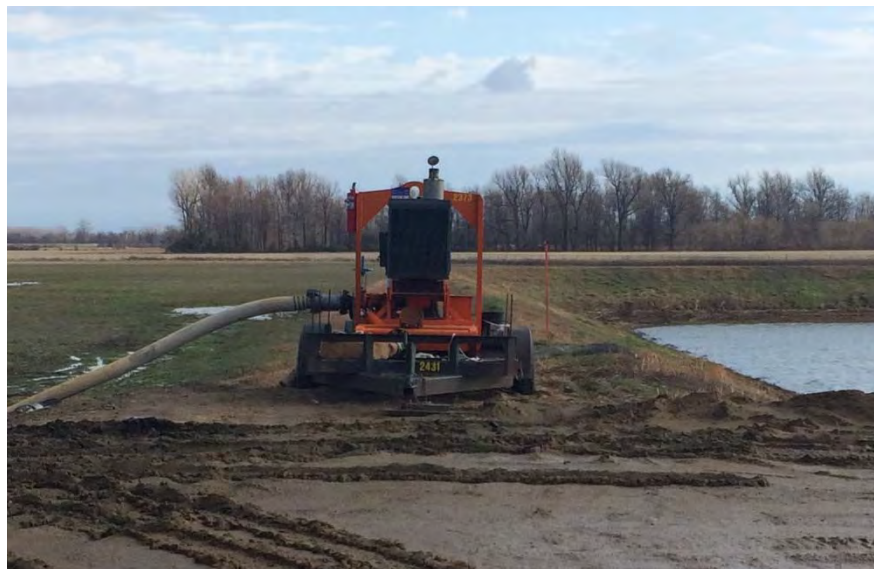
The sedimentation pond was being pumped to the Lined Ash Pond during the inspection. Based on discussion with plant personnel, the sedimentation pond is pumped periodically and is typically pumped to a water level where pump suction can no longer be maintained. No significant erosion, uncontrolled vegetation, or other signs of distress were observed on the inner or outer side slopes of the sedimentation pond.

Photograph No. 10  
AECI UWL Inspection  
Mobile pump unit, pumping from sedimentation pond

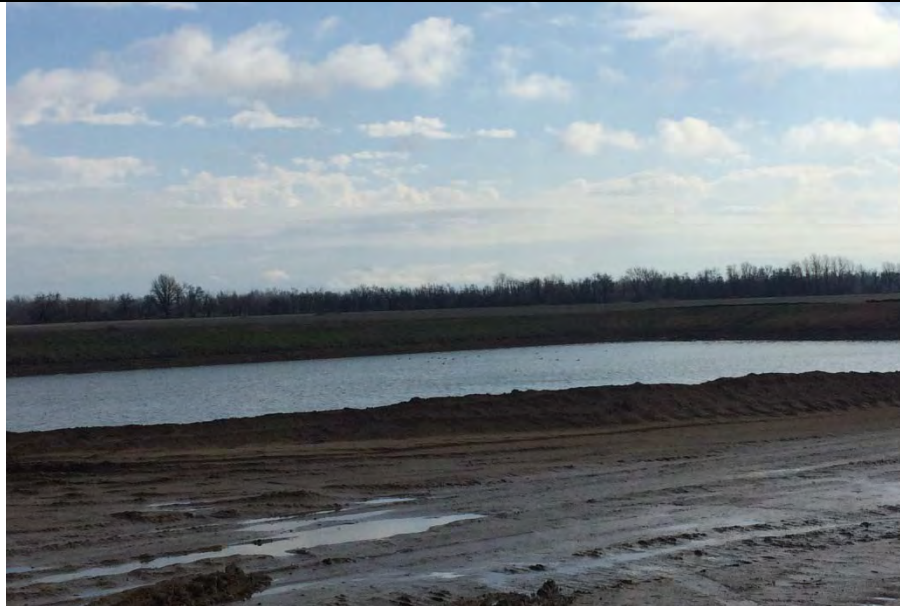
Photograph No. 11  
AECI UWL Inspection  
Sedimentation pond

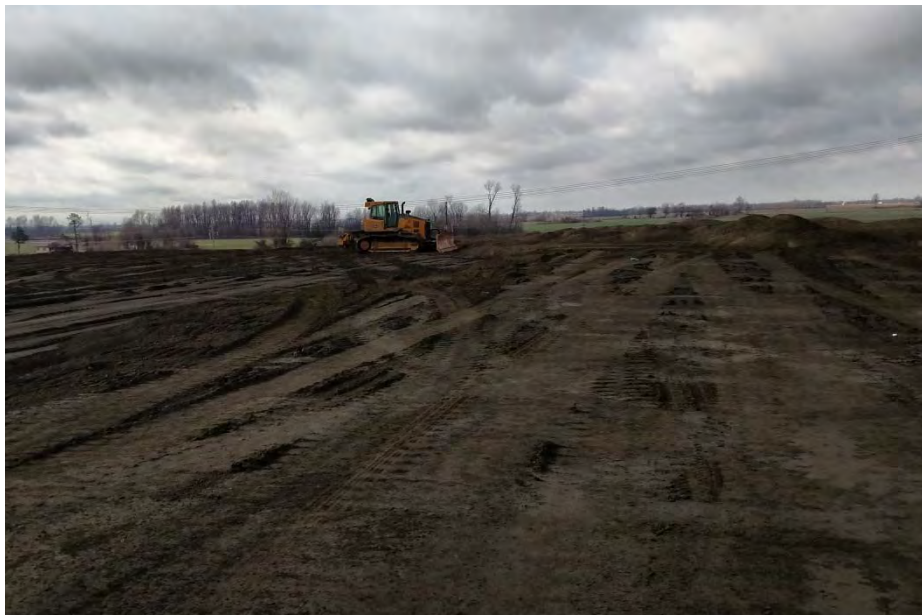
At the time of the inspection, no active CCR placement was taking place. CCRs had been disposed from trucks on the top of the landfill the previous night and were to be spread by a tracked dozer later that day. This sequence of disposal and spreading CCRs in 4-6 inch lifts is typical based on discussion with AECl personnel. CCRs are placed in a way to promote positive drainage off the top of the landfill. In general, we did not observe standing water, settlement, significant erosion, or other signs of distress on the top of the landfill.

Photograph No. 12  
AECI UWL Inspection  
Top of landfill; bulldozer used for CCR grading

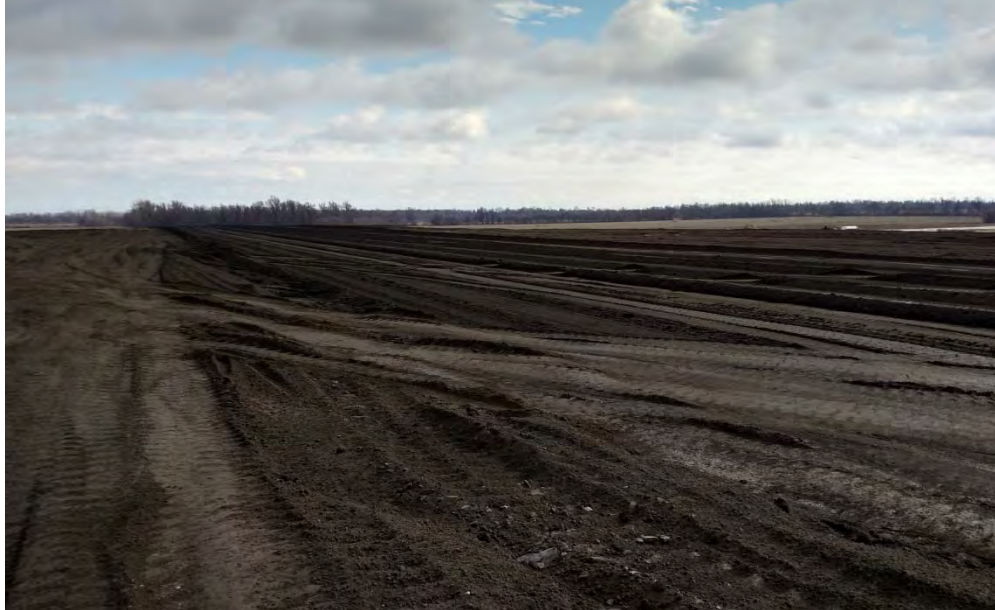
Photograph No. 13  
AECI UWL Inspection  
Top of landfill

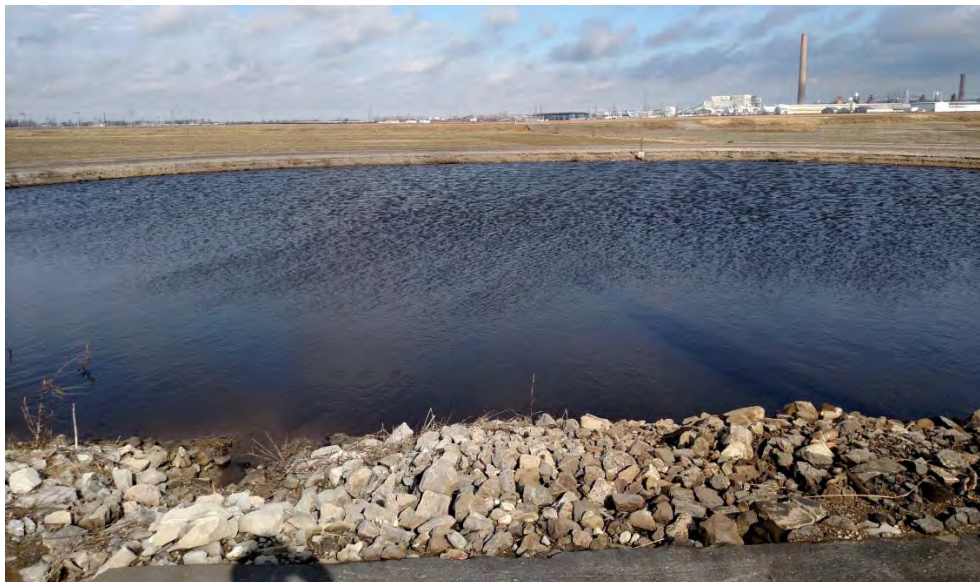
No significant erosion, uncontrolled vegetation, or other signs of distress were observed at the leachate collection pond. The level in the pond was below the posted acceptable operating level. Based on discussion with AECI personnel, the leachate pond is periodically pumped into a haul truck and sprayed on the landfill for dust control. Plant personnel have not encountered problems keeping the water level in the leachate pond controlled, even during rainy periods. Plant personnel report that beyond normal maintenance of the leachate pump system, no operational issues have been encountered.

Photograph No. 14  
AECI UWL Inspection  
Leachate collection pond

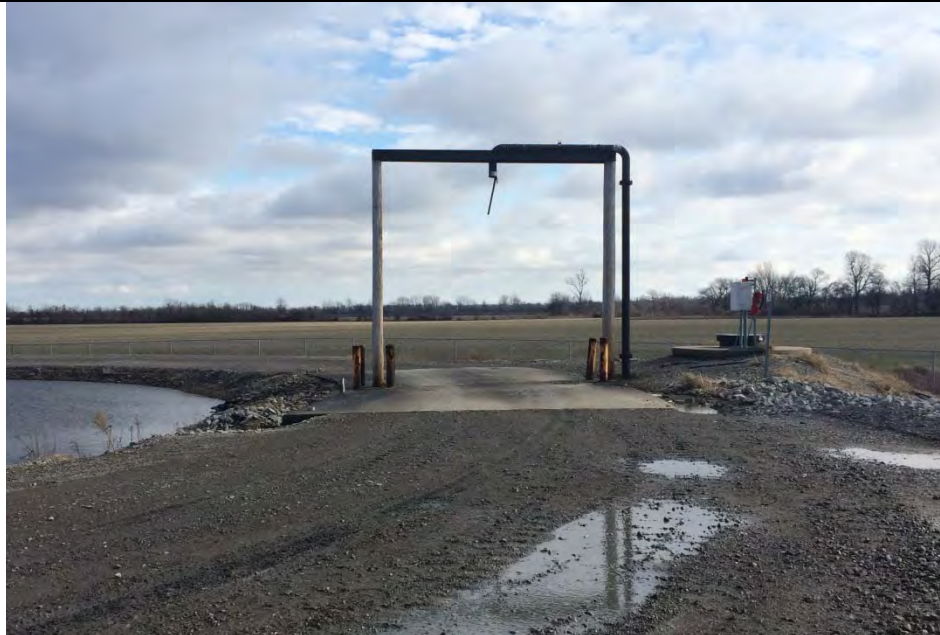
Photograph No. 15  
AECI UWL Inspection  
Leachate loadout structure

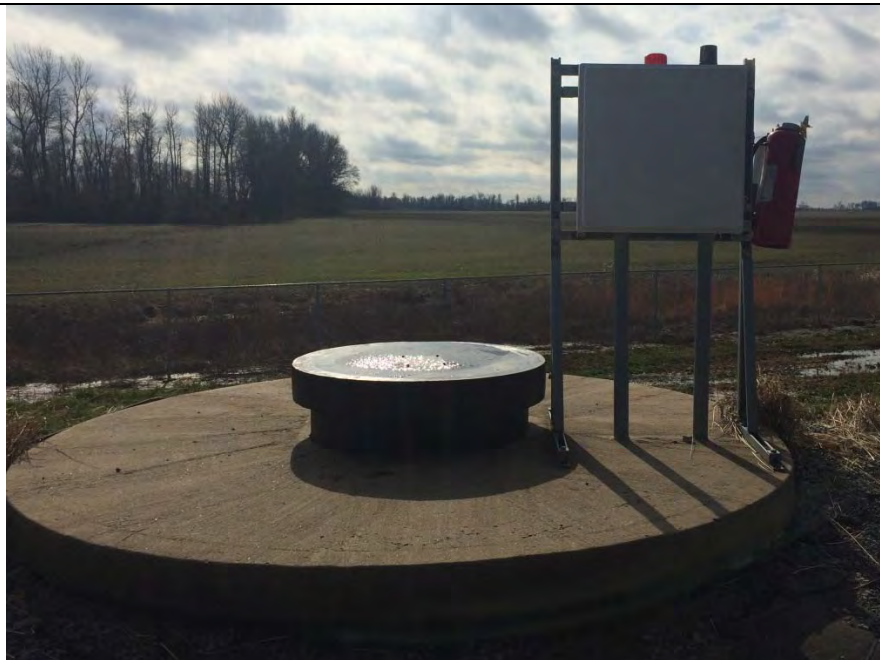
The leachate collection pump system was recently cleaned and as routine system maintenance, parts of the pump system were replaced. Based on discussion with plant personnel, the leachate collection system is operating as intended.

Photograph No. 16  
AECI UWL Inspection  
Leachate loadout pump structure cover, electrical control box for pump
