Subject: Annual CCR Surface Impoundment PE Inspection
Pond 003
AECI New Madrid Power Plant
New Madrid, Missouri

**REPORT ON
INITIAL ANNUAL CCR SURFACE IMPOUNDMENT
PE INSPECTION
POND 003
NEW MADRID POWER PLANT
NEW MADRID, MISSOURI**

by Haley & Aldrich, Inc.
Cleveland, OH

File No. 40616-300
January 2016

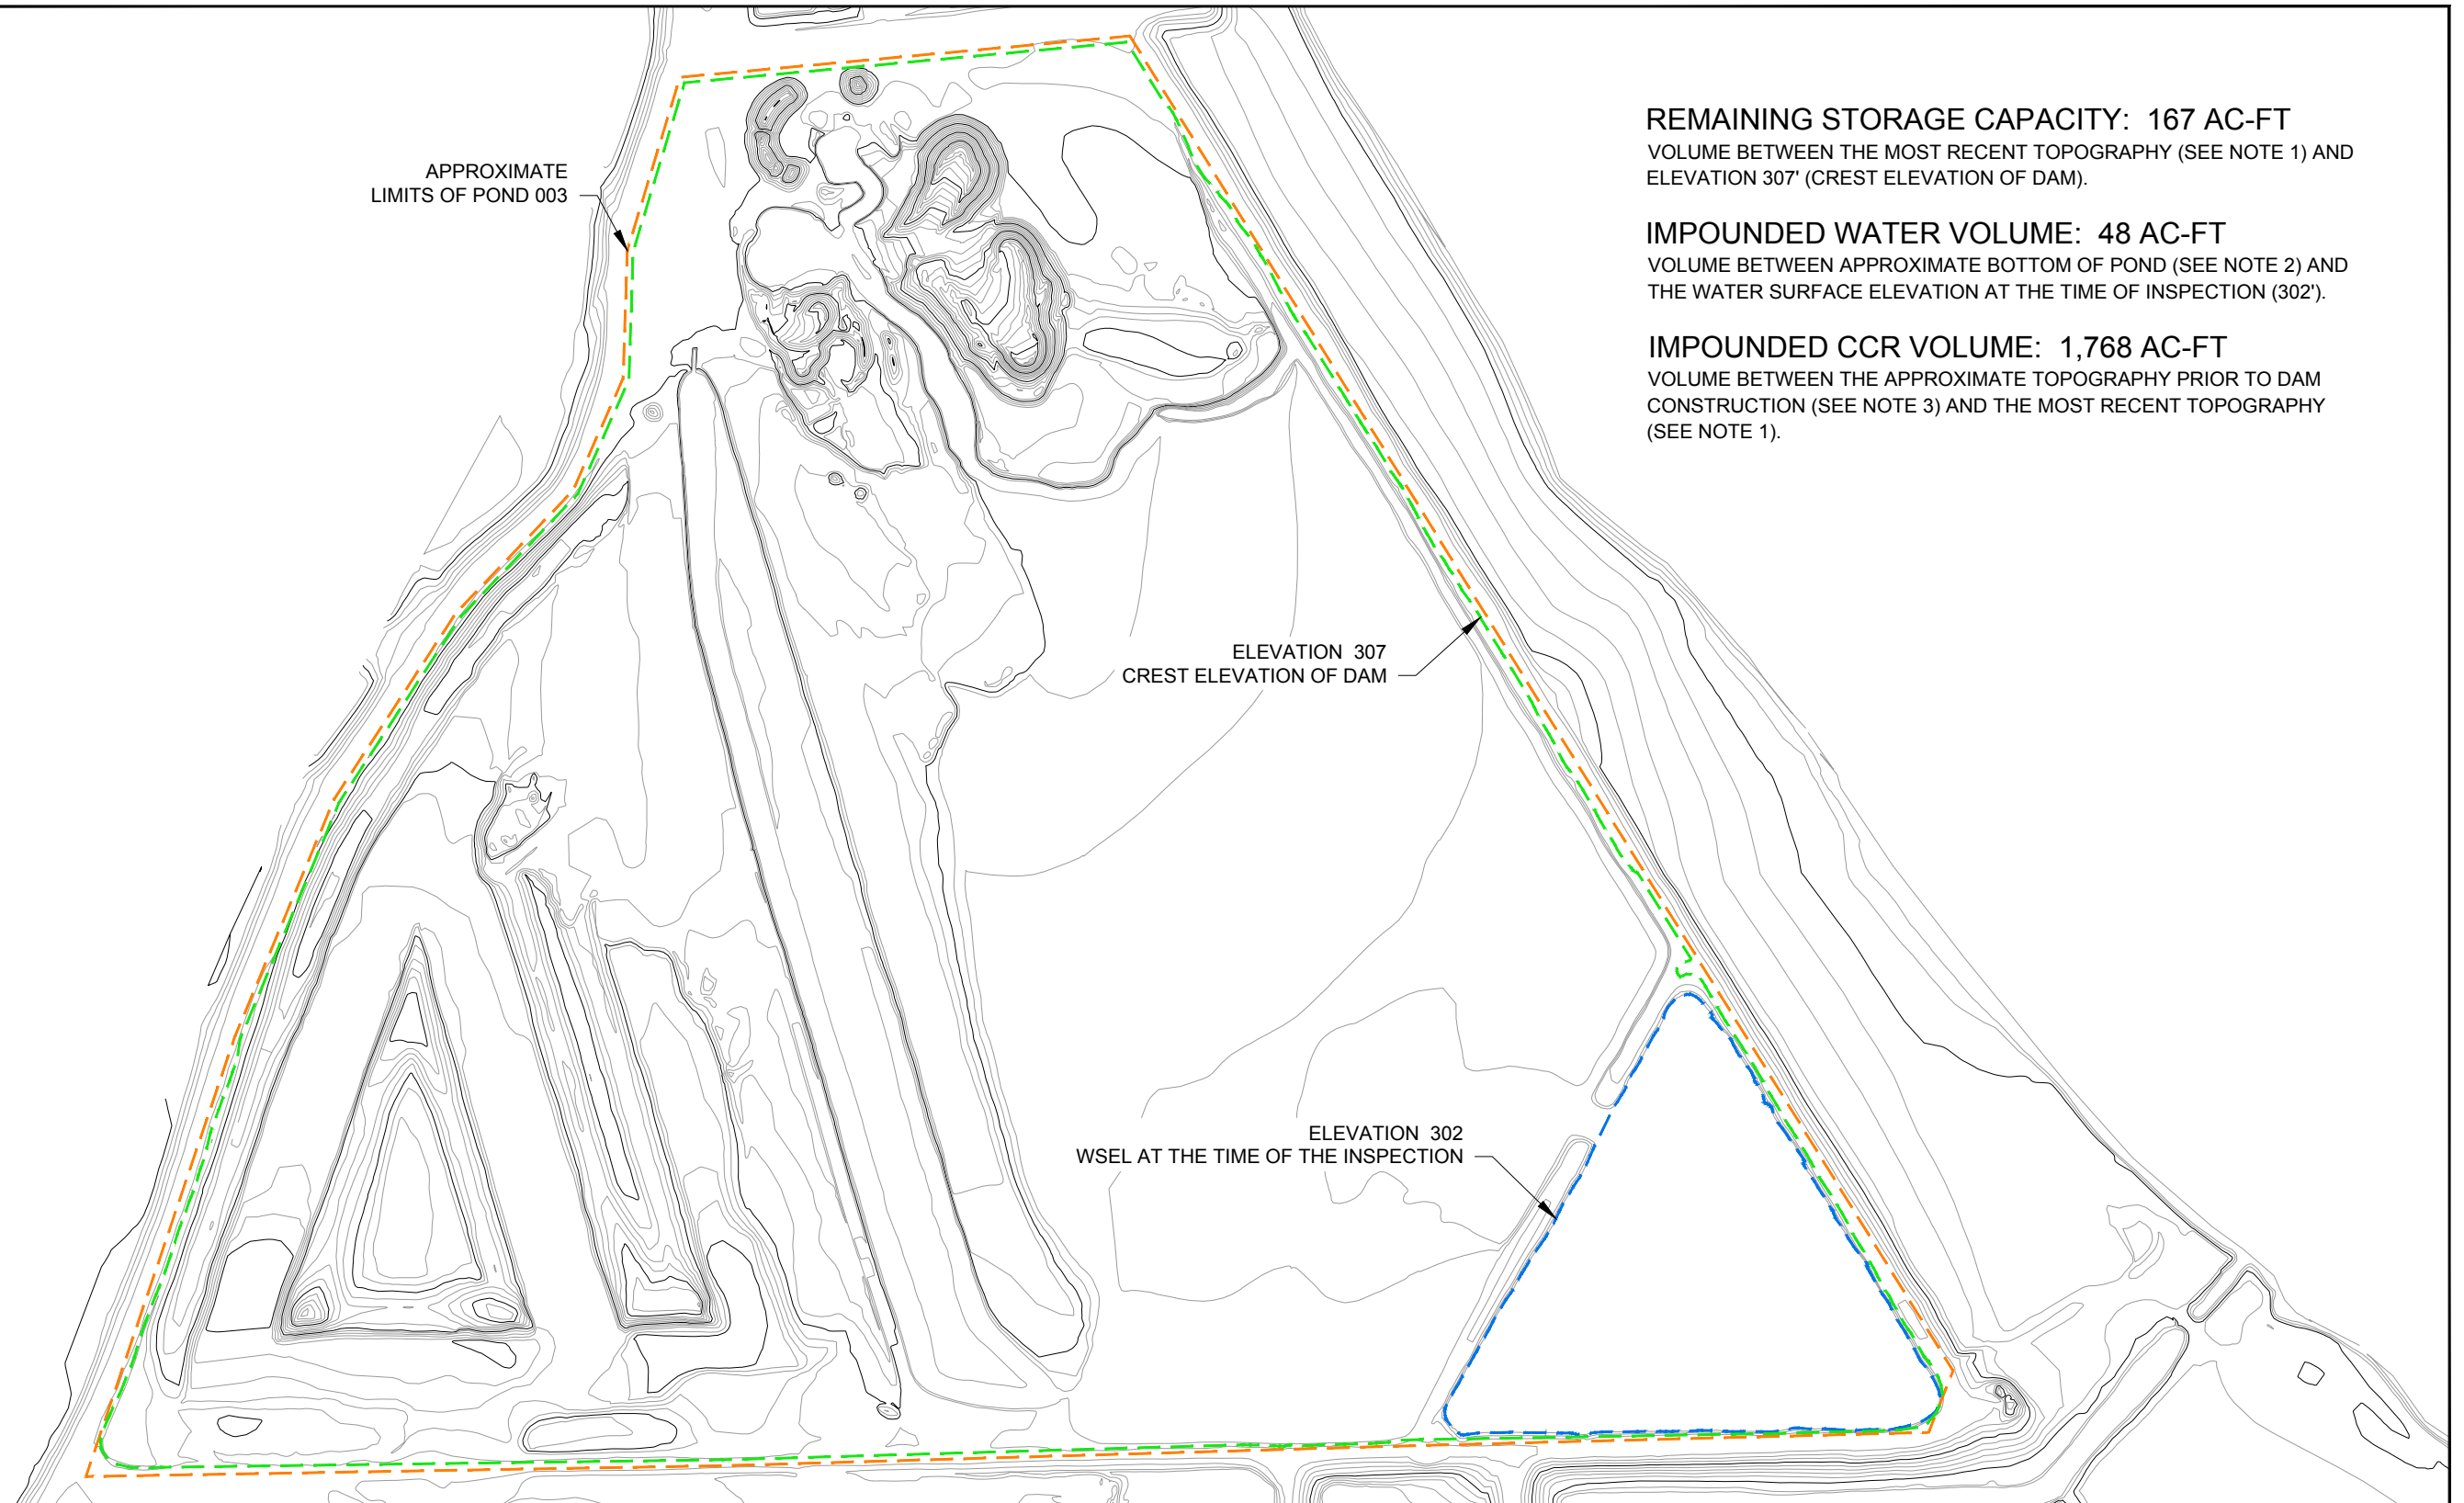
FIGURE 4

The remaining storage capacity of the impoundment was approximated to be 167 Acre-ft. As described in Figure 4, the remaining storage capacity was approximated by determining the volume of the impoundment as of the survey conducted 4-8 October 2014 below El. 307 ft., which is the low crest elevation of the dike.

The impounded water volume was approximated to be 48 Acre-ft. As described on Figure 4, the volume of impounded water was approximated by determining the volume of the impoundment as of the survey conducted 4-8 October 2014 below El. 302 ft., the elevation of the pond on the inspection date. Since no bathymetric data was available, the bottom of the pond was approximated to be at El. 296 assuming some material being above the low elevation from the original USGS topo.

The impounded CCR volume was approximated to be 1,768 Acre-ft. As described on Figure 4, the volume of impounded CCR was approximated by determining the volume between the survey conducted 4-8 October 2014 and the topography provided by USGS 1971.

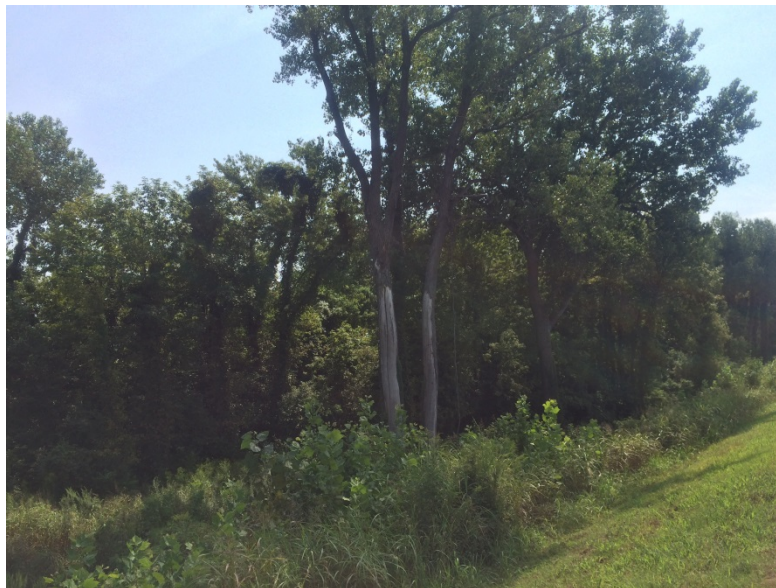
Photograph No. 4
Pond 003
Dead trees at downstream toe of eastern embankment

NAME OF DAM: <u>Pond 003</u>		STATE ID #: <u>MO-0001171</u>			
INSPECTION DATE: <u>September 1, 2015</u>		NID ID #: <u>N/A</u>			
EMBANKMENT (D/S SLOPE)					
AREA INSPECTED	CONDITION	OBSERVATIONS	NO ACTION	MONITOR	REPAIR
D/S SLOPE	1. WET AREAS (NO FLOW)	None observed	X		
	2. SEEPAGE	None observed	X		
	3. SLIDE, SLOUGH, SCARP	None observed	X		
	4. EMB.-ABUTMENT CONTACT	N/A	X		
	5. SINKHOLE/ANIMAL BURROWS	None observed	X		
	6. EROSION	None observed	X		
	7. UNUSUAL MOVEMENT	None observed	X		
	8. VEGETATION (PRESENCE/CONDITION)	Woody vegetation near toe of embankment			X
ADDITIONAL COMMENTS: <u>Two dead trees within 50 ft. of embankment.</u> <hr/> <hr/> <hr/>

- Cut/mow the embankments and routinely mow the embankment slopes (upstream and downstream) and downstream areas to maintain vegetation at a height of 6 in. or less.
- Cut the two (2) dead trees downstream of Pond 003.
- Monitor the mature trees downstream of Pond 003 for signs of decay and impact to the dike during the weekly and monthly inspections.
- Conduct a video inspection of outlet pipes from the drop inlet structures to confirm structural integrity.

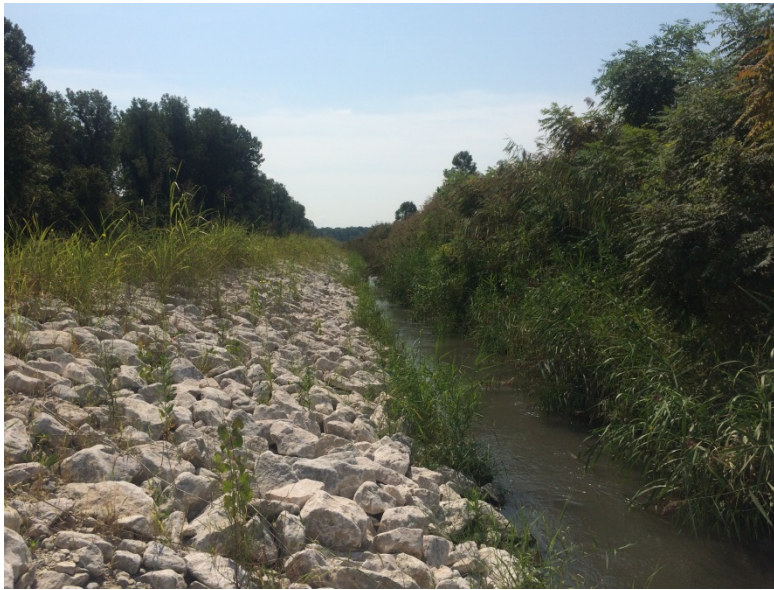
Photograph No. 5

Upstream slope with riprap and vegetation on eastern embankment

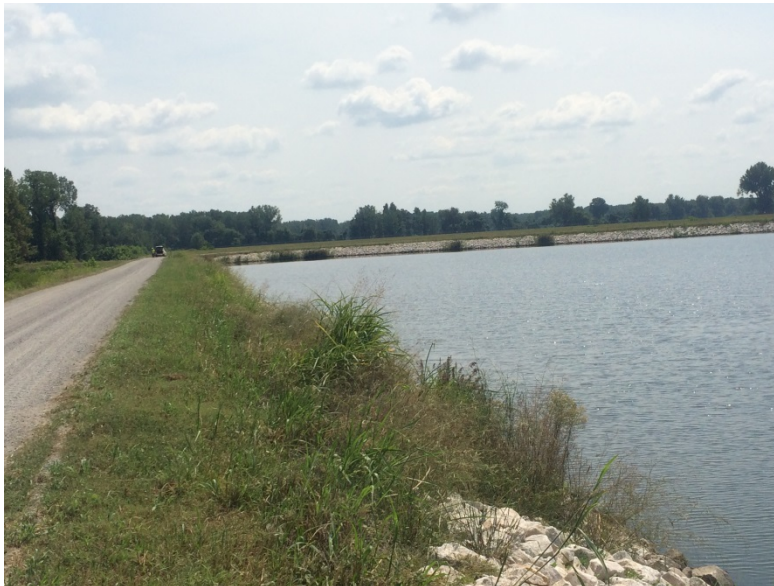
Photograph No. 6

Upstream slope of south end of eastern embankment with riprap and vegetation

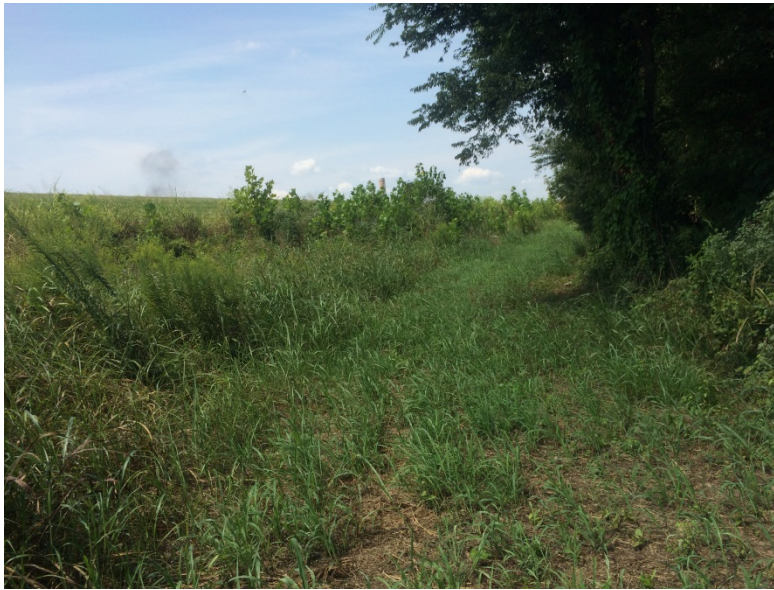
Photograph No. 7

Vegetation at toe of downstream slope of south end of eastern embankment

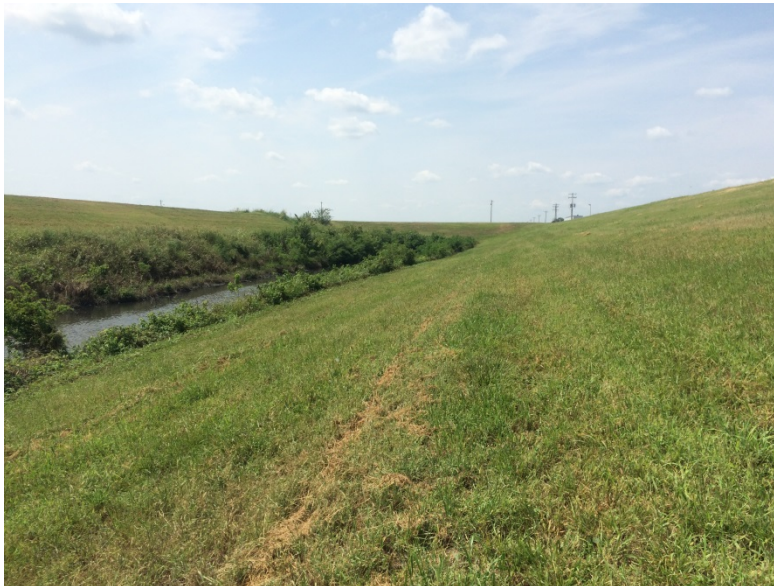
Photograph No. 8

Downstream slope of southern embankment
Discharge channel at left

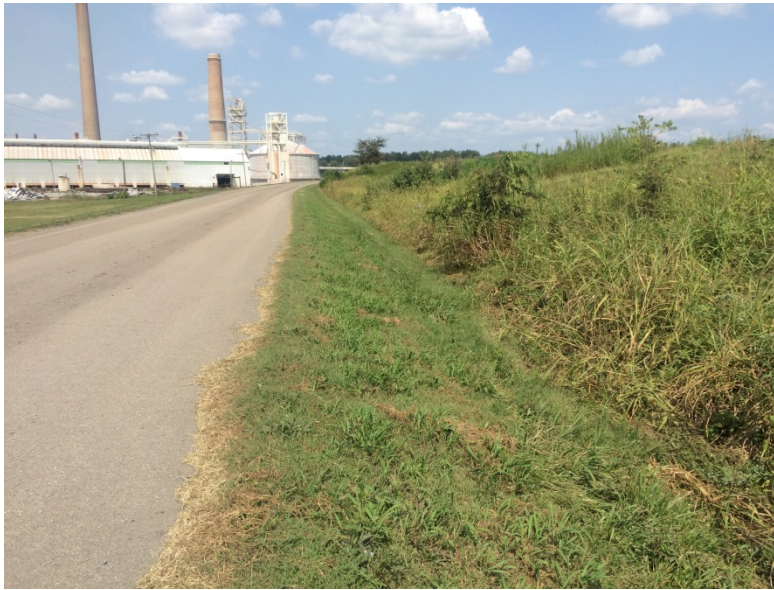
Photograph No. 13

Upstream slope on western embankment

Note vegetation growing on Ash stockpiled above water level to the right.

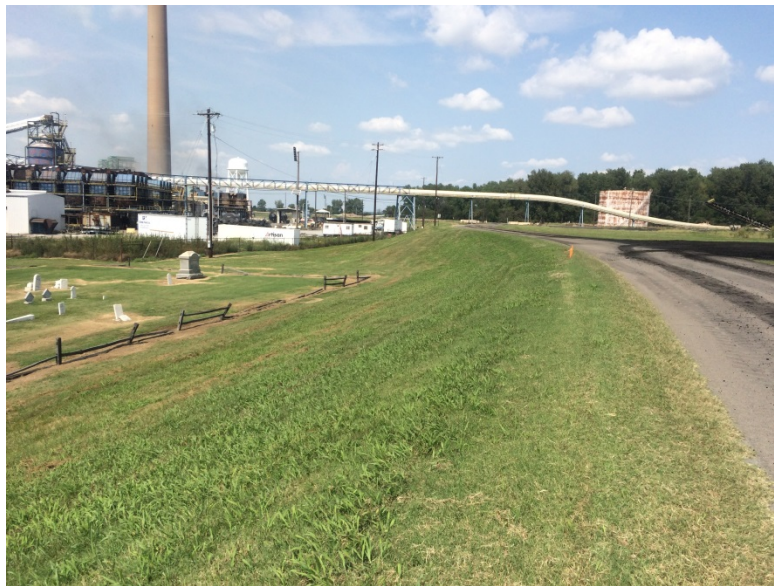
Photograph No. 14

Downstream slope of Mississippi River Levee/Unlined Ash Pond Dam
