**REPORT ON
INITIAL PERIODIC STRUCTURAL STABILITY ASSESSMENT
POND 003
NEW MADRID POWER PLANT
NEW MADRID, MISSOURI**

by Haley & Aldrich, Inc.
Cleveland, Ohio

for Associated Electric Cooperative, Inc.
New Madrid, Missouri

File No. 40616-300
October 2016

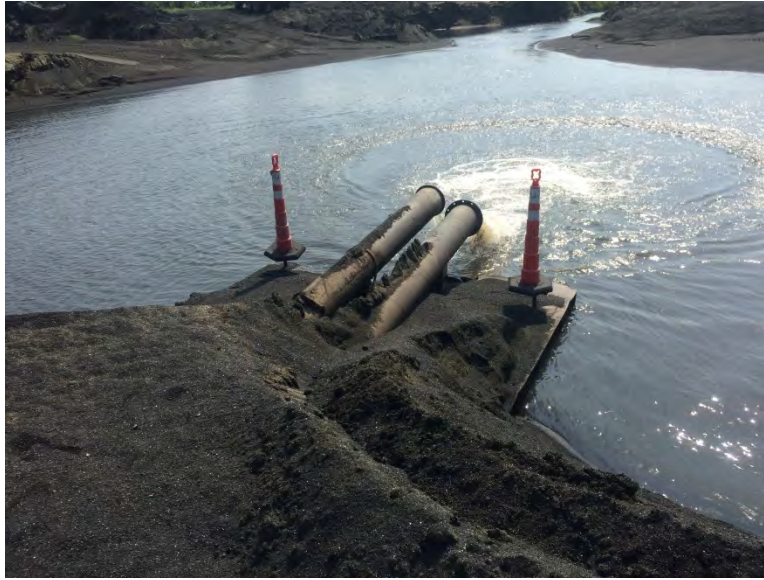
Photograph No. 1
Pond 003 - two inlet pipes

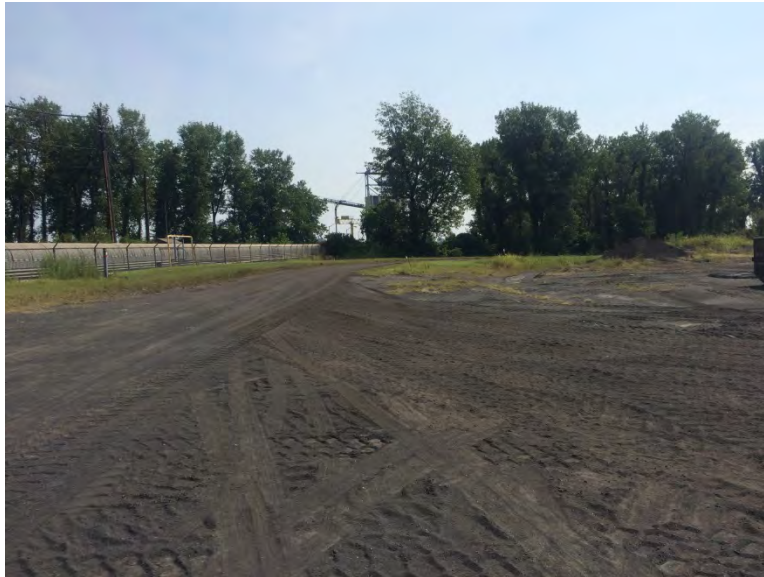
Photograph No. 2
Pond 003
Crest and access road on northern embankment

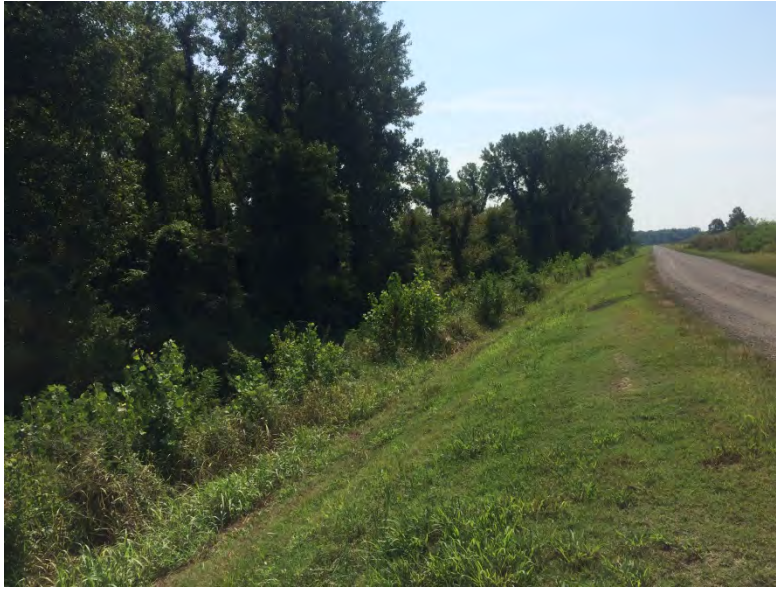
Photograph No. 3
Pond 003
Downstream slope on eastern embankment

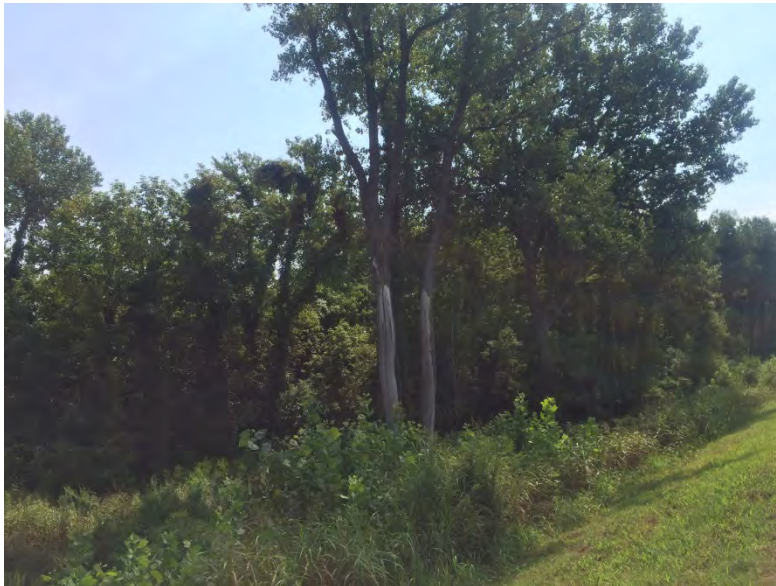
Downstream of the eastern portion of the dike mature trees exist within about 25 ft of the downstream toe of the dam. At the southern end of the eastern side, the trees exist within about 40 ft of the downstream toe of the dike. Between the toe of the dike and the trees, 12 in. to 36 in. tall grass existed during our inspection. During our site visit, we observed two (2) trees, approximately 30 in. diameter, which were dead and closest to the dike. Wet or soft spots were not observed.

Photograph No. 4
Pond 003
Dead trees at downstream toe of eastern embankment

- Cut/mow the embankments and routinely mow the embankment slopes (upstream and downstream) and downstream areas to maintain vegetation at a height of 6 in. or less.
- Cut the two (2) dead trees downstream of Pond 003.
- Monitor the mature trees downstream of Pond 003 for signs of decay and impact to the dike during the weekly and monthly inspections.
- Conduct a video inspection of outlet pipe from the drop inlet structures when flow is reduced to expose the downstream end of the pipe.

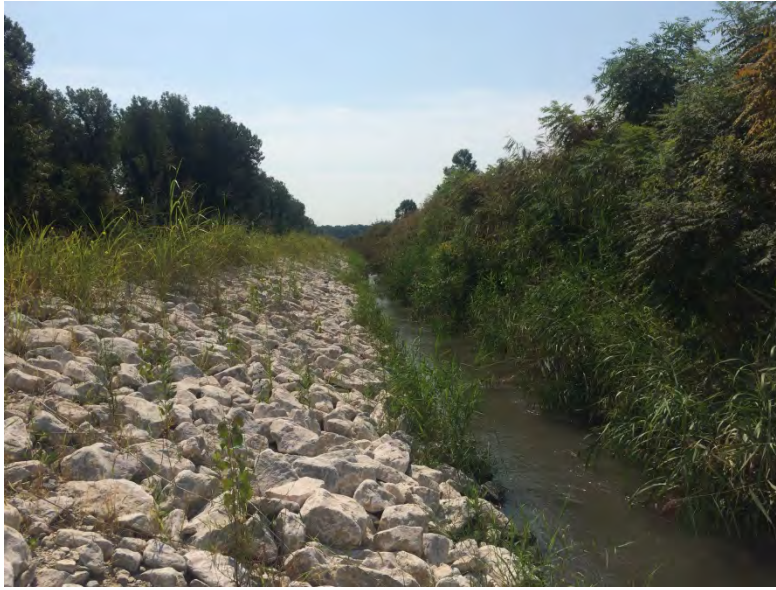
Photograph No. 5
Pond 003

Upstream slope with riprap and vegetation on eastern embankment

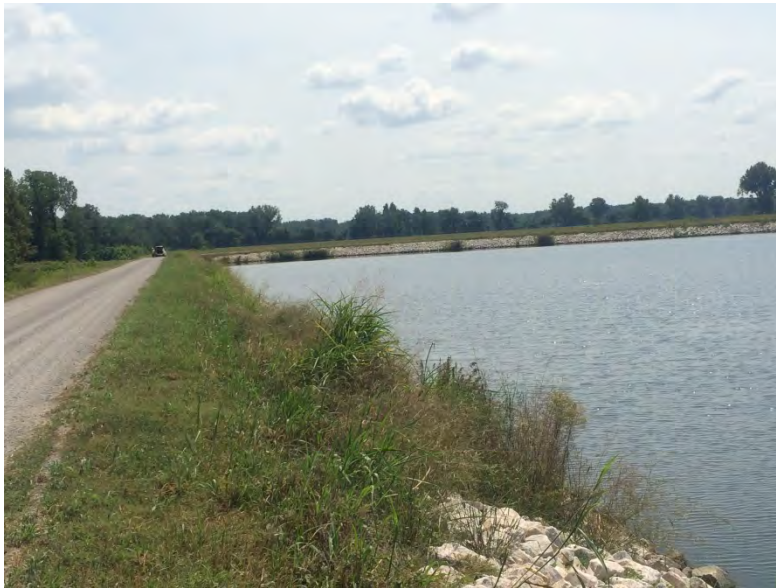
Photograph No. 6
Pond 003

Upstream slope of south end of eastern embankment with riprap and vegetation

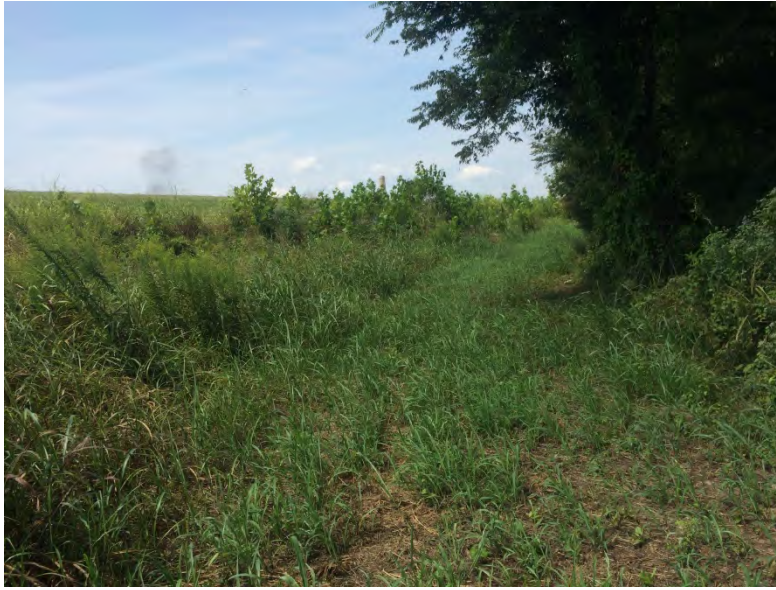
Photograph No. 7

Vegetation at toe of downstream slope of south end of eastern embankment

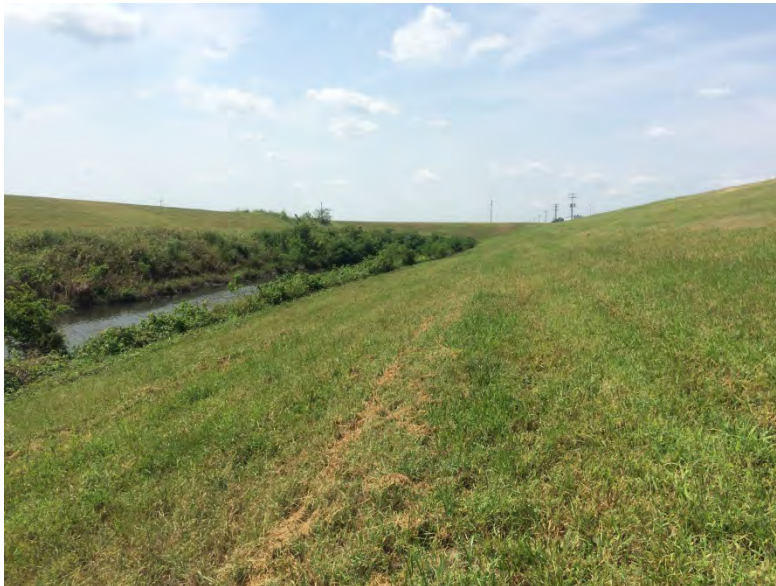
Photograph No. 8

Downstream slope of southern embankment
Discharge channel at left

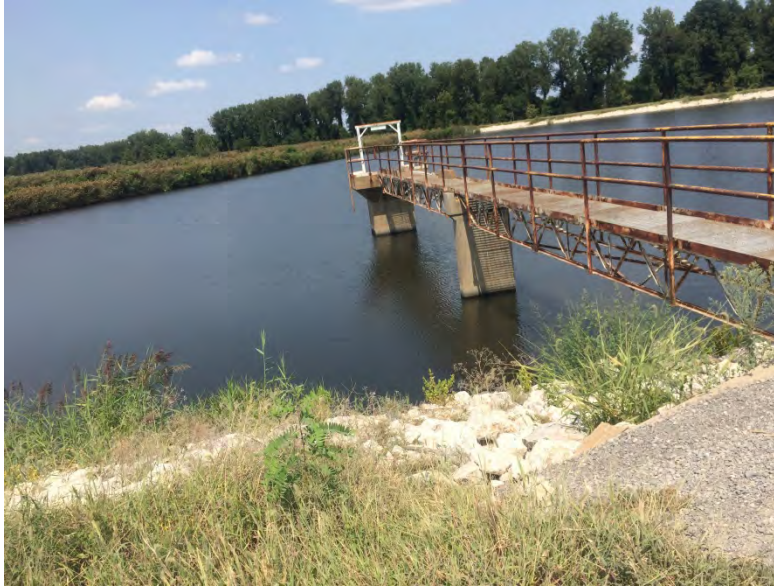
Pond 003 discharges through a concrete box intake structure located at the southeastern end of the impoundment. Being a concrete structure, the structure is non-erodible and appears to be in good condition. There is no emergency spillway.

Photograph No. 9
Pond 003
Concrete drop inlet spillway with concrete stop logs

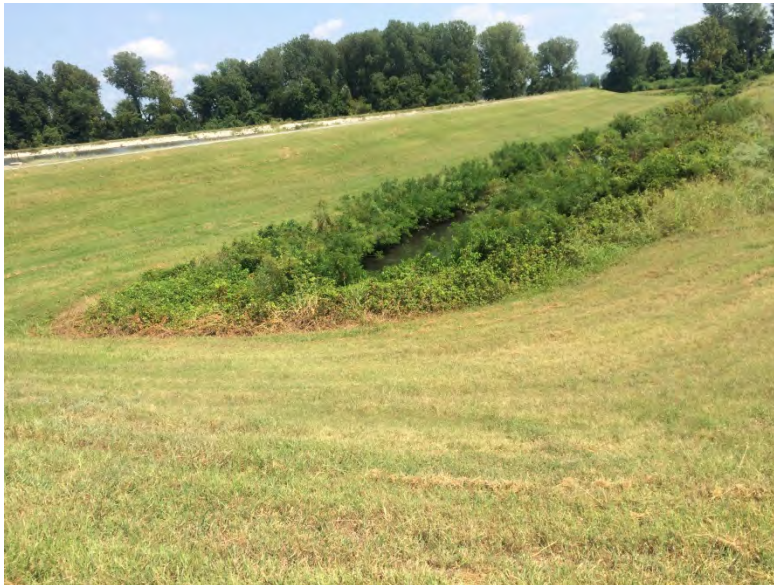
Photograph No. 10
Pond 003
Discharge Channel

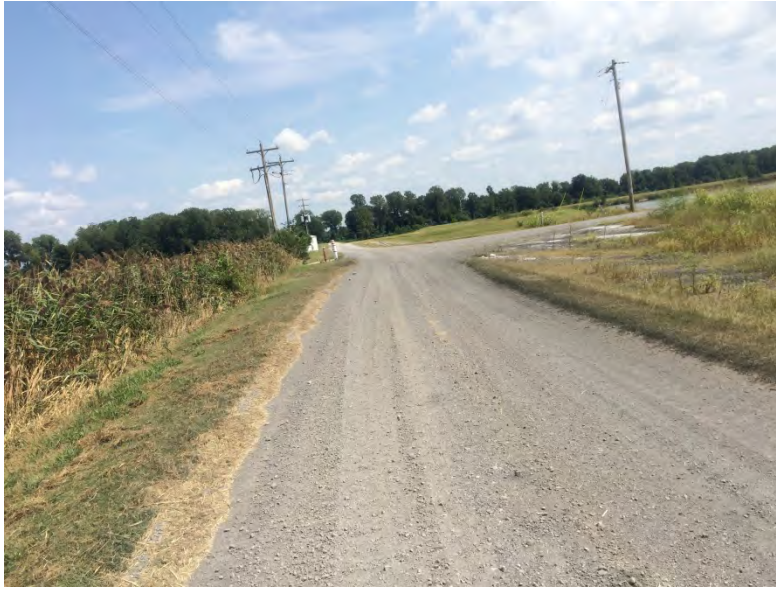
Photograph No. 11
Pond 003
Crest on southern embankment

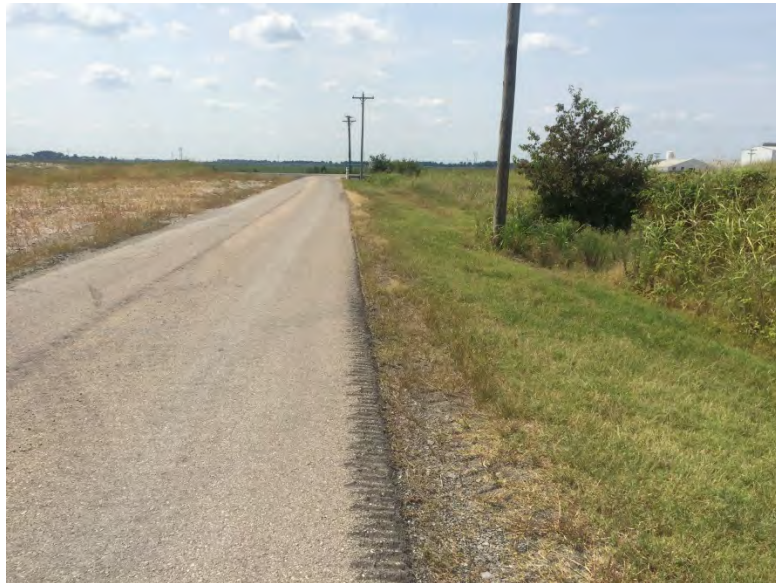
Photograph No. 12
Pond 003
Paved Crest on southern embankment

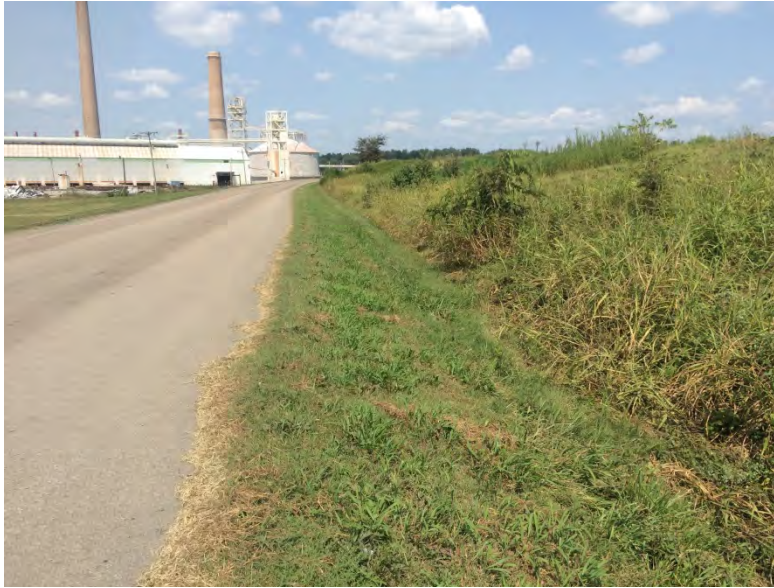
Photograph No. 13

Upstream slope on western embankment

Note vegetation growing on Ash stockpiled above water level to the right.
