REPORT ON
PERIODIC STRUCTURAL STABILITY ASSESSMENT
POND 001 – CELL 003
THOMAS HILL ENERGY CENTER
CLIFTON HILL, MISSOURI

by Haley & Aldrich, Inc.
Cleveland, Ohio

for Associated Electric Cooperative, Inc.
Clifton Hill, Missouri

File No. 128064-022
October 2021

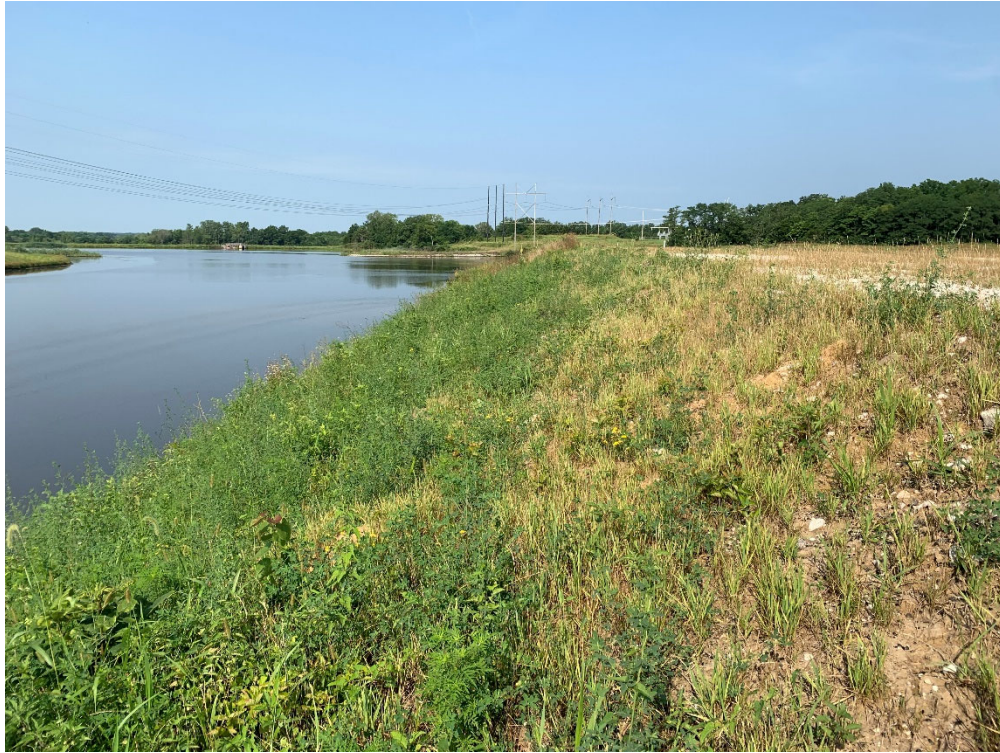
Photo No. 1
Vegetation greater than 1 ft along Cell 002 downstream embankment

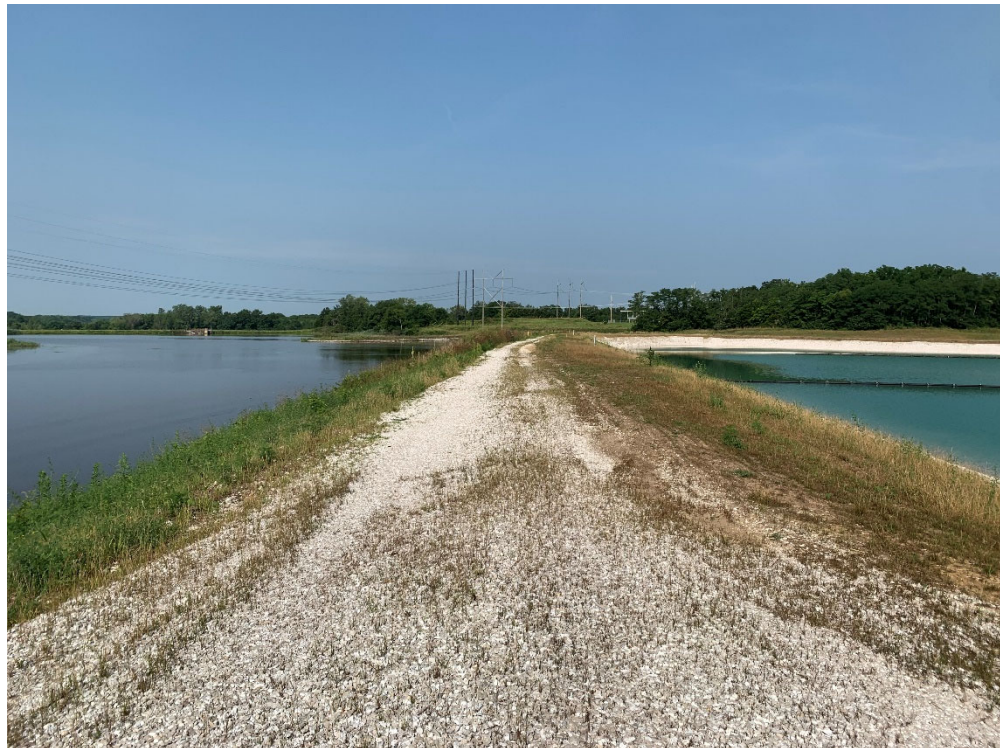
Photo No. 2
Aggregate surface on Cell 002 embankment crest

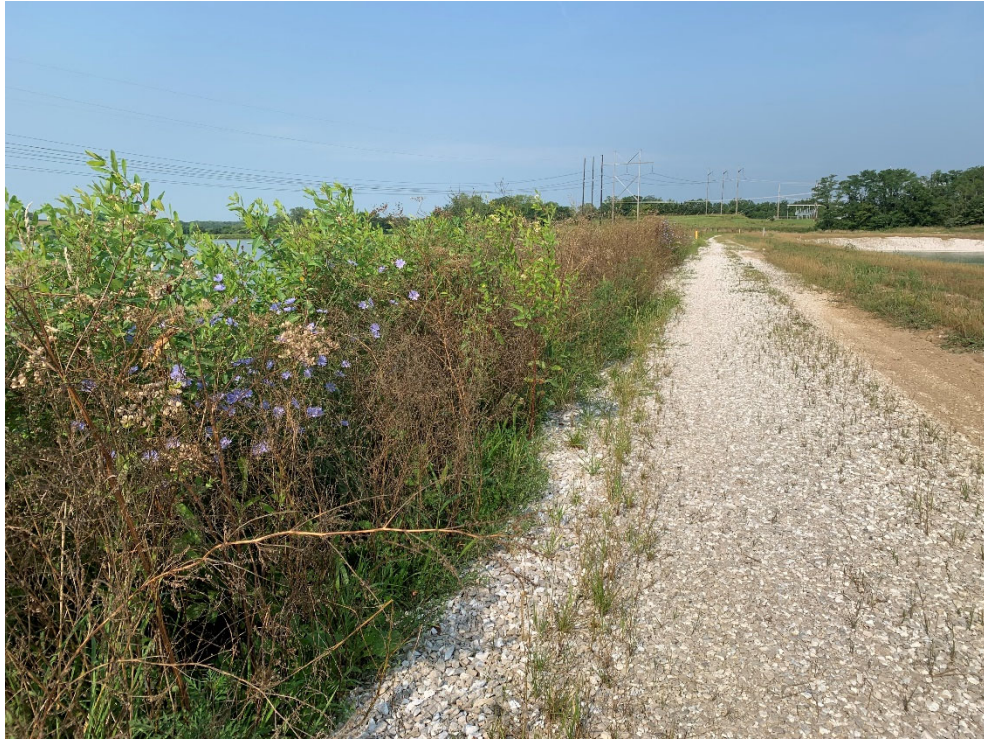
Photo No. 3

Tall vegetation along Cell 002 downstream embankment facing west
Aggregate surface along top of Cell 002 embankment crest

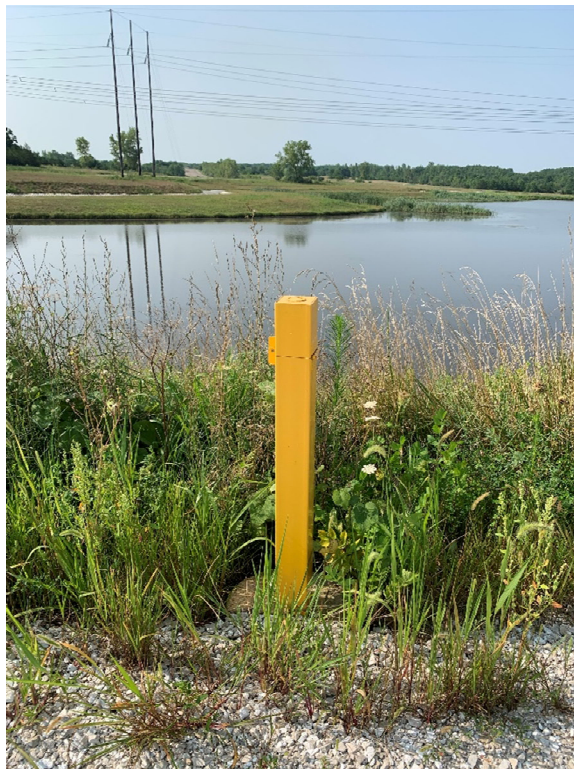
Photo No. 4

Monitoring well along Cell 002 embankment

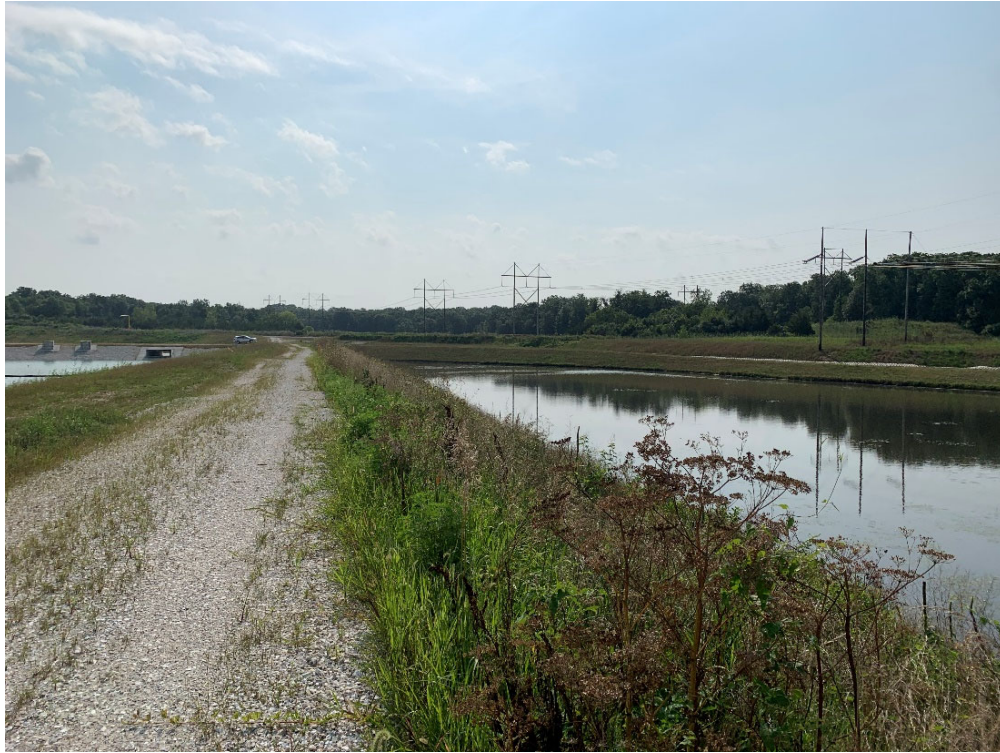
Photo No. 5
Tall vegetation near midpoint of Cell 002 downstream slope

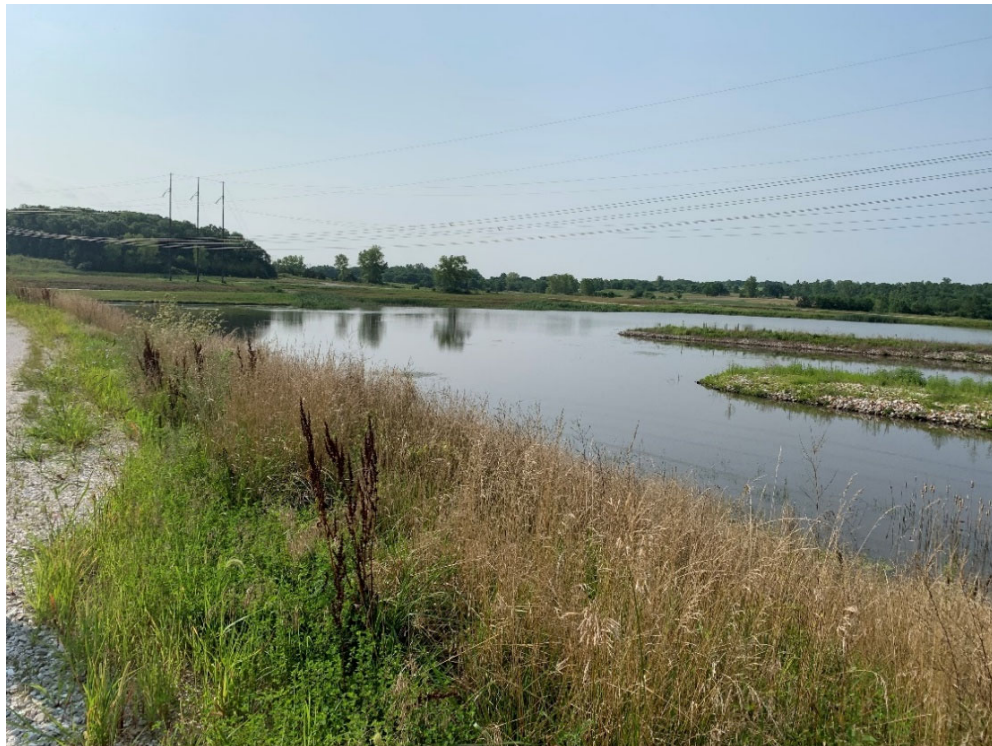
Photograph No. 6
Tall vegetation at northwest corner of Cell 003 facing southeast

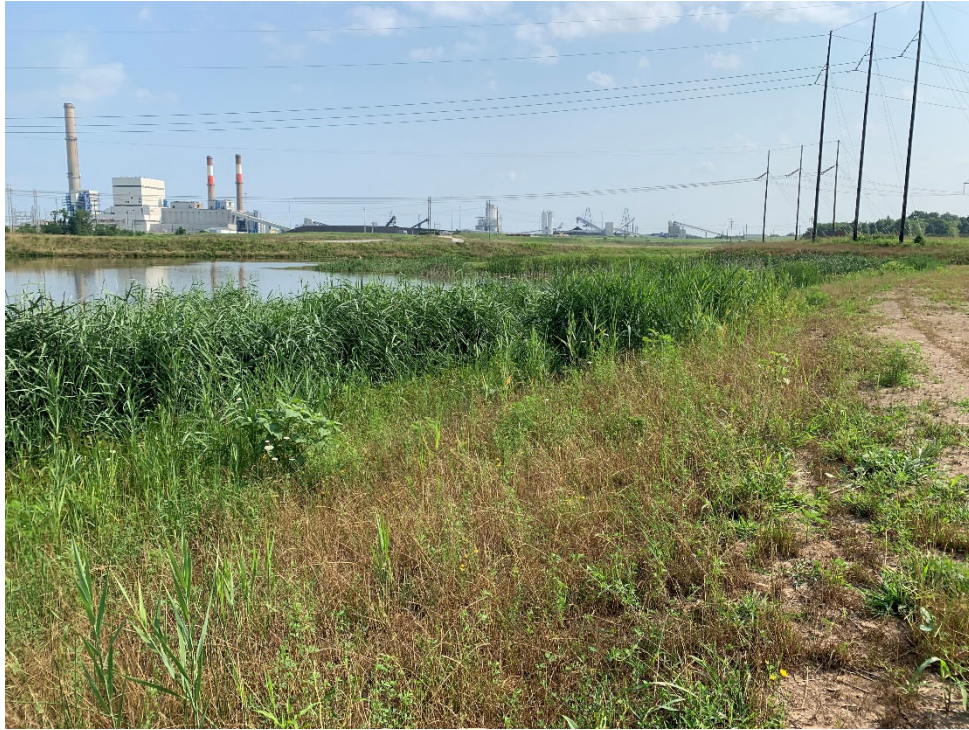
1. Tall vegetation consisting of grass and shrubs up to 4 feet high exist on the upstream slopes.
2. Woody vegetation observed in the southwest corner of downstream slope.
3. Tall vegetation up to 4 feet high on downstream slopes.
4. A staff gage is not present for AECl to regularly document the water level in the unit.

Photo No. 7
Tall vegetation southeastern corner of Cell 003 facing north

1. Tall vegetation – Cut vegetation and maintain at the required maximum height per the regulations. Maintain in a manner to reduce and control woody vegetation.
2. Woody Vegetation – Remove woody vegetation encroaching on downstream embankment.
3. Tall vegetation – Cut vegetation and maintain at the required maximum height per the regulations. Maintain in a manner to reduce and control woody vegetation.
4. Staff gage – Install staff gage to document water level in unit.

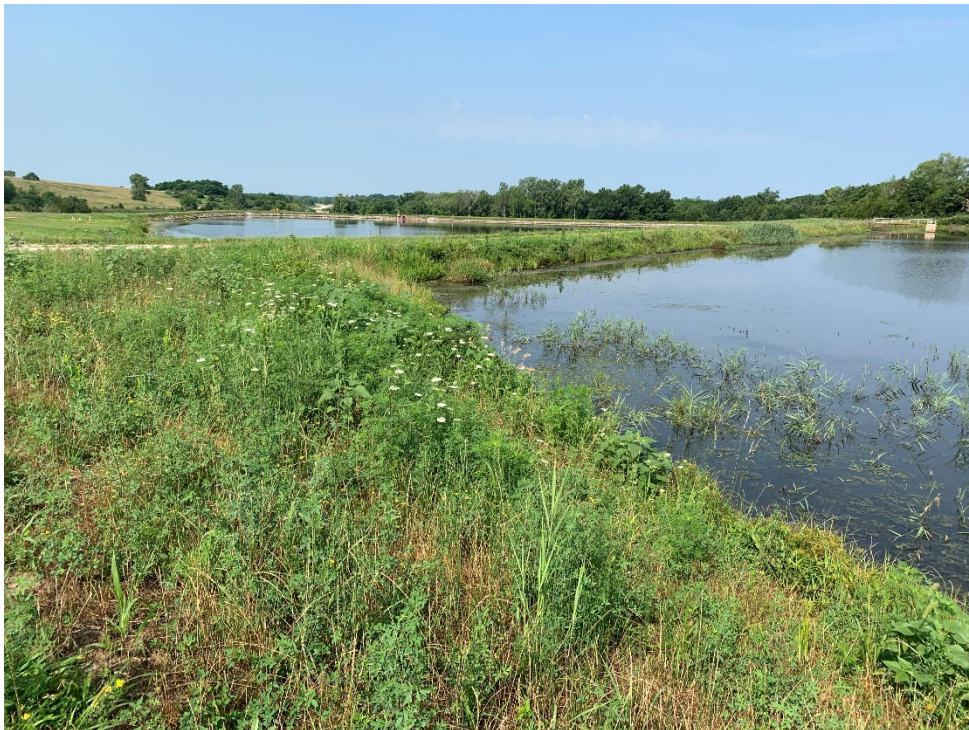
Photo No. 8
Vegetation greater than 1 ft along upstream slope of Cell 003 embankment

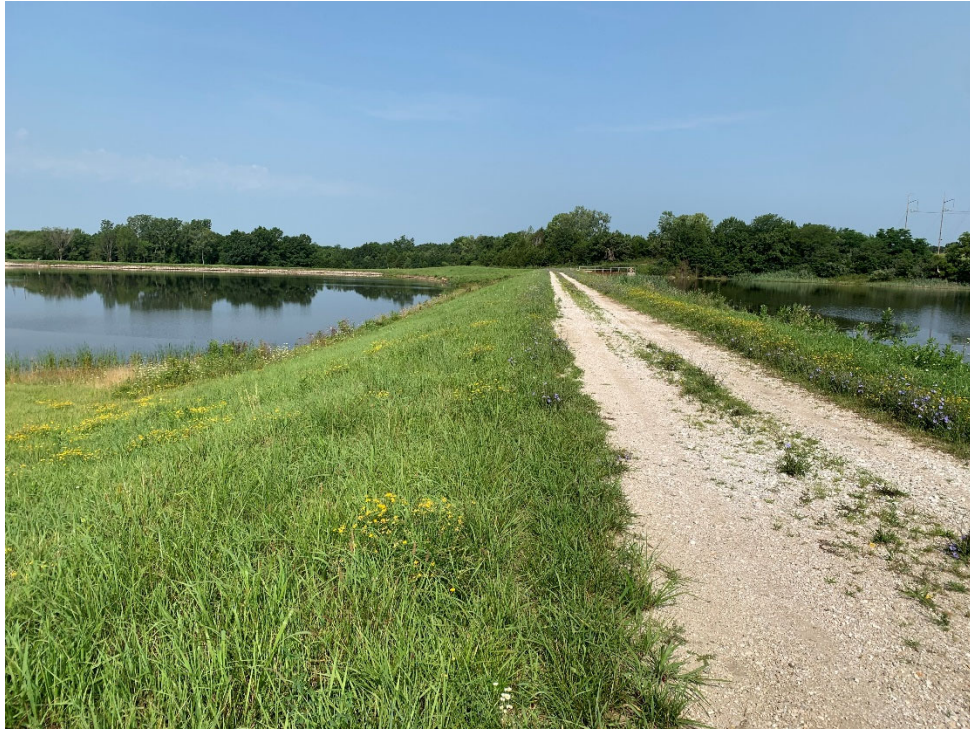
Photo No. 9
Downstream slope and aggregate surface atop Cell 003 embankment

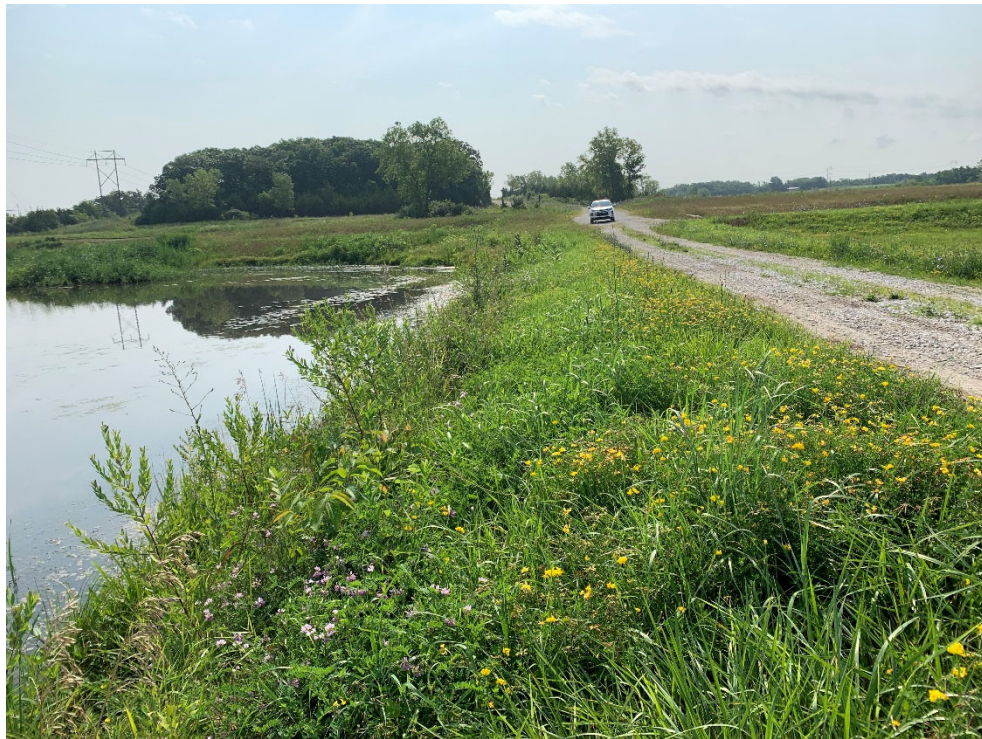
Photo No. 10
Tall vegetation along upstream slope of Cell 003 embankment facing southeast

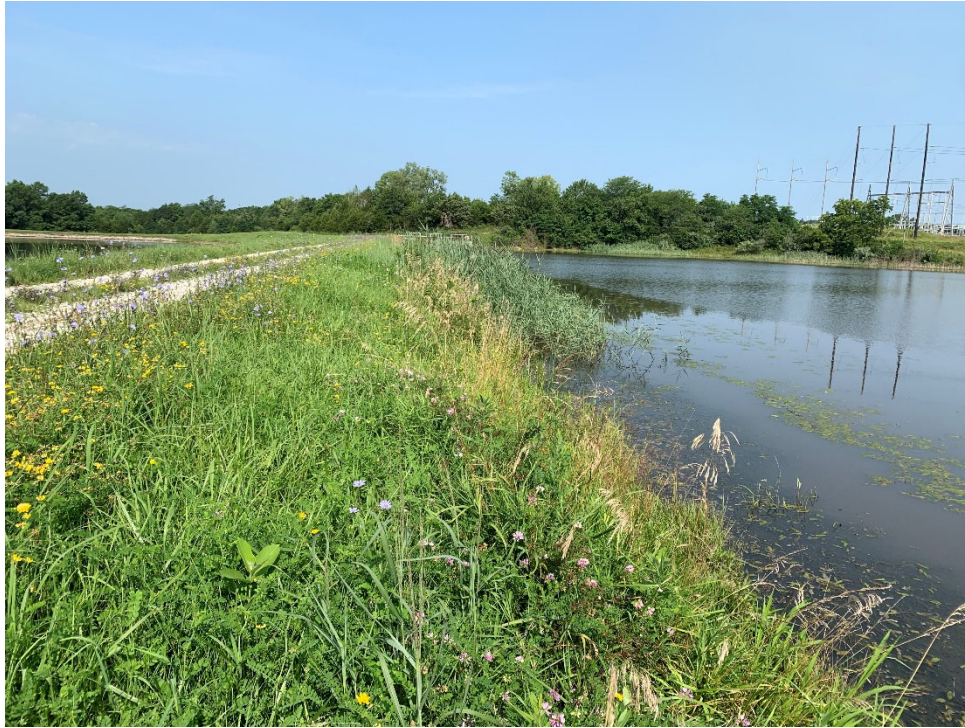
Photo No. 11

Tall vegetation along upstream slope of Cell 003 embankment facing northwest

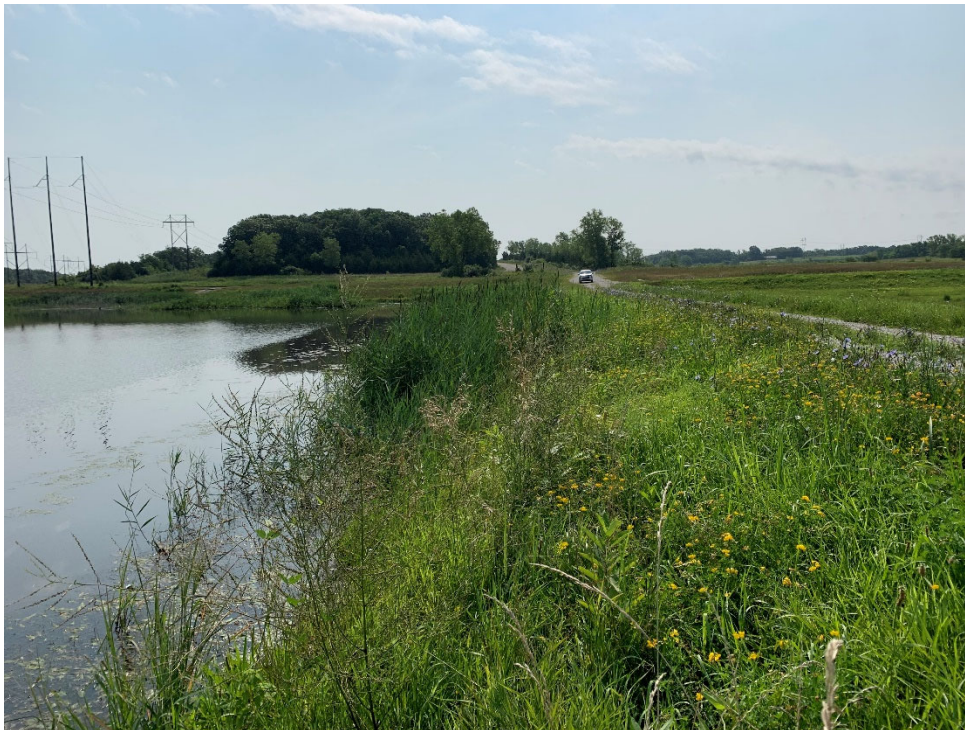
Photo No. 12

Tall vegetation along upstream slope at midpoint of Cell 003 embankment facing southeast

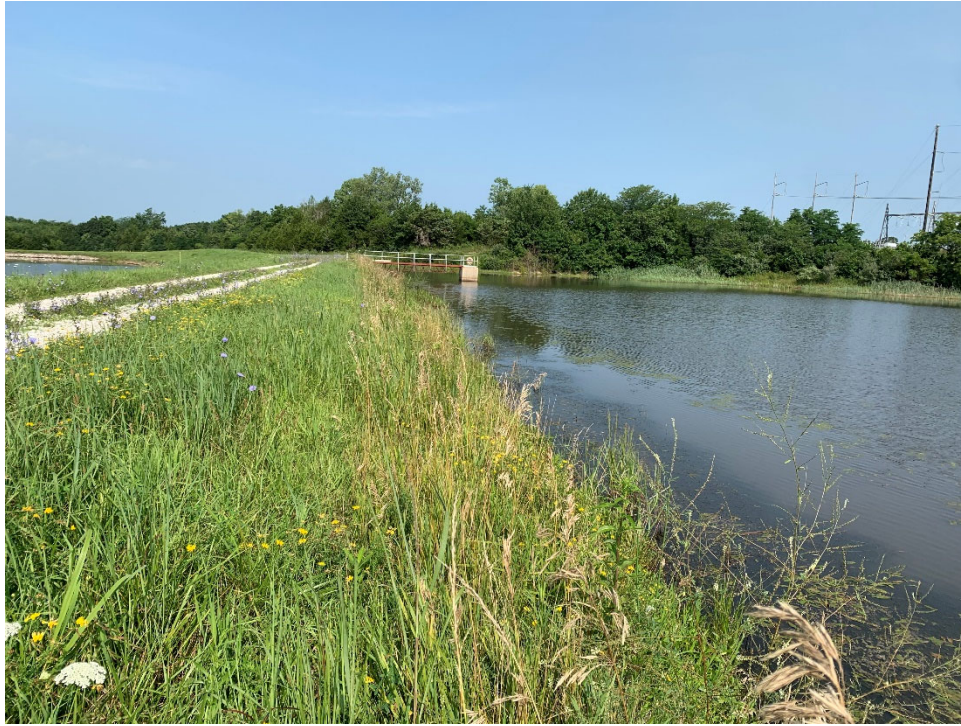
Photo No. 13

Tall vegetation along upstream slope at midpoint of Cell 003 embankment facing northwest

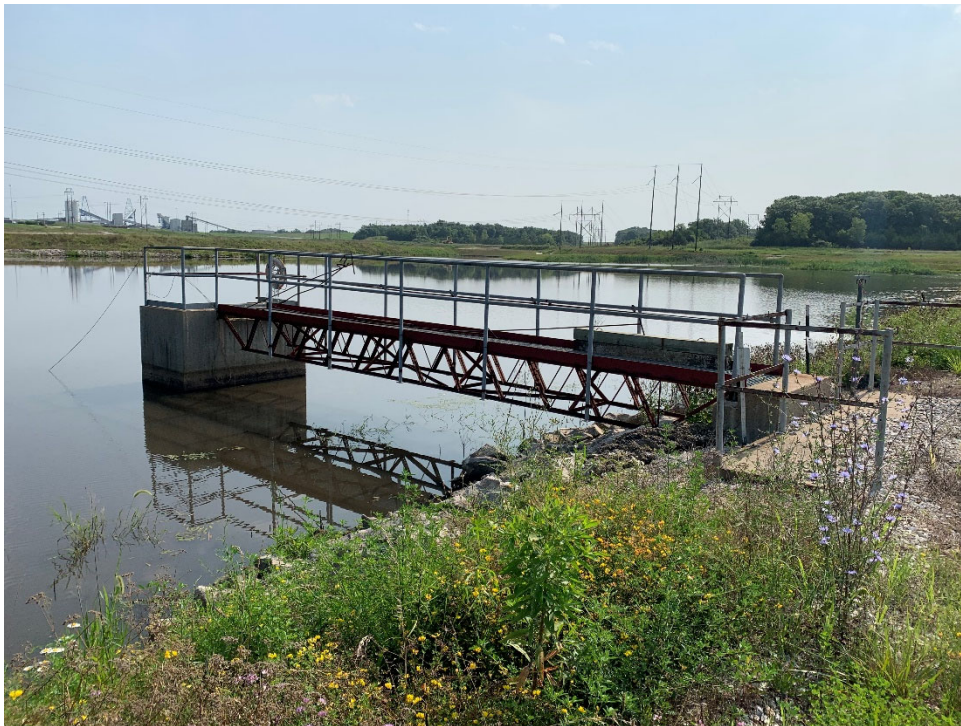
Photo No. 14

Cell 003 hydraulic structures include the rectangular concrete decant structure and outlet pipe. Flow entering the decant structure is conveyed through the Cell 003 south embankment and discharges underwater into Cell 004. The decant structure was judged to be in good condition.

Cell 003 outlet control structure

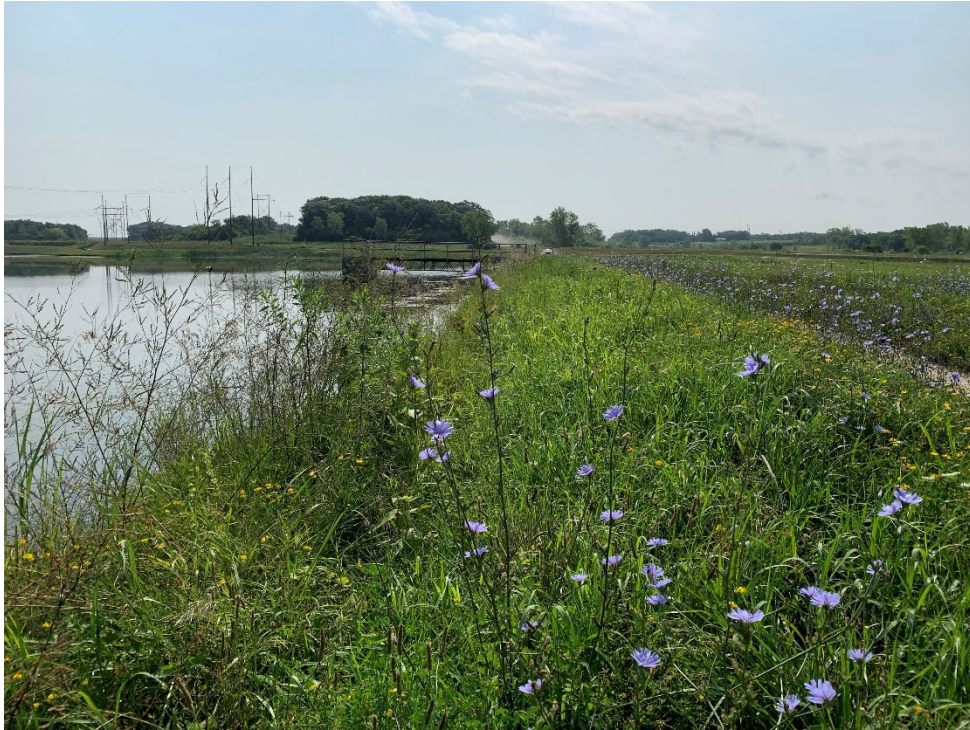
Photo No. 15

Tall vegetation southwest corner of upstream slope on Cell 003 embankment facing southeast

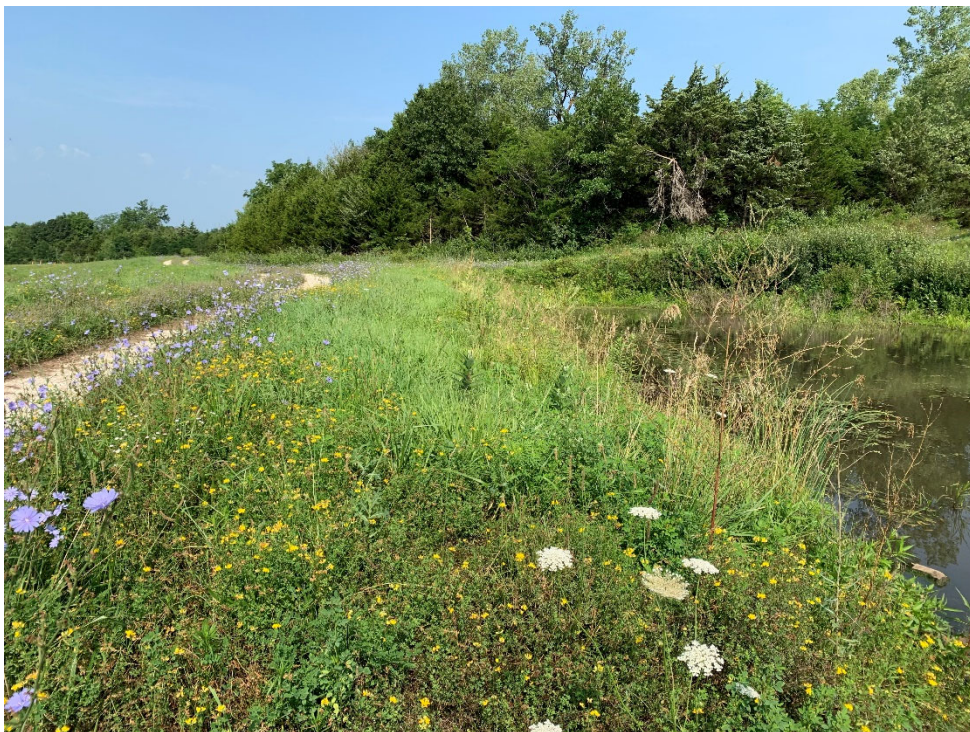
Photo No. 16

Tall vegetation southwest corner of upstream slope on Cell 003 embankment facing northwest

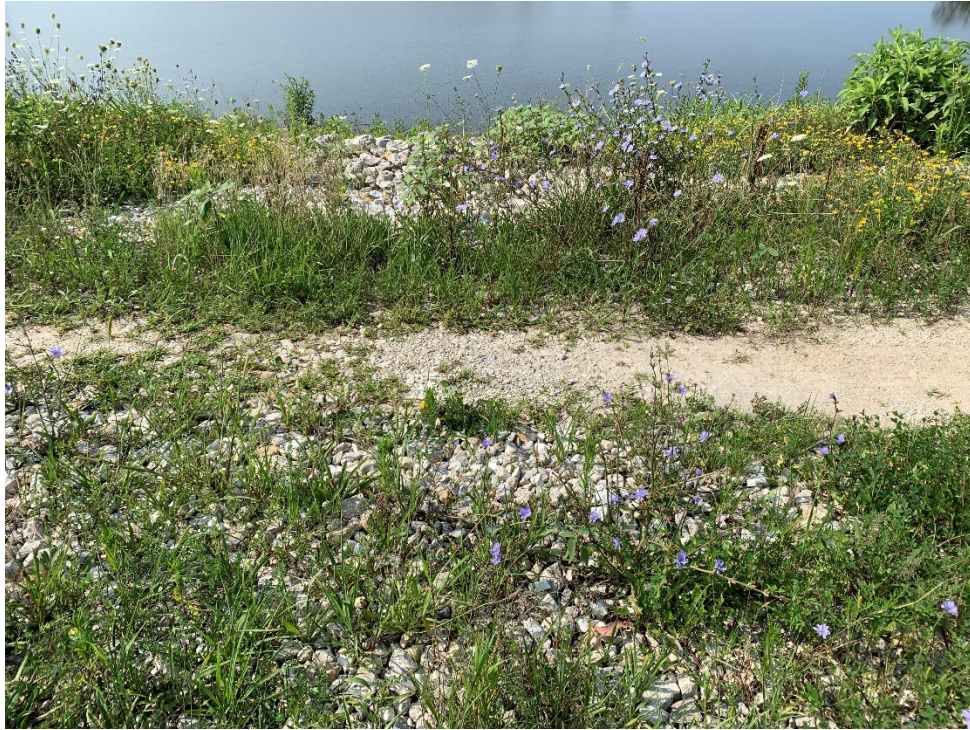
The emergency spillway in Cell 003 consists of an 18-ft wide riprap-lined channel which is approximately 2 ft in depth located across the crest of the south dike. The emergency spillway channel was judged to have adequate erosion protection to withstand short-term, infrequent flows.

Photo No. 17
Cell 003 emergency spillway facing north

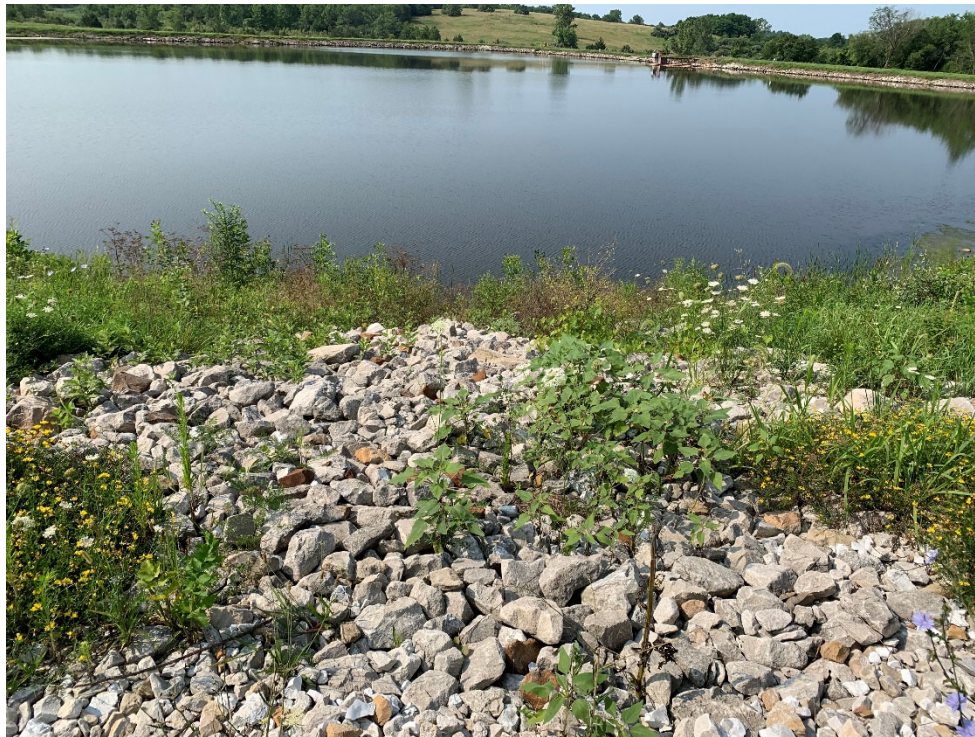
Photo No. 18
Cell 003 emergency spillway facing south

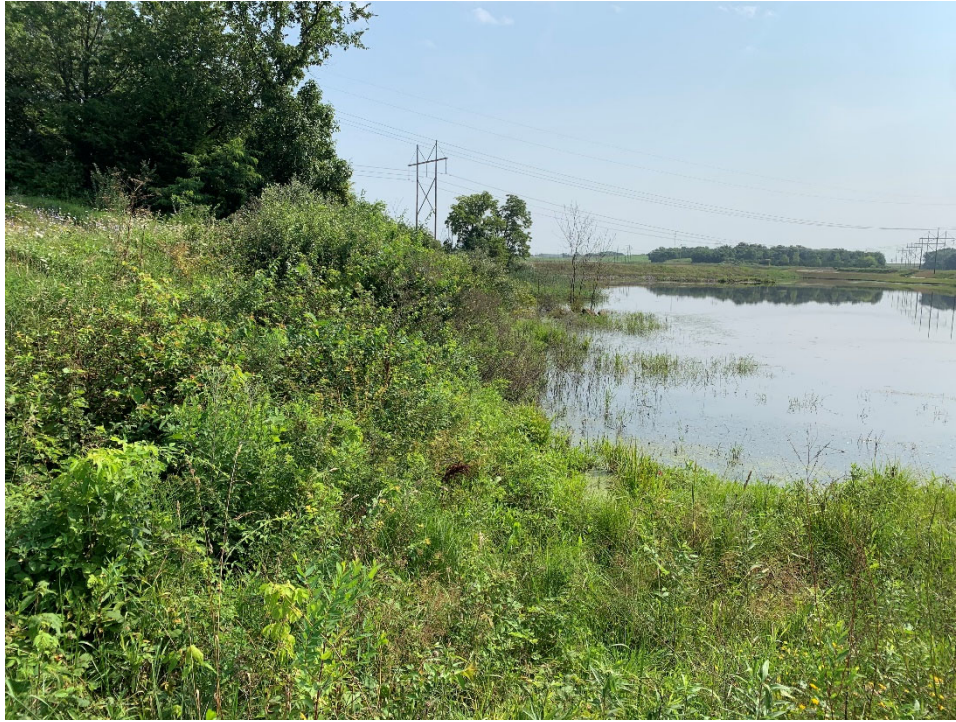
Photo No. 19
Tall vegetation along west incised slope

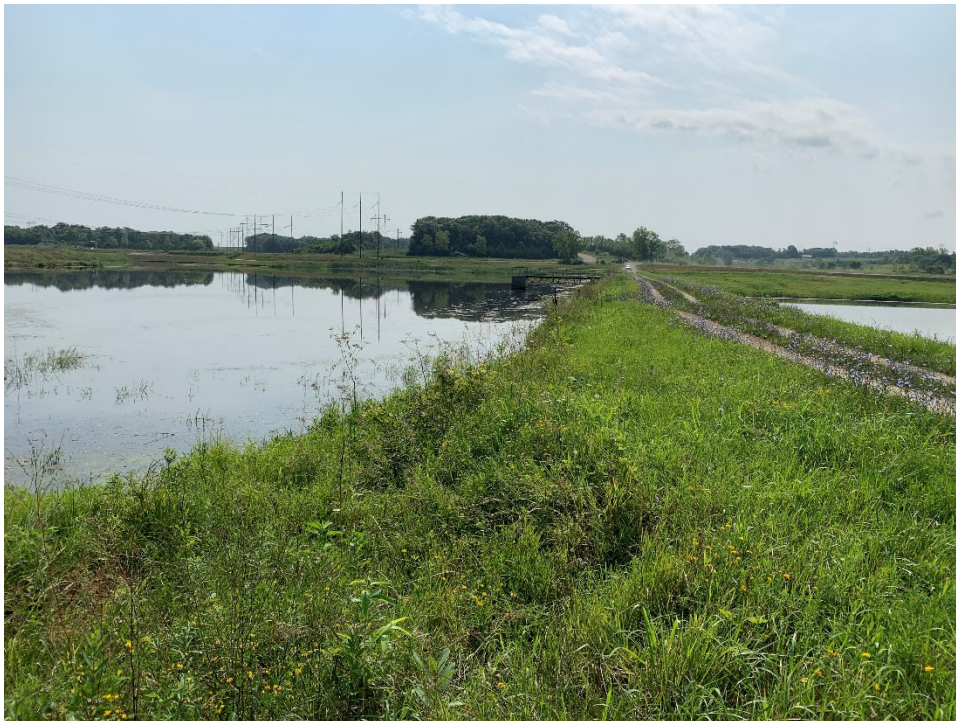
Photo No. 20
Overview of Cell 003 from southwest corner
