**REPORT ON
PERIODIC STRUCTURAL STABILITY ASSESSMENT
POND 001 – CELL 004
THOMAS HILL ENERGY CENTER
CLIFTON HILL, MISSOURI**

by Haley & Aldrich, Inc.
Cleveland, Ohio

for Associated Electric Cooperative, Inc.
Clifton Hill, Missouri

File No. 128064-022
October 2021

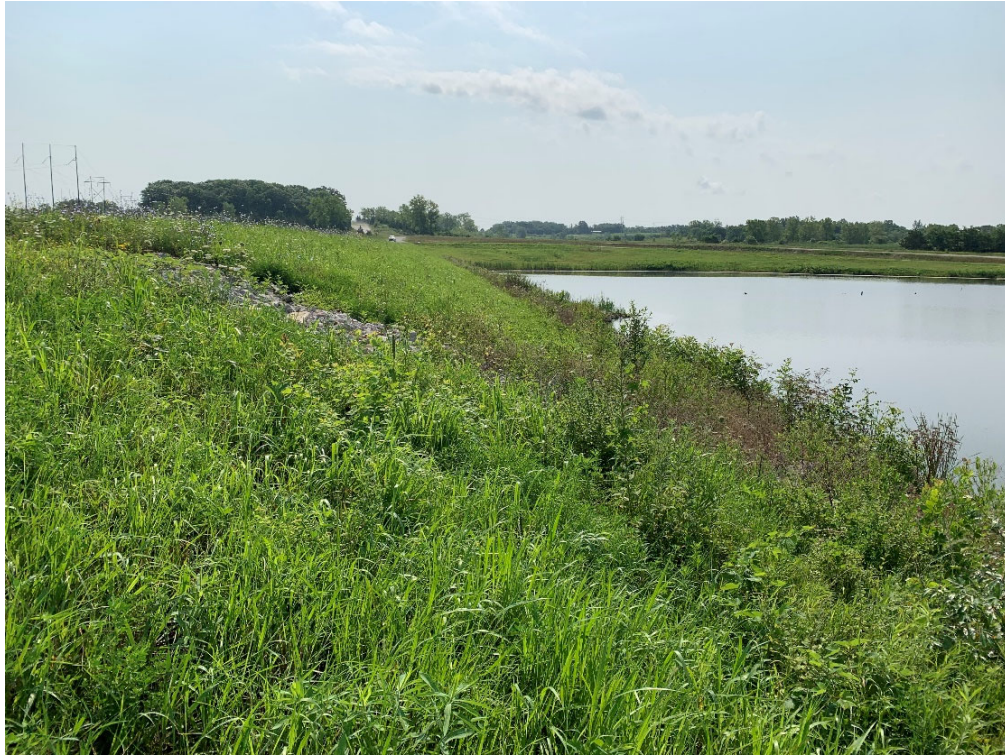
Photo No. 1

Tall vegetation along downstream slope of Cell 003 embankment facing west

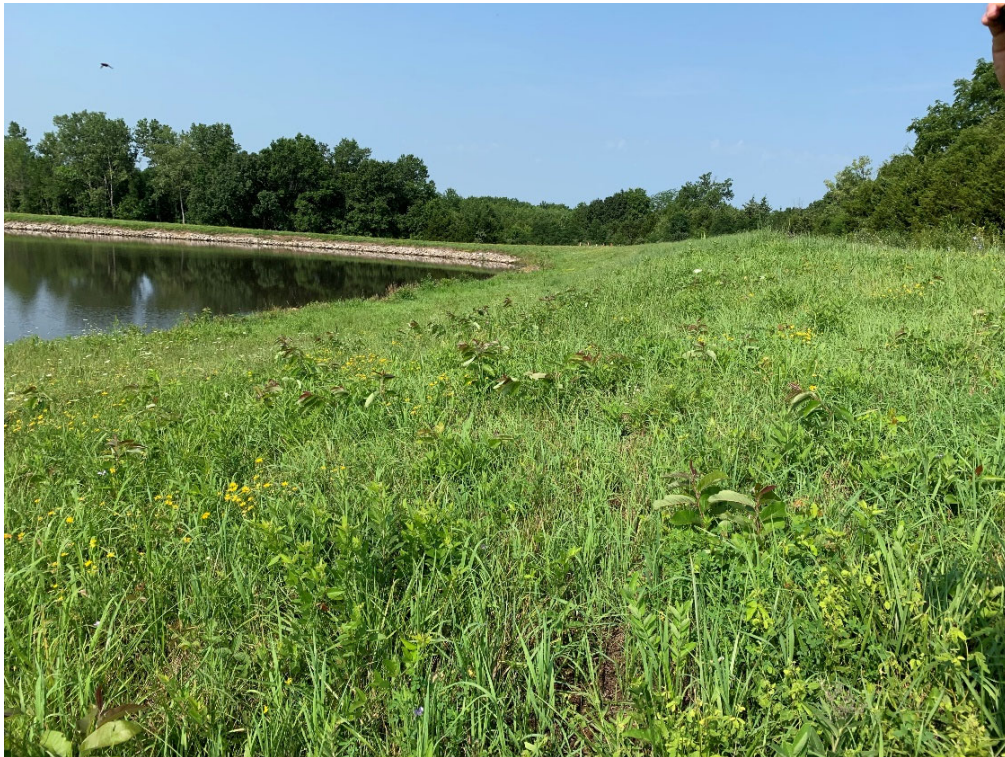
Photo No. 2

Vegetation greater than 1 ft along incised slope of northwest embankment

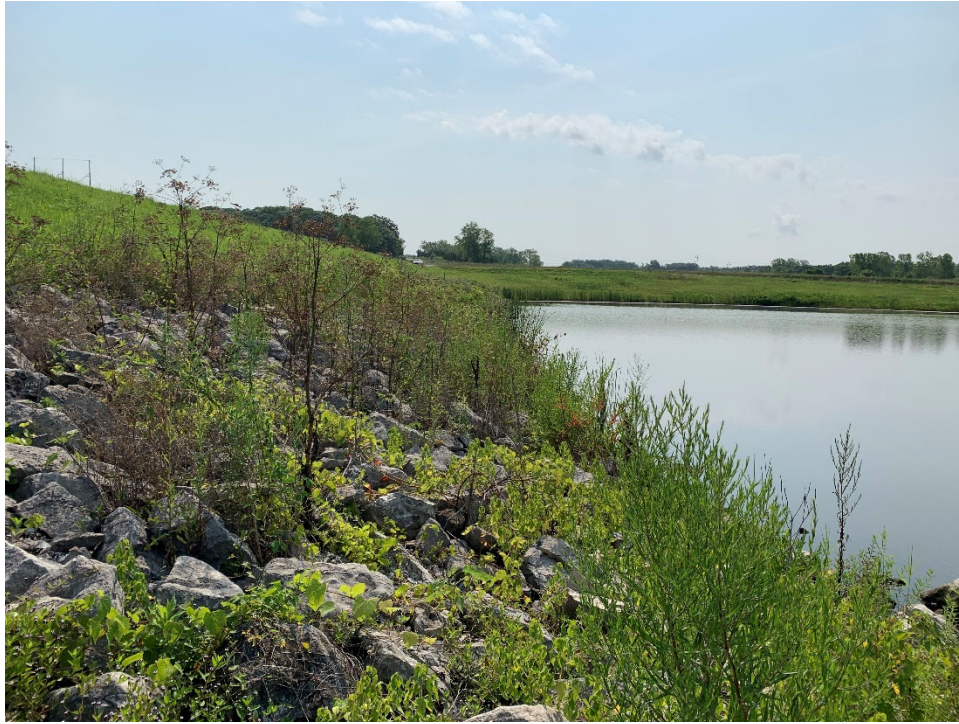
Photo No. 3

Tall vegetation at emergency spillway downstream slope of Cell 003 embankment

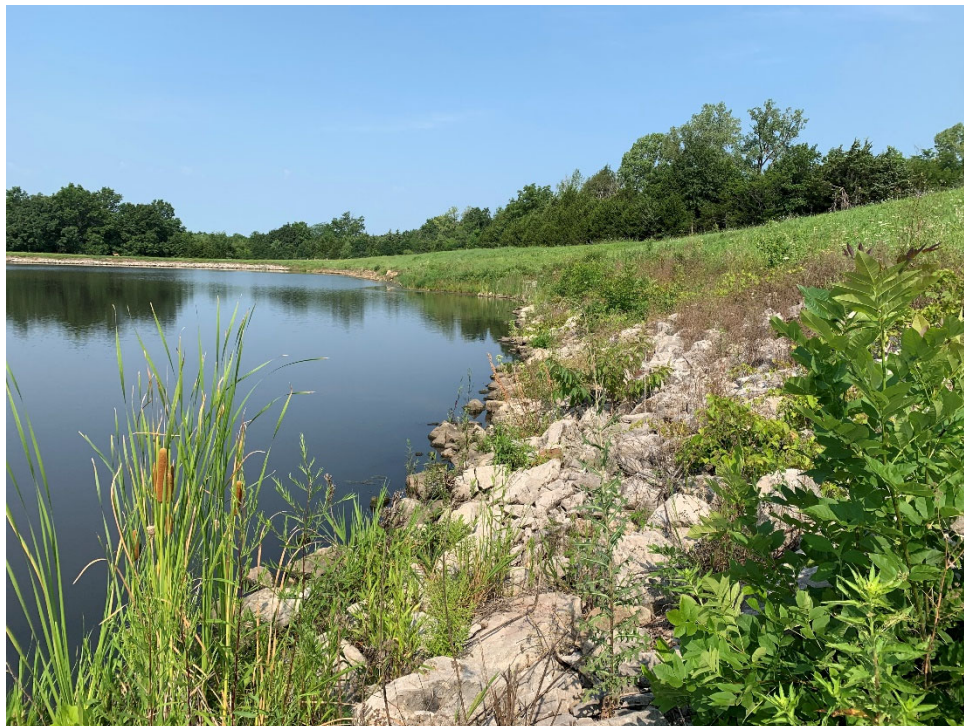
Photo No. 4

Tall vegetation along incised slope of northwest embankment

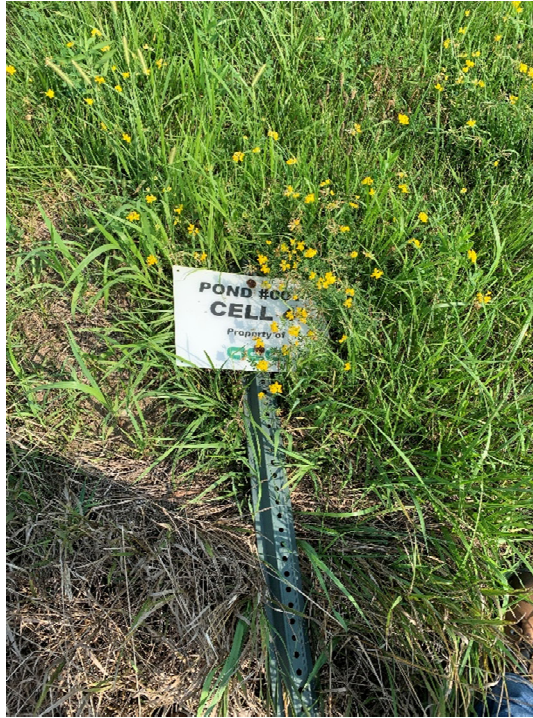
Photo No. 9
Sign labeling Cell 004 needs reinstalled

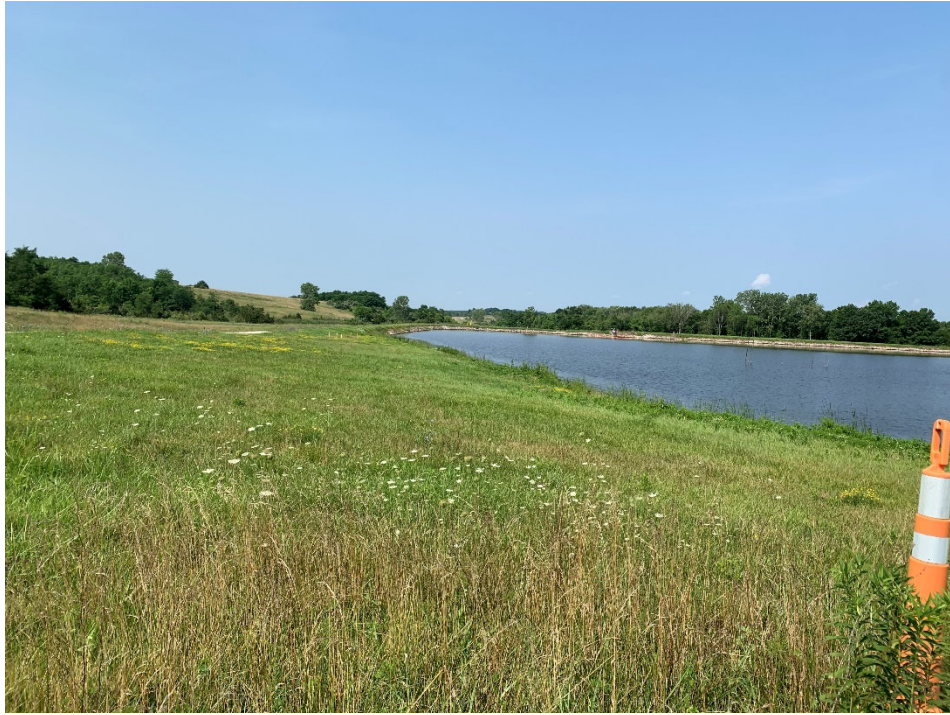
Photo No. 11
Vegetation greater than 1 ft along east embankment facing southwest

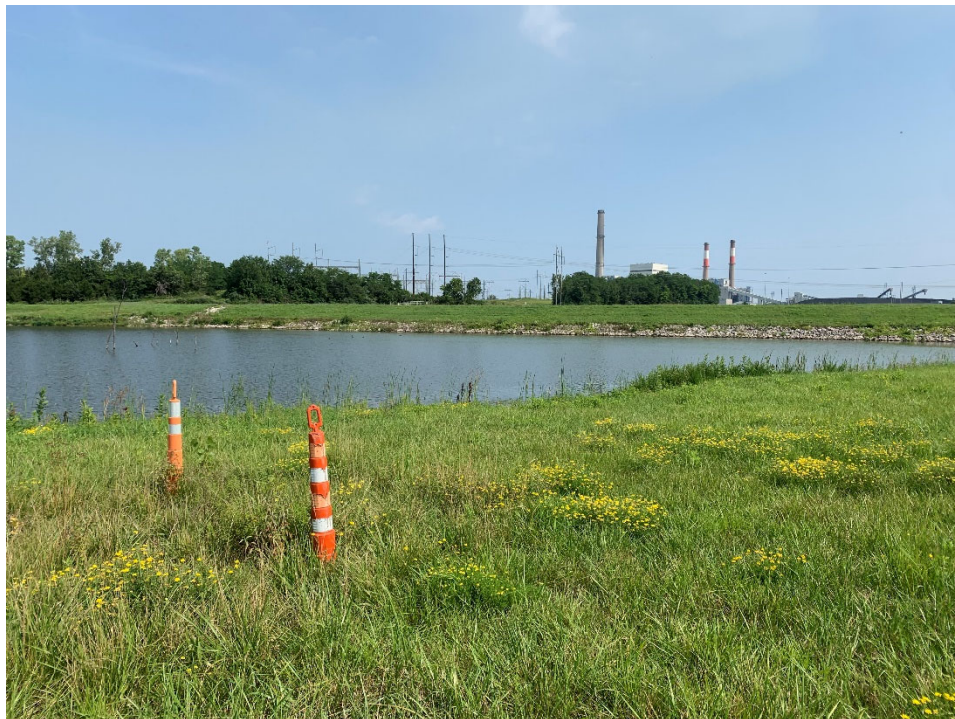
Photo No. 12
Vegetation greater than 1 ft along east embankment
Overview of Cell 003 embankment in background

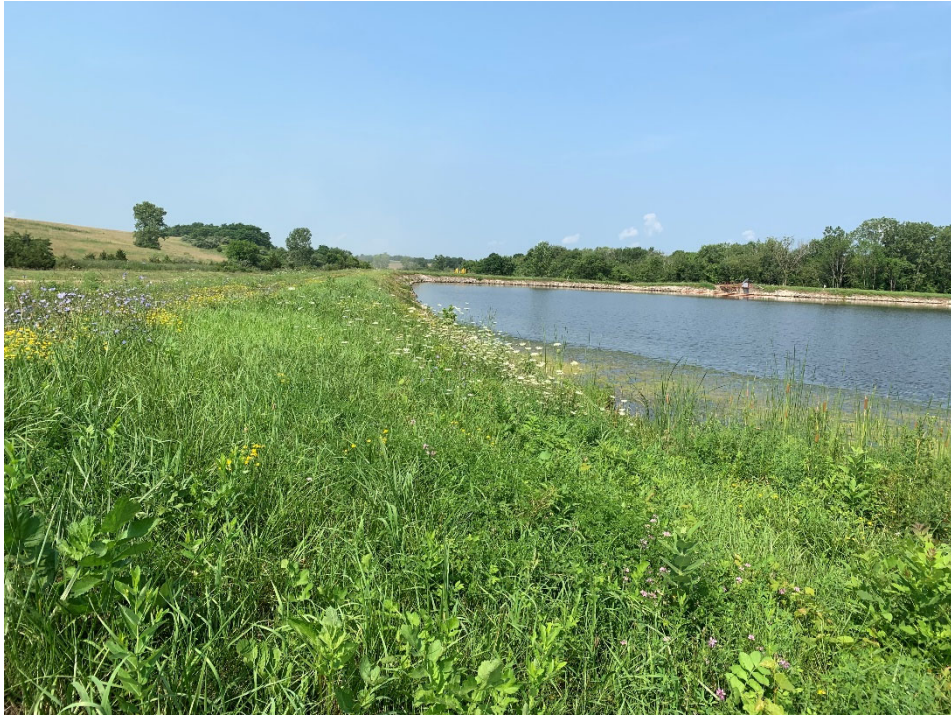
Photo No. 13

Tall vegetation along upstream slope of incised east embankment facing southwest

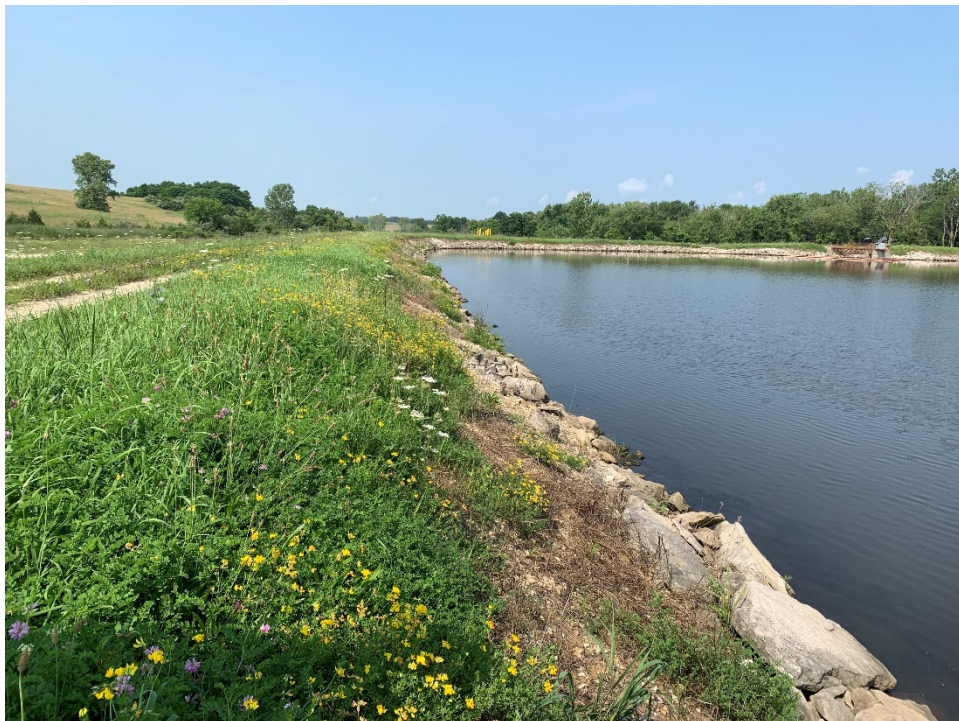
Photo No. 14

Tall vegetation as well as bare spots along upstream slope of Cell 004 southeast embankment

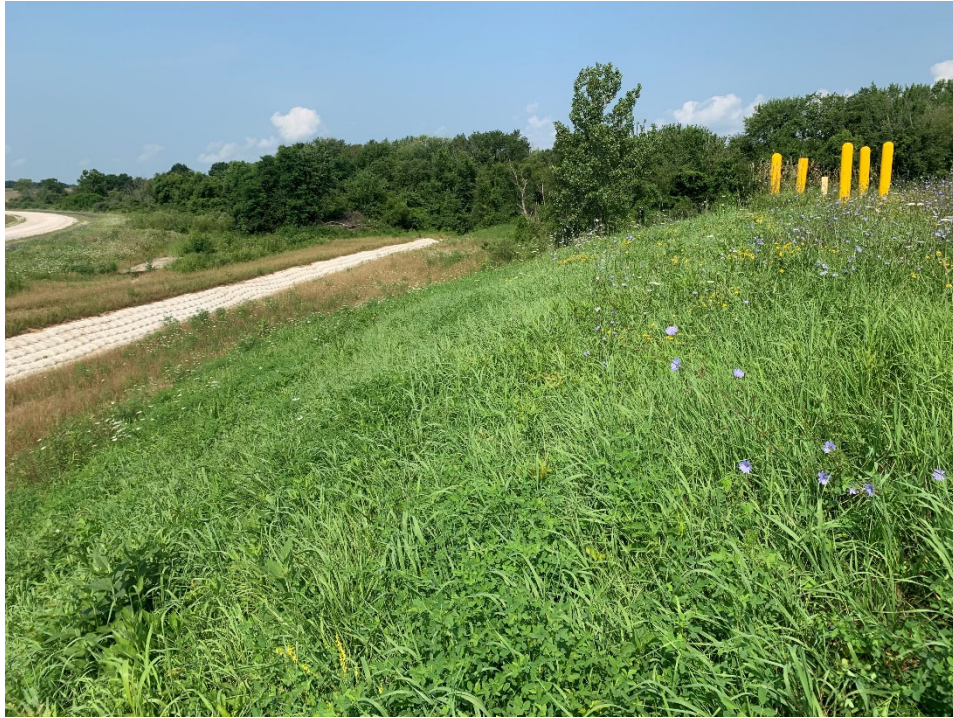
Photo No. 15

Vegetation greater than 1 ft along downstream slope of southern Cell 004 embankment
East Ditch shown at left

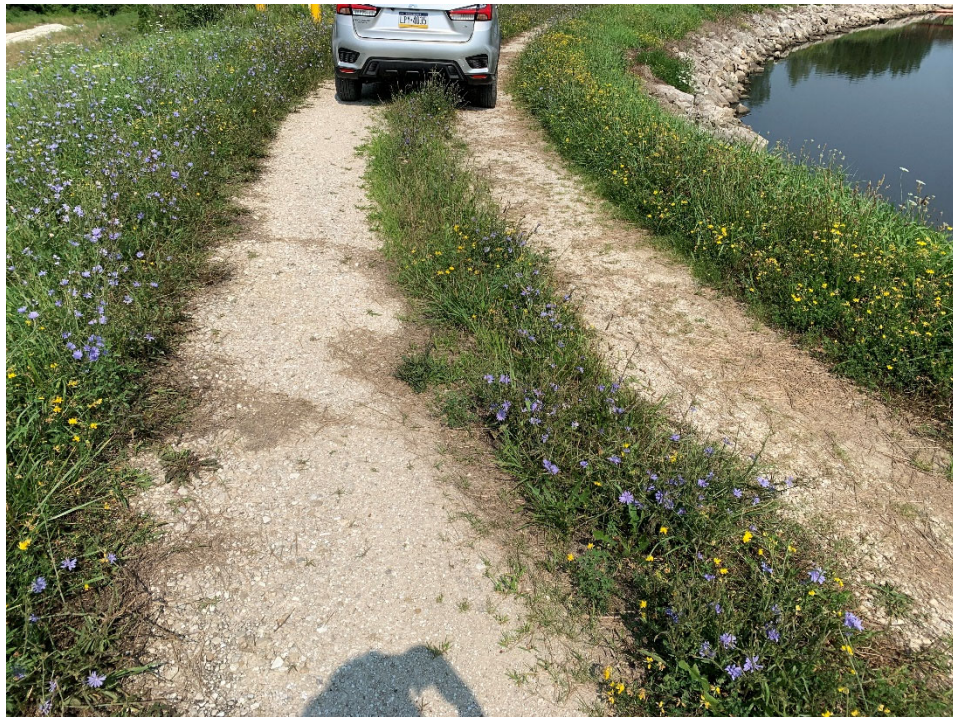
Photo No. 16

Aggregate surface and vegetation greater than 1 ft atop southern Cell 004 embankment

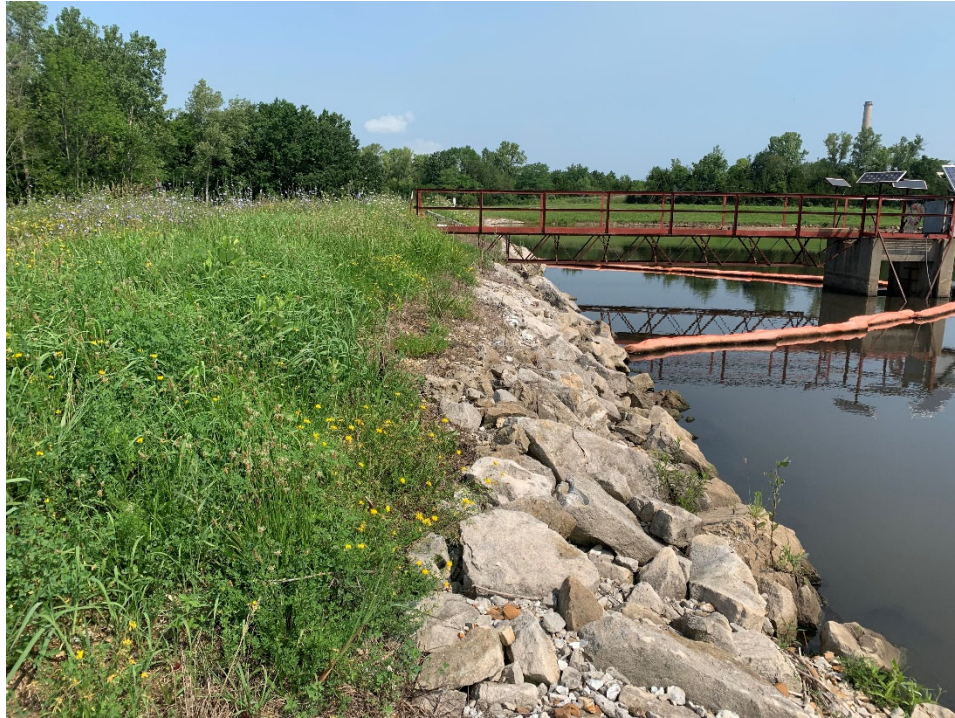
Photo No. 17

Vegetation greater than 1 ft and aggregate along upstream slope of Cell 004 embankment
Cell 004 outlet structure walkway shown in background

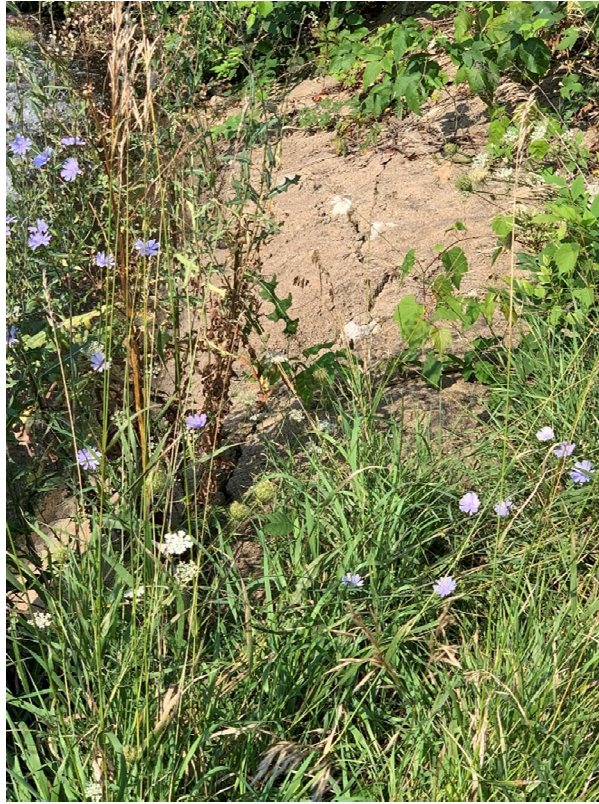
Photo No. 21

The primary spillway in Cell 004 consists of the concrete decant structure located in the south corner of the impoundment. The concrete construction is non-erodible and designed to carry sustained flows. A minor crack in the concrete apron at the downstream end of the outlet pipe was noted but did not appear to affect the performance of the outlet or cause instabilities.

Crack in concrete apron along northwest slope of outlet discharge stream

AREA INSPECTED	CONDITION	OBSERVATIONS	NO ACTION	MONITOR	REPAIR
UNDERLYING HYDRAULIC STRUCTURES /PIPES	TYPE	Not observed	X		
	INLET				
	CONDUIT				
	OUTLET STRUCTURE/HEADWALL	Fair. Crack in concrete apron in discharge channel	X		
	EROSION ALONG STRUCTURE	None present	X		
	SEEPAGE/LEAKAGE	None present	X		
	DEBRIS/BLOCKAGE	None present	X		
	UNUSUAL MOVEMENT				
	DOWNSTREAM AREA				
	MISCELLANEOUS

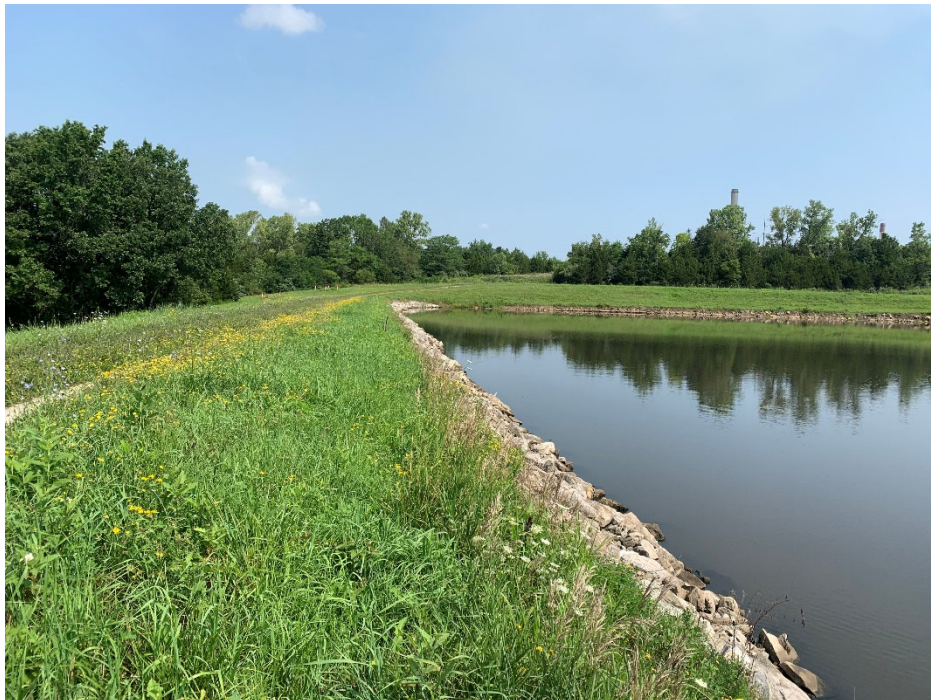
Photo No. 22

Vegetation greater than 1 ft along upstream slope of Cell 004 southwest embankment

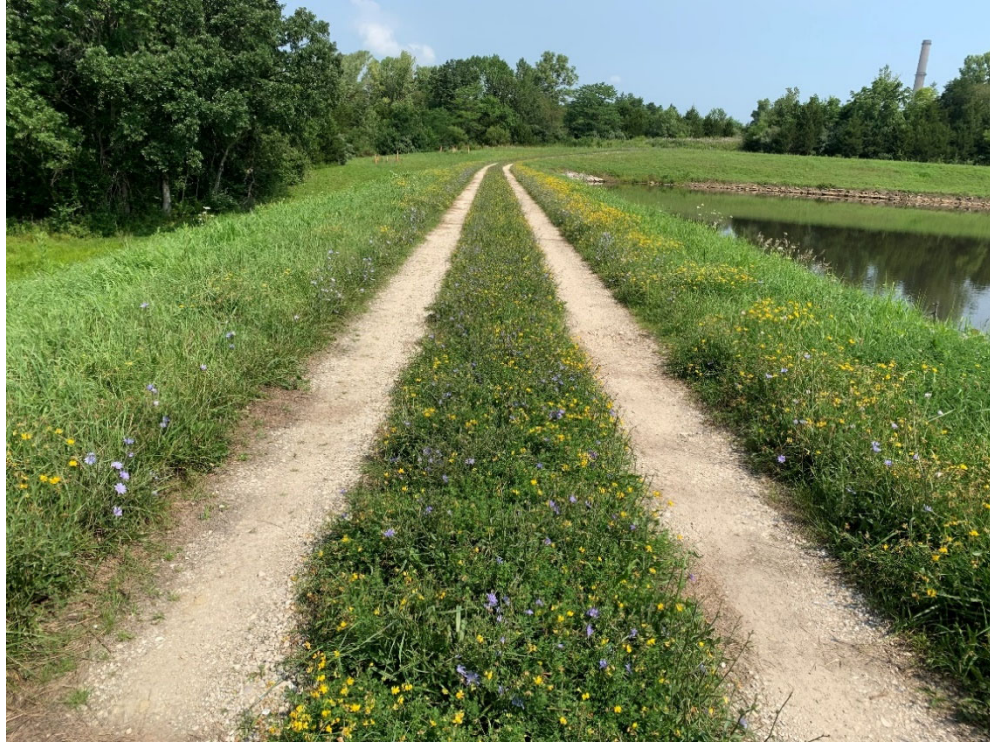
Photo No. 23

Aggregate surface and vegetation greater than 1 ft atop Cell 004 southwest embankment

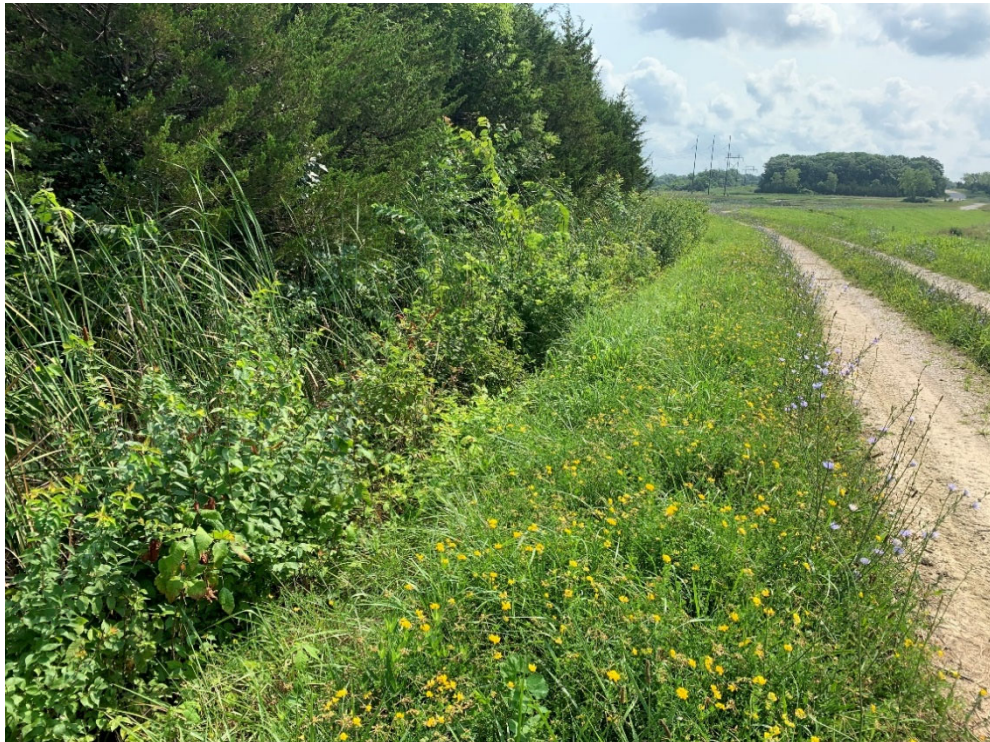
Photo No. 24

Tall vegetation along downstream slope of Cell 004 northwest embankment

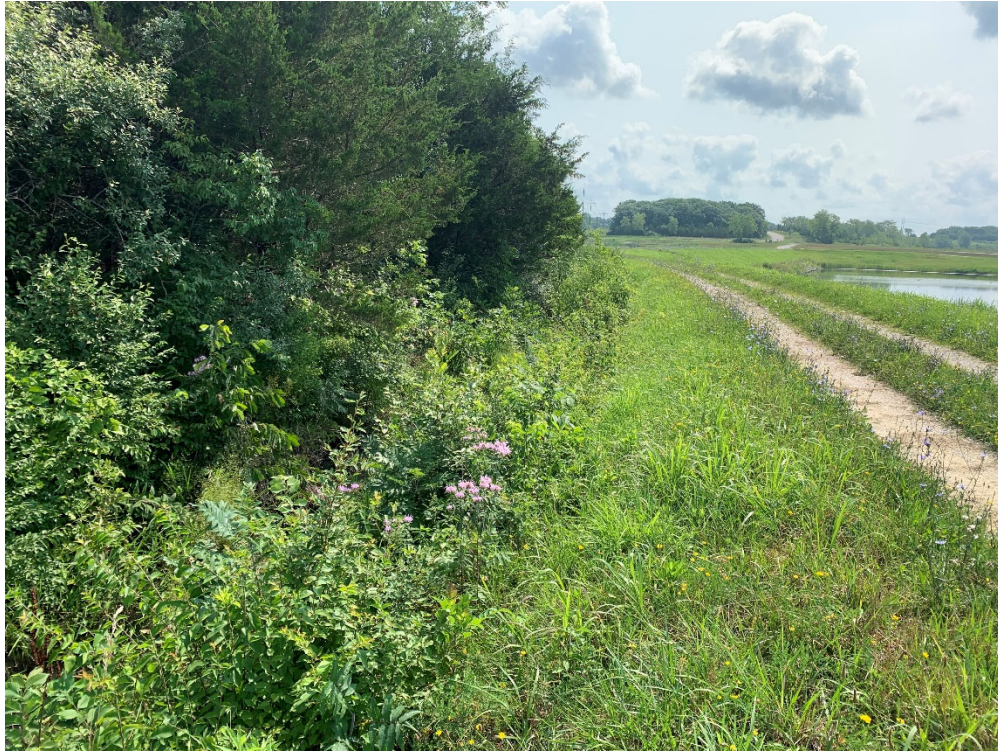
Photo No. 25

Tall vegetation along downstream slope of Cell 004 northwest embankment

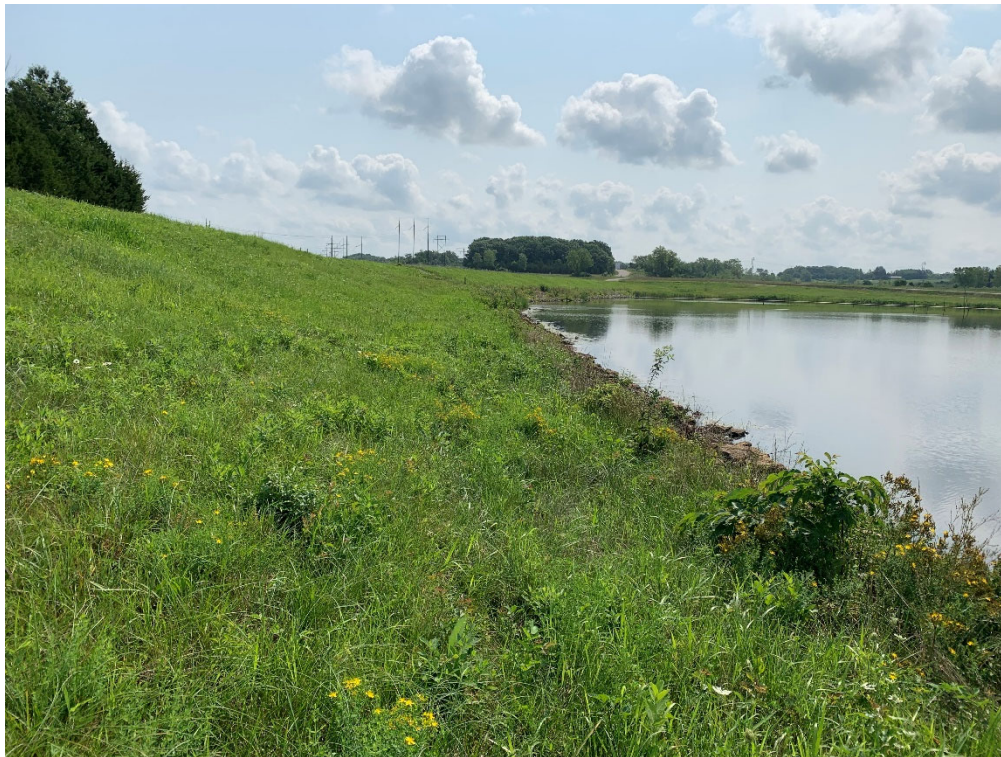
Photo No. 26

Tall vegetation at upstream slope of Cell 004 northwest embankment facing northeast

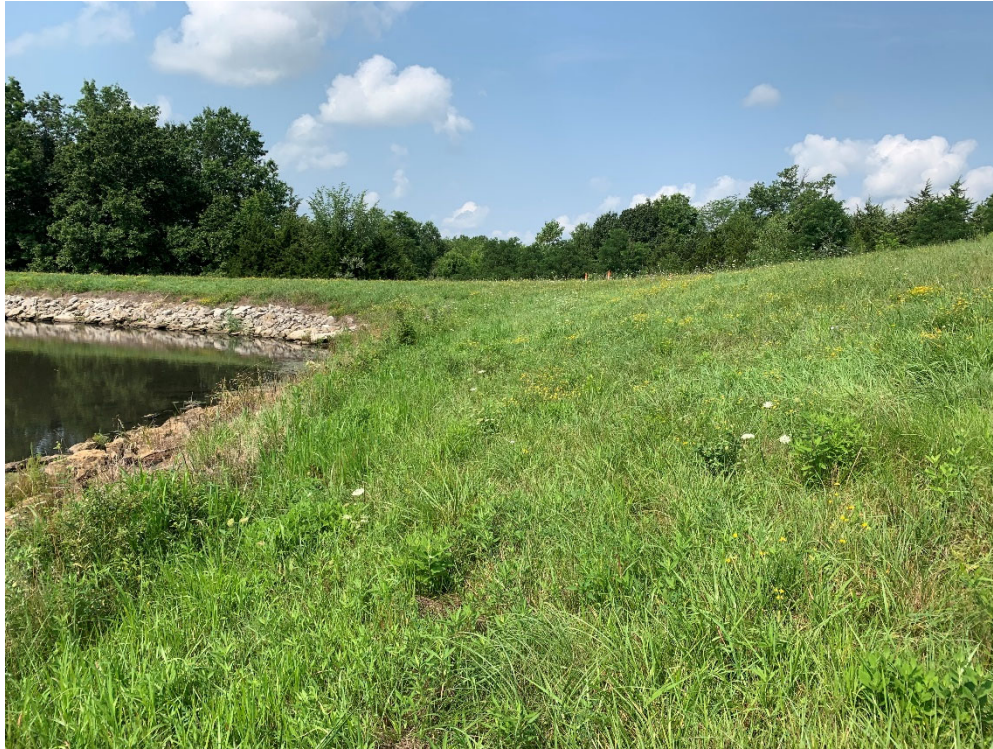
Photo No. 27

Tall vegetation at upstream slope of Cell 004 northwest embankment facing southwest

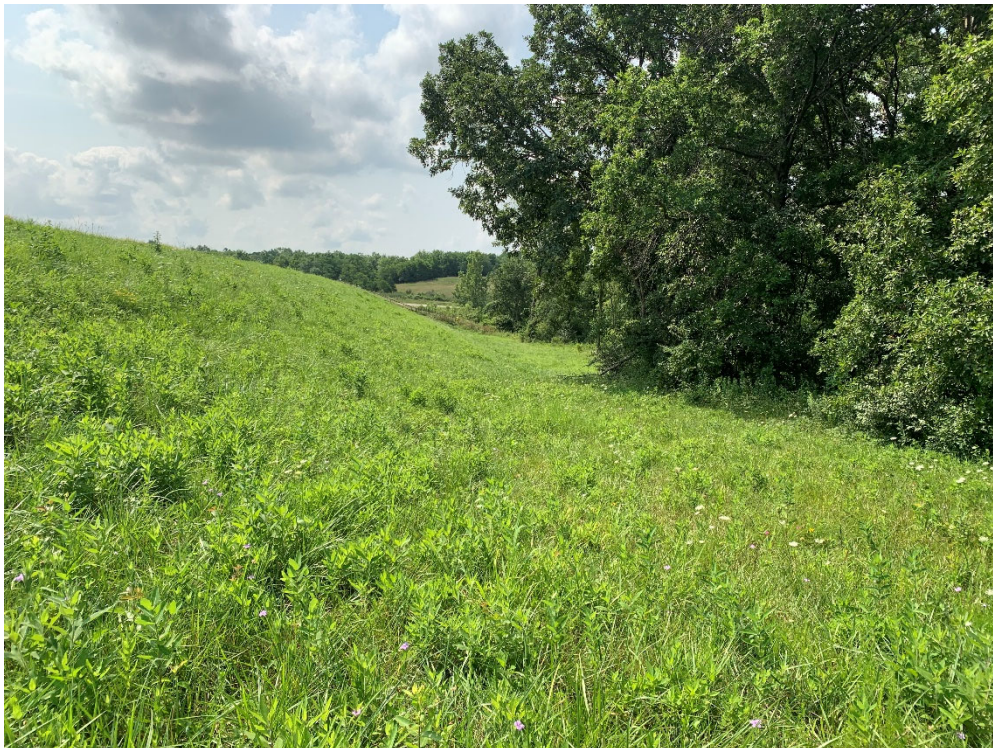
Photo No. 28

Vegetation greater than 1 ft along downstream slope of Cell 004 west embankment

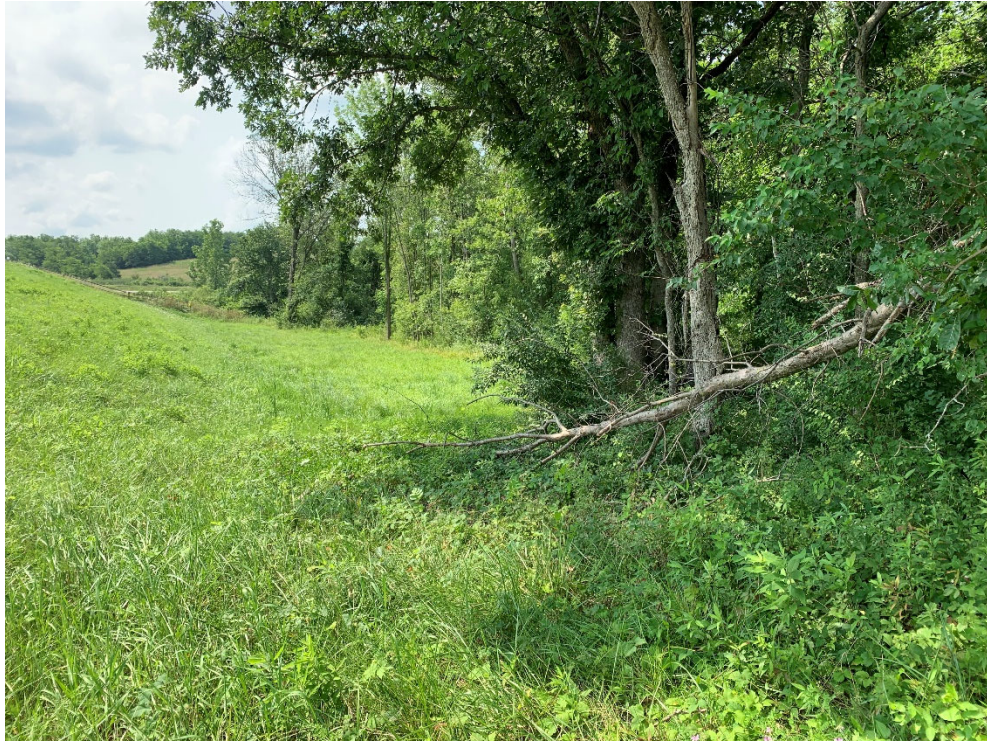
Photo No. 29
Woody vegetation near toe of slope at Cell 004 west embankment

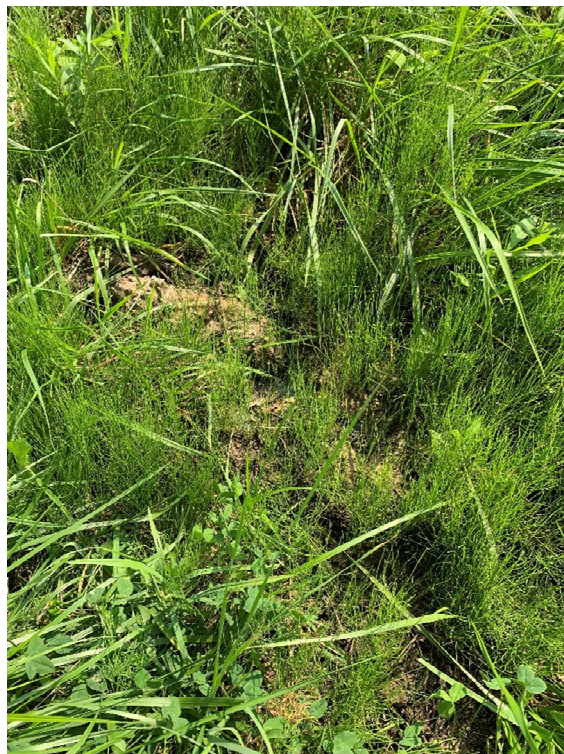
During the inspection, evidence of seepage was noted along the southwest embankment. This seep has been noted in previous weekly and annual inspections. Flowing water was not present at the site and there was no visible erosion or instability at the time of the inspection.

Photo No. 30
Evidence of seepage at toe of slope along Cell 004 west embankment

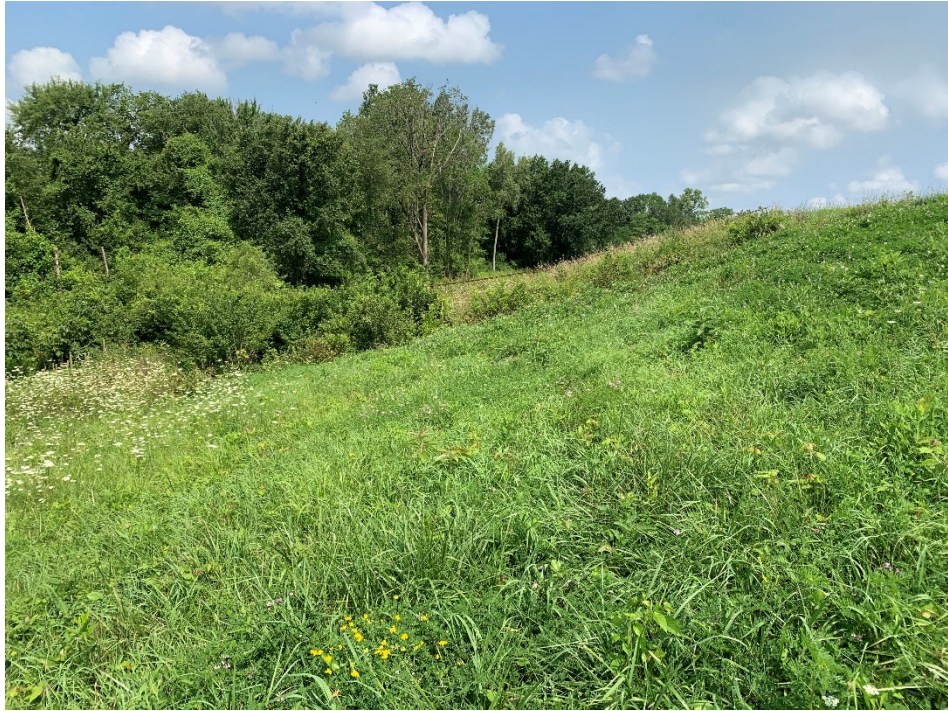
Photo No. 31

Vegetation greater than 1 ft along downstream slope of Cell 004 west embankment
