Subject: 2025 Annual Inspection by a Qualified Professional Engineer
Cell 003, Thomas Hill Energy Center
Clifton Hill, Missouri

REPORT ON
2025 ANNUAL INSPECTION BY A QUALIFIED PROFESSIONAL
ENGINEER
CELL 003 CCR SURFACE IMPOUNDMENT
THOMAS HILL ENERGY CENTER
CLIFTON HILL, MISSOURI

File No. 0212832
August 2025

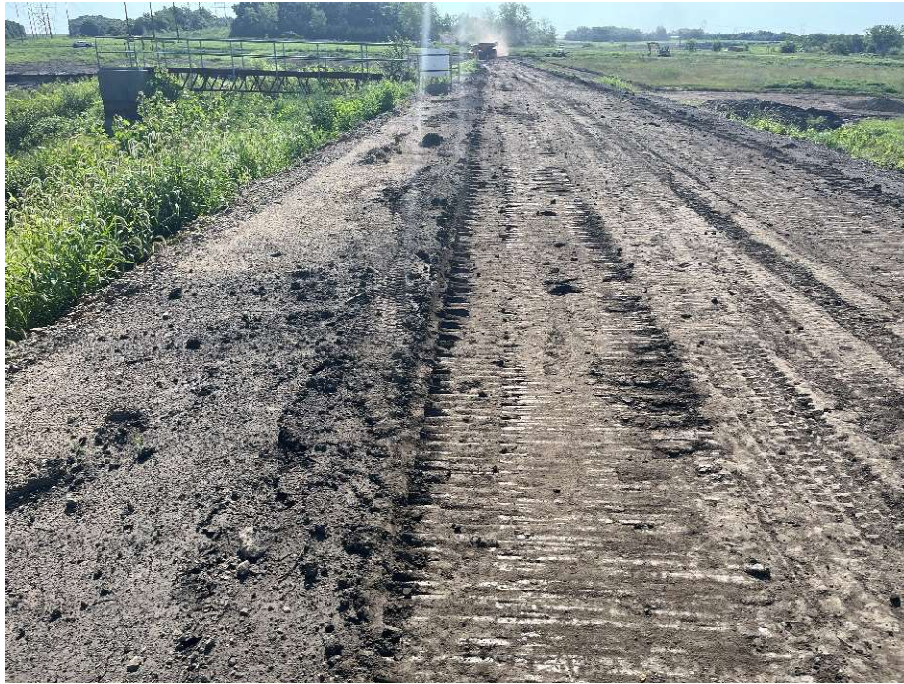
Photo 1: Access road on Cell 003 embankment crest (looking east)

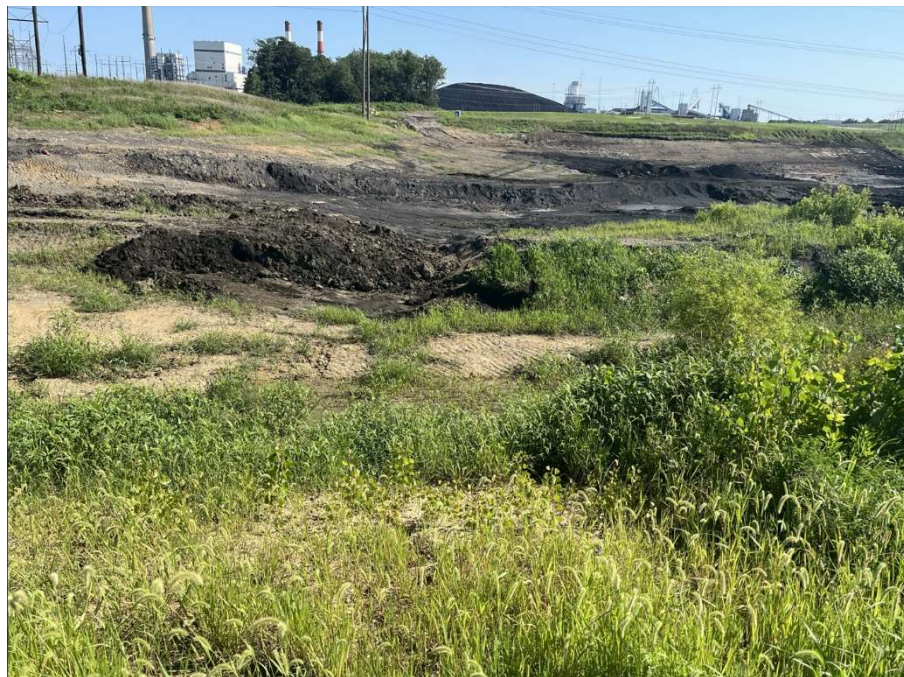
Photo 2: Southwest corner of Cell 003 (looking northwest)

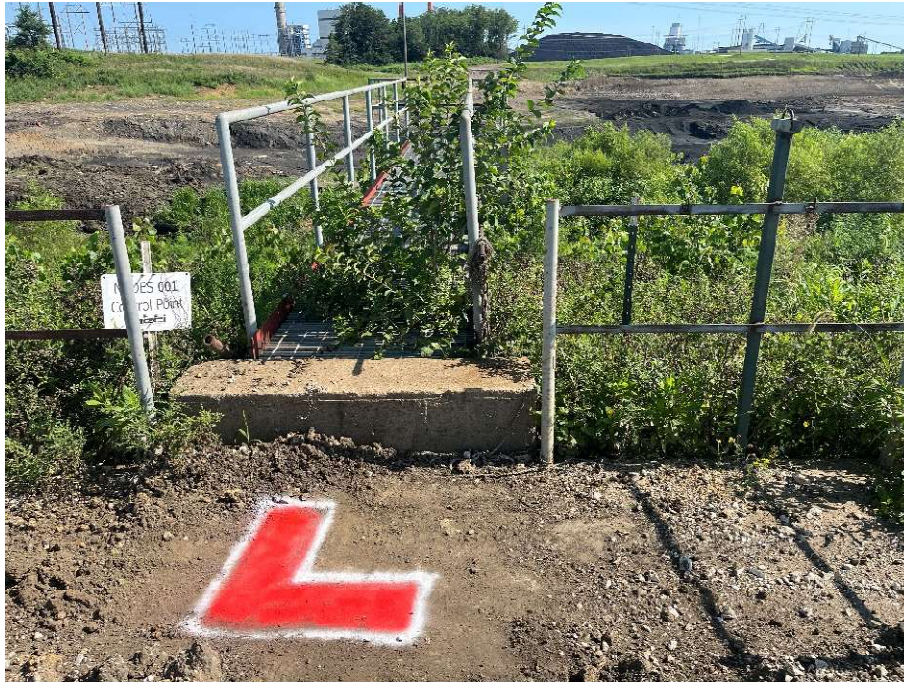
The outlet structure from Cell 003 consists of a rectangular concrete drop inlet tower equipped with 60 in. wide concrete stop logs. The reinforced concrete principal spillway inlet structure that penetrates the common Cell 003/004 embankment appeared to be intact, stable and properly aligned. Since the commencement of the closure activities, the water inside the impoundment has been removed and the hydraulic structure has not been utilized as per normal operations. The Cell 003 emergency spillway consists of an 18-ft wide riprap-lined channel which is approximately 2 feet in depth located across the crest of the south dike. To provide vehicle access across the riprapped channel, the riprap has been topped off with a layer of crushed stone within the limits of access road. The emergency spillway also appeared to be structurally sound and showed no signs of distress.

Photo 3: Outlet structure of Cell 003 (looking north)

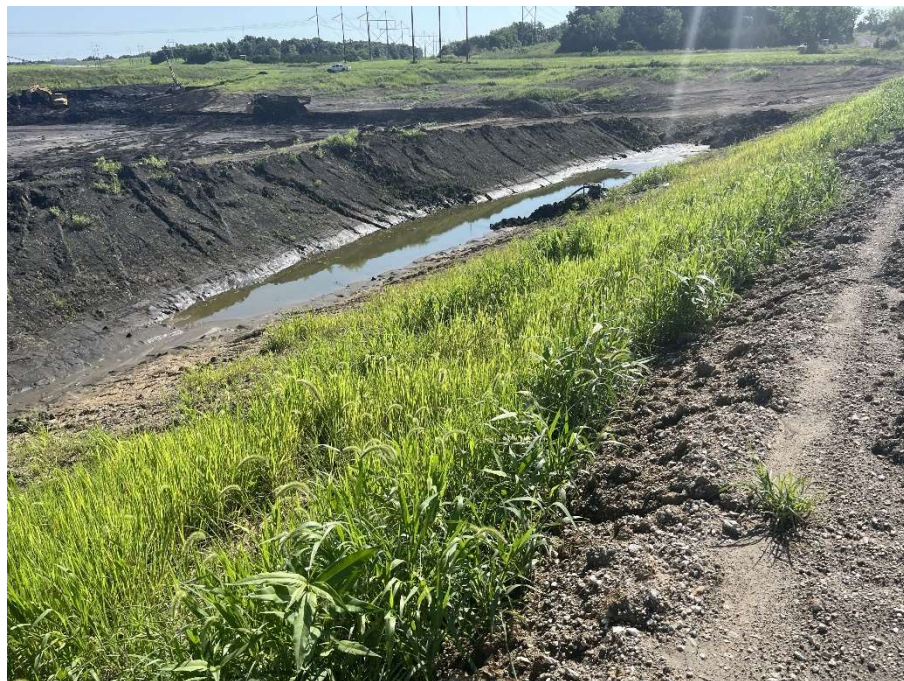
No changes in geometry of the impounding structure since the previous annual inspection were observed. There was no discernible sag, slumping, bulging or other geometric indications of adverse embankment or slope performance. The embankment showed no signs of instability or unusual movement and had no noticeable deviation from its design. Haley & Aldrich also observed the old berm, located just north of the existing present-day embankment and abandoned in place during the 1984-1985 modifications.

Photo 4: Abandoned old berm located north of present-day embankment (looking northeast)

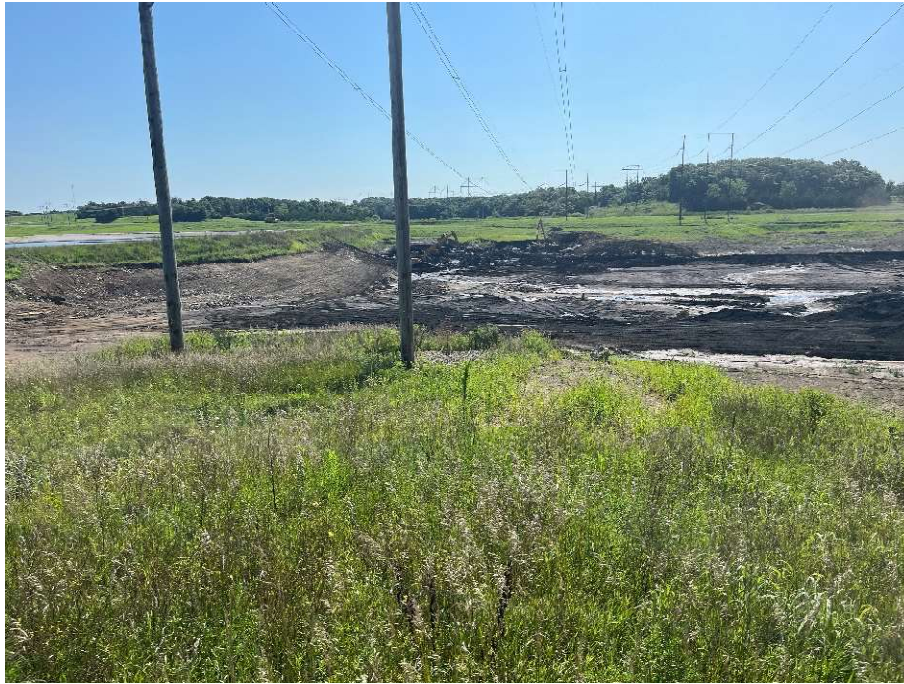
Photo 5: Typical view of the impoundment (looking east)

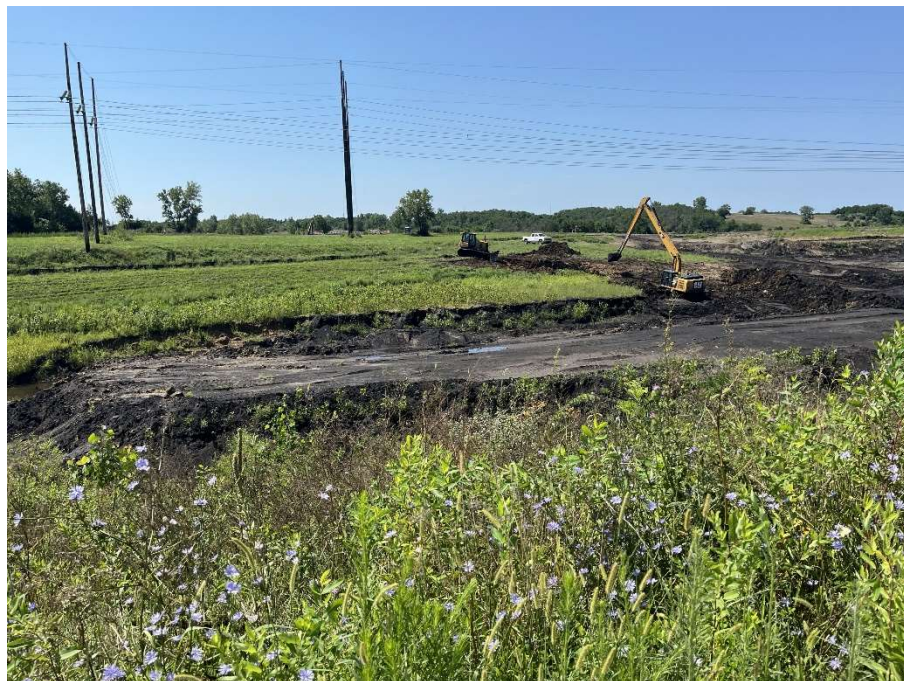
Photo 6: Northeast corner of the impoundment (looking south)

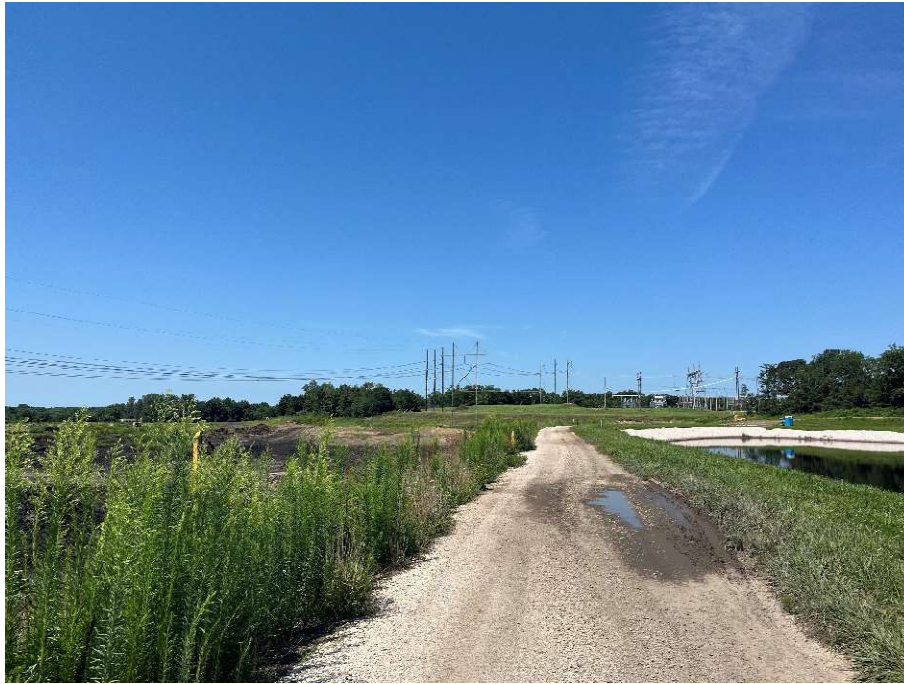
Photo 7: Access road along Cell 002 embankment, north side of Cell 003 (looking west)

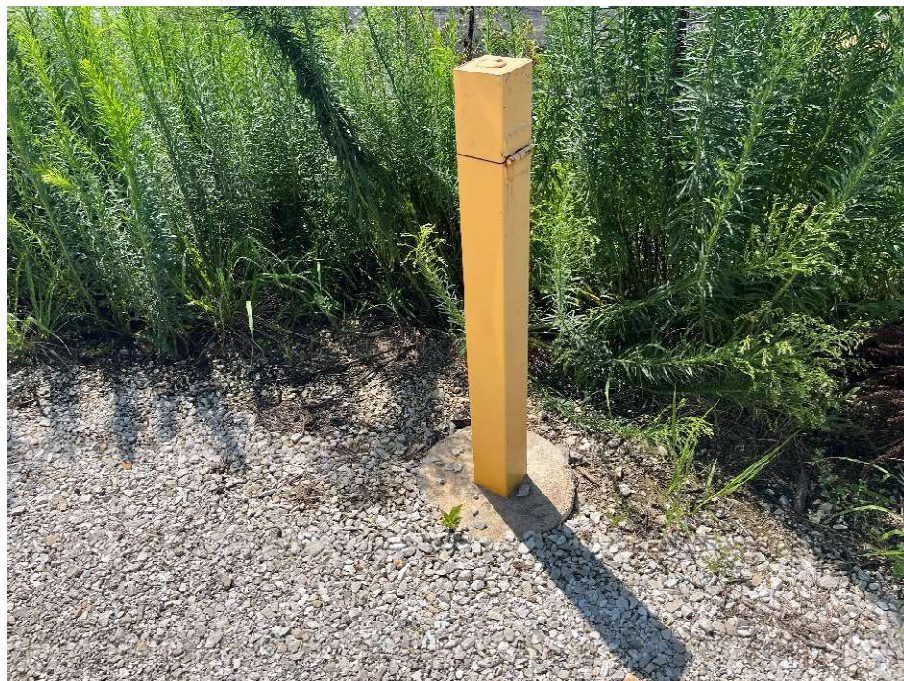
Photo 8: Observation well HAOW-002-A on the Cell 002 embankment, north side of Cell 003

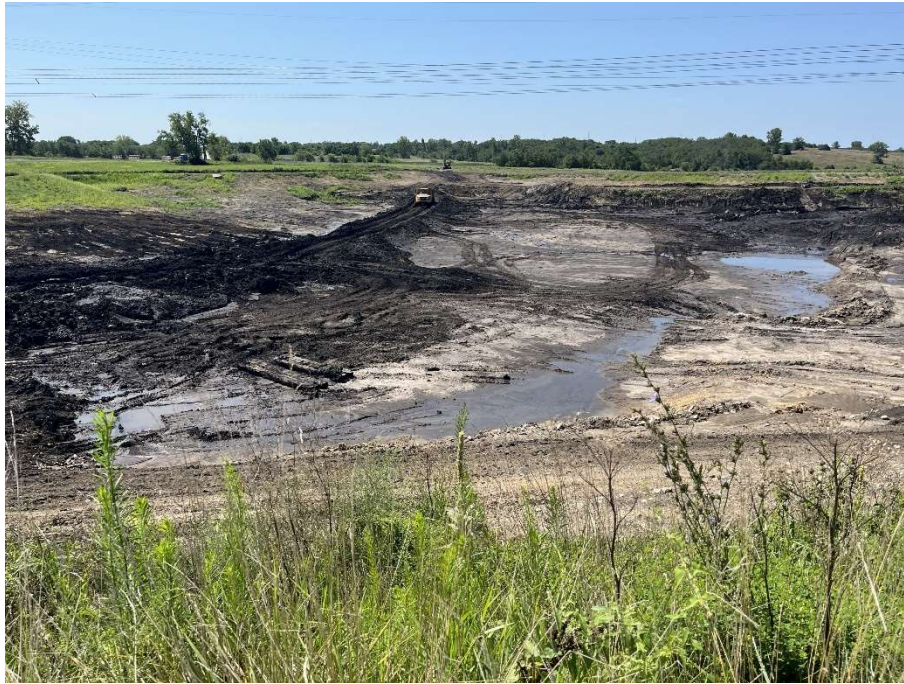
Photo 9: Typical view of the impoundment (looking south)

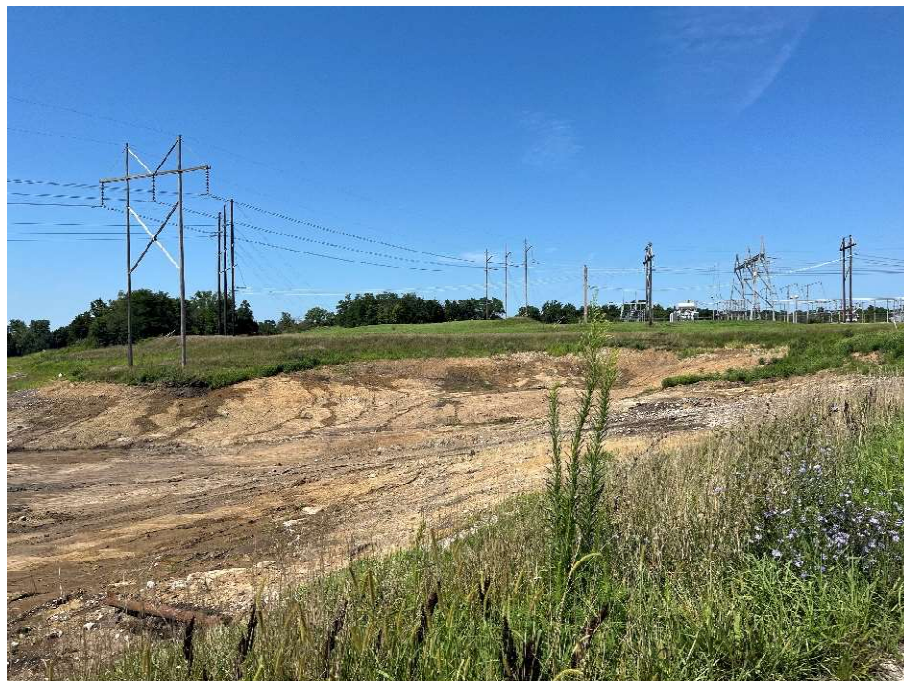
Photo 10: Northwest corner of the impoundment (looking southwest)
