Subject: 2025 Annual Inspection by a Qualified Professional Engineer
Cell 004, Thomas Hill Energy Center
Clifton Hill, Missouri

REPORT ON
2025 ANNUAL INSPECTION BY A QUALIFIED PROFESSIONAL
ENGINEER
CELL 004 CCR SURFACE IMPOUNDMENT
THOMAS HILL ENERGY CENTER
CLIFTON HILL, MISSOURI

File No. 0212832
August 2025

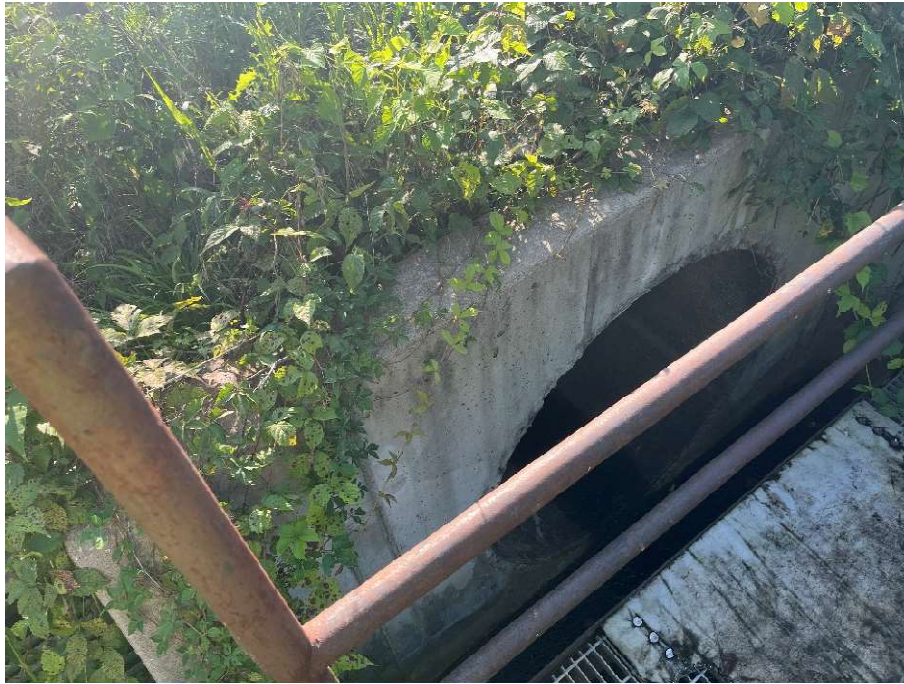
Photo 1: Downstream end of the outlet pipe

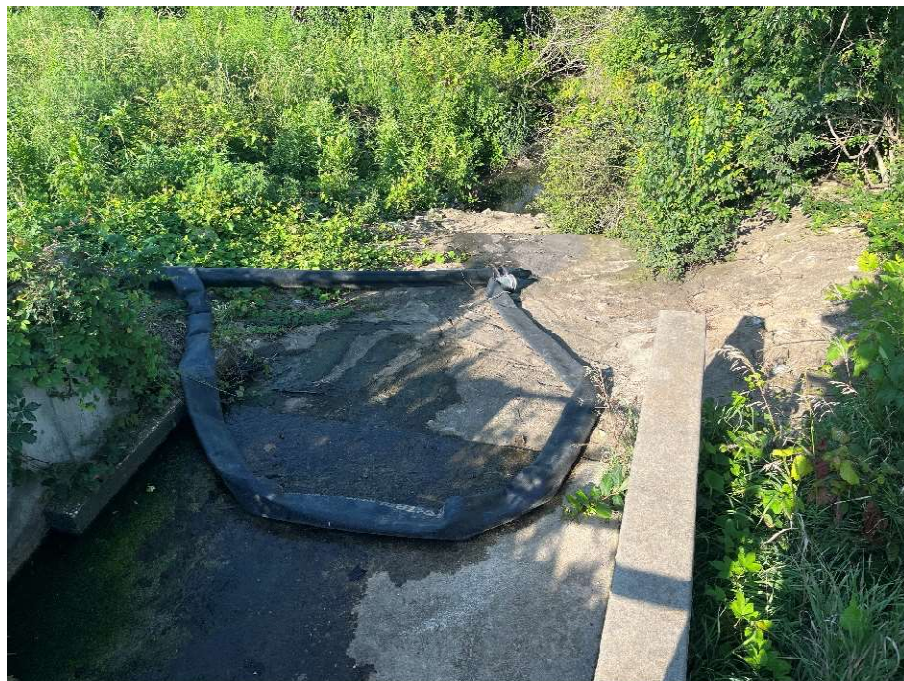
Photo 2: Open concrete channel at the downstream end of the outlet pipe (looking southeast)

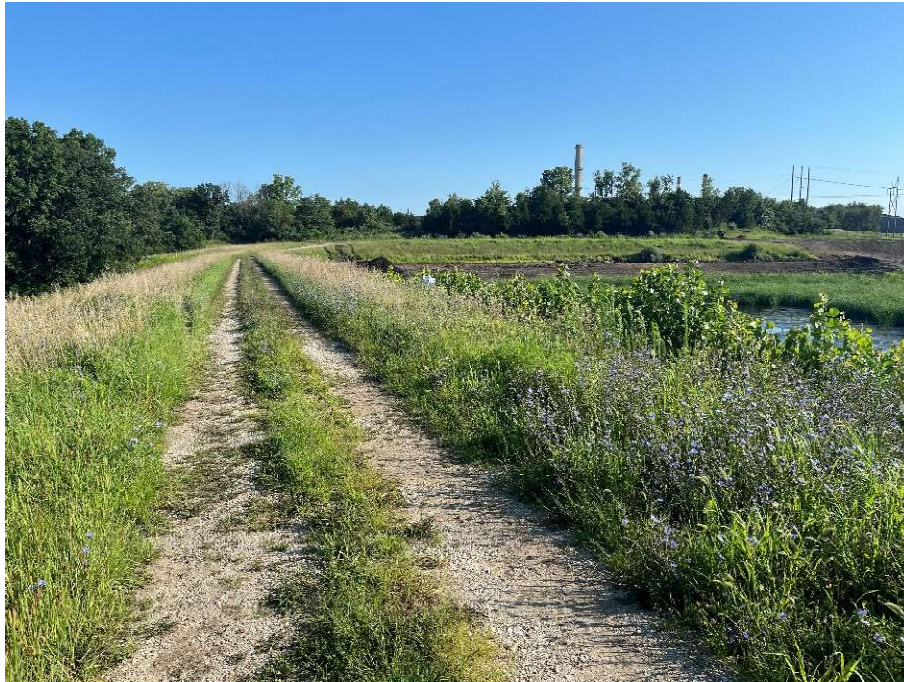
Photo 3: Access road on the crest of Cell 004 embankment (looking northwest)

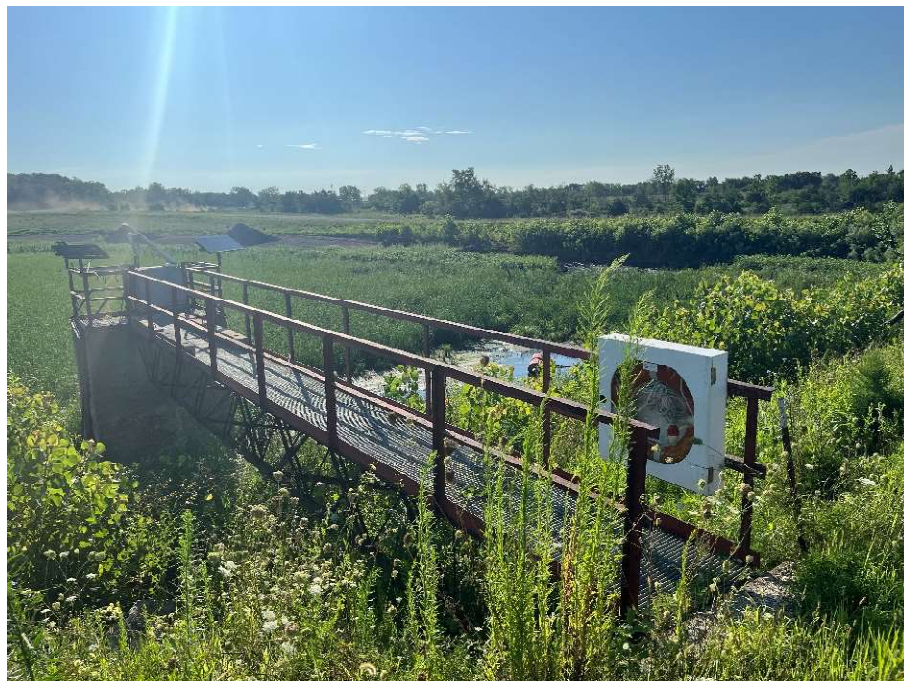
Photo 4: Walkway for the existing outlet structure (looking east)

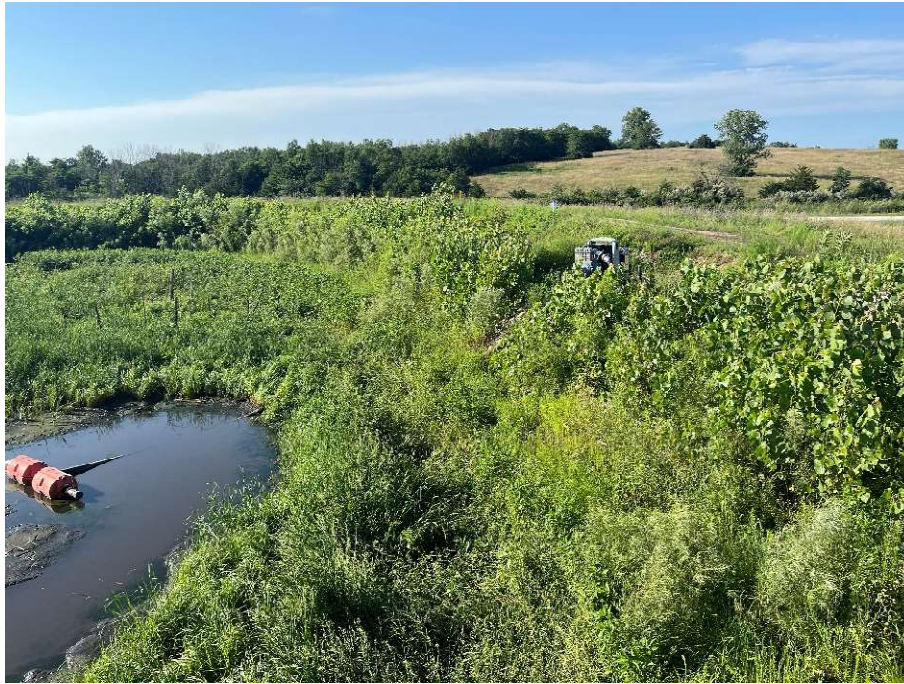
Photo 5: Typical view of the southern end of the impoundment (looking southeast)

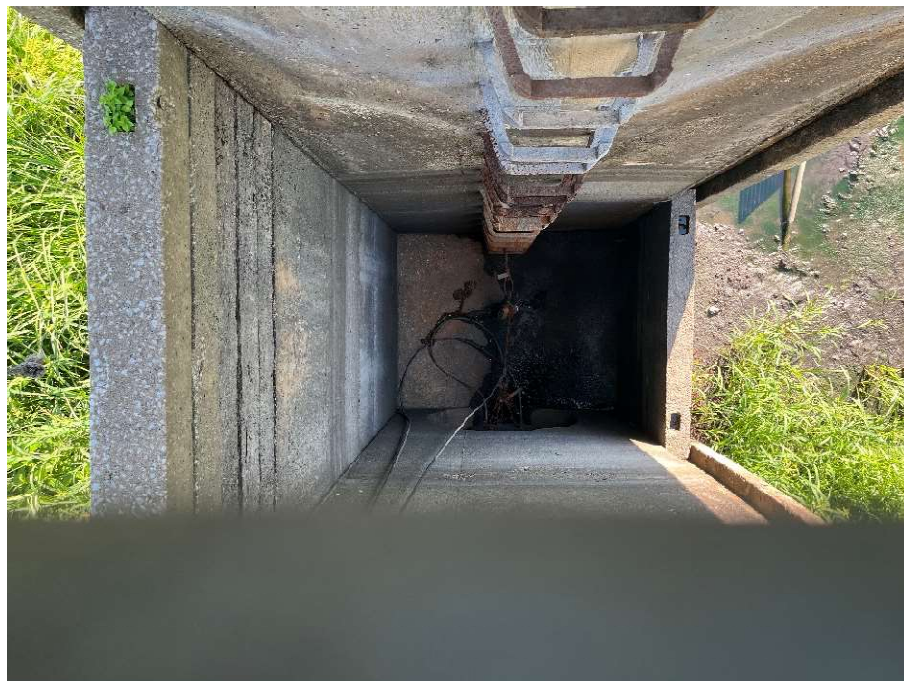
The outlet structure from Cell 004 consists of a rectangular concrete drop inlet tower equipped with 60 in. wide concrete stop logs with a 48-in. diameter steel pipe that penetrates the Cell 004 south embankment. These hydraulic structures appeared to be intact, stable and properly aligned. Since the commencement of the closure activities, the water inside the impoundment has been removed and the hydraulic structure has not been utilized as per normal operations. The Cell 004 emergency spillway consists of an 18-ft wide riprap-lined channel which is approximately 2 feet in depth located across the crest of the south embankment. To provide vehicle access across the riprapped channel, the riprap has been topped off with a layer of crushed stone within the limits of access road. The emergency spillway also appeared to be structurally sound and showed no signs of distress.

Photo 6: Looking down at the concrete drop inlet tower structure with stop logs at Cell 004

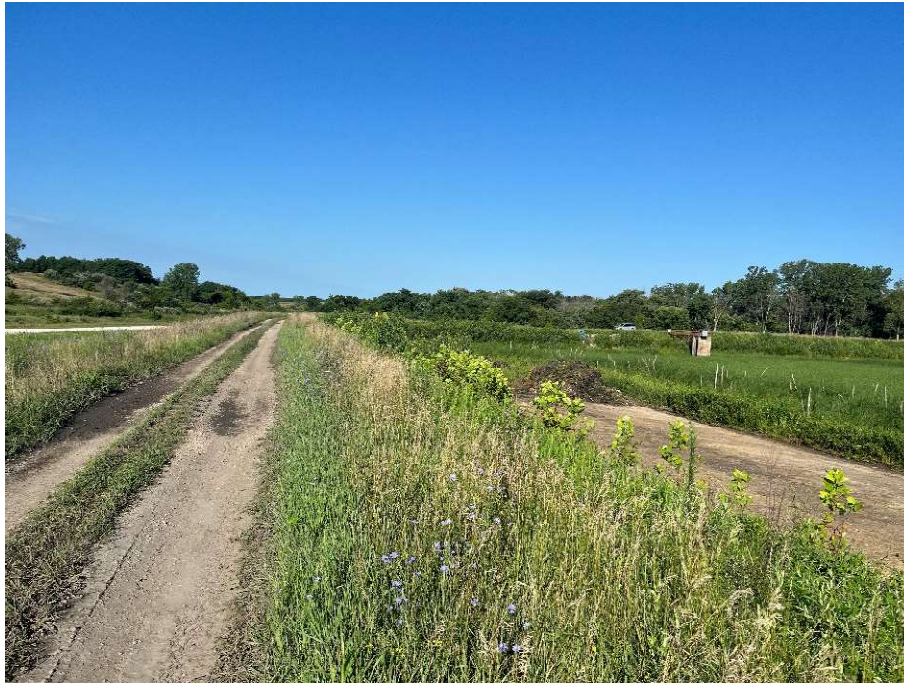
Photo 7: Access road on the east side of the Cell 004 (looking southwest)

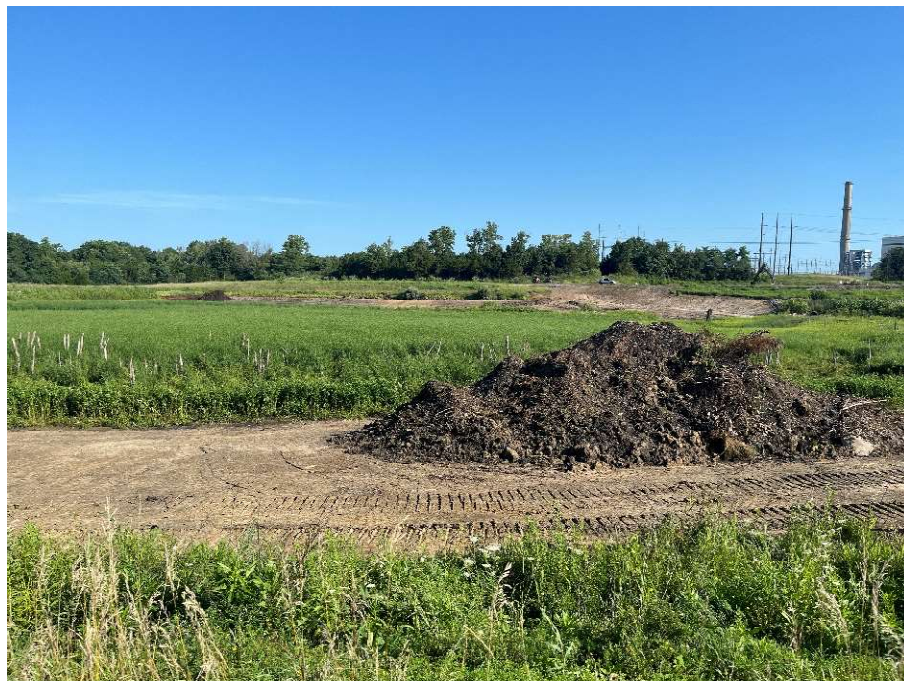
Photo 8: Typical view of the pond (looking northwest)

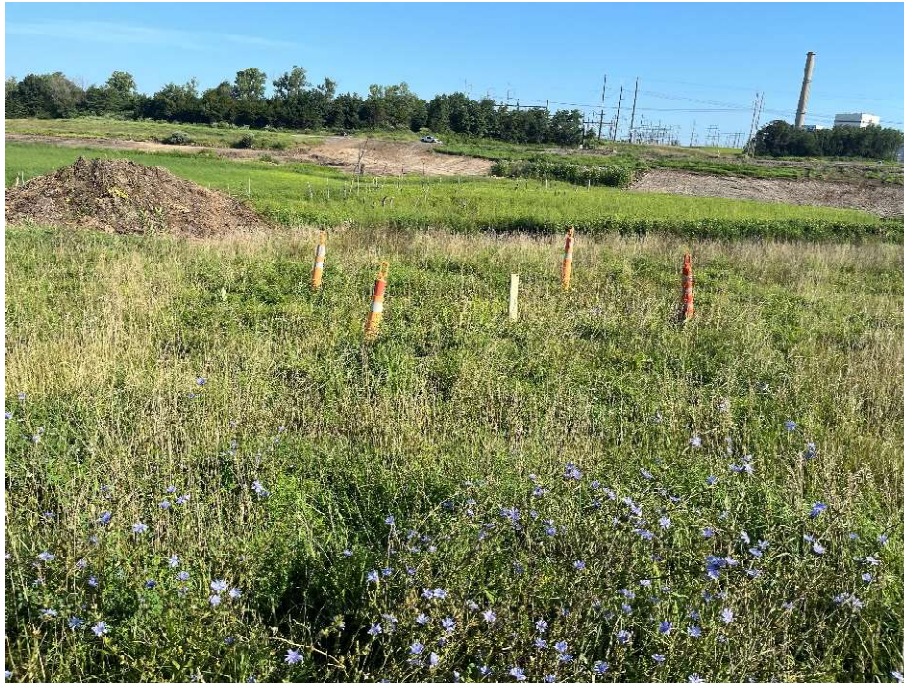
Photo 9: Monitoring well TPZ-11 (looking northwest)

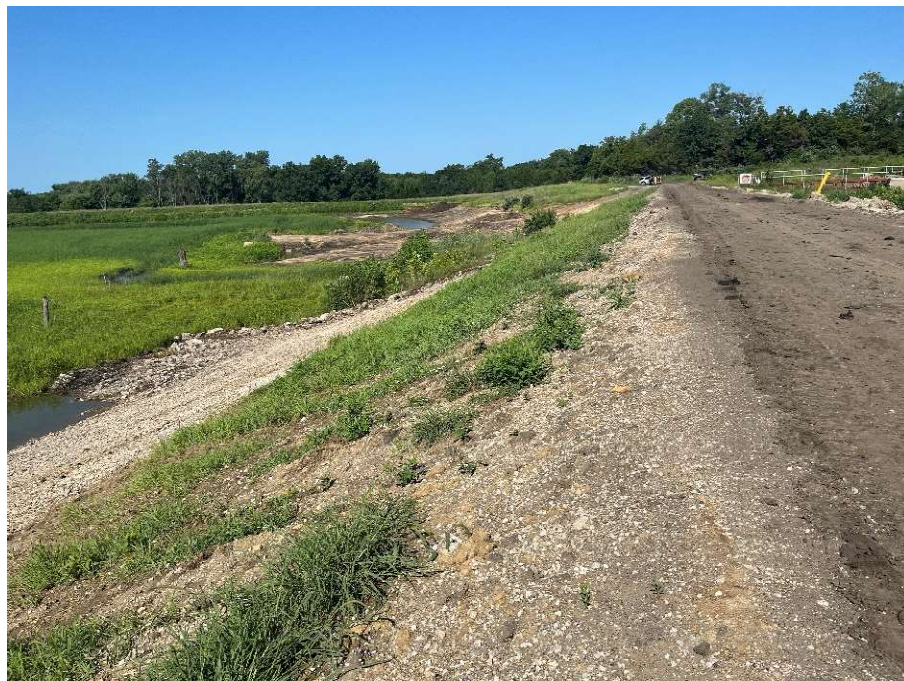
Photo 10: Access road along Cell 003 embankment, north side of Cell 004 (looking west)

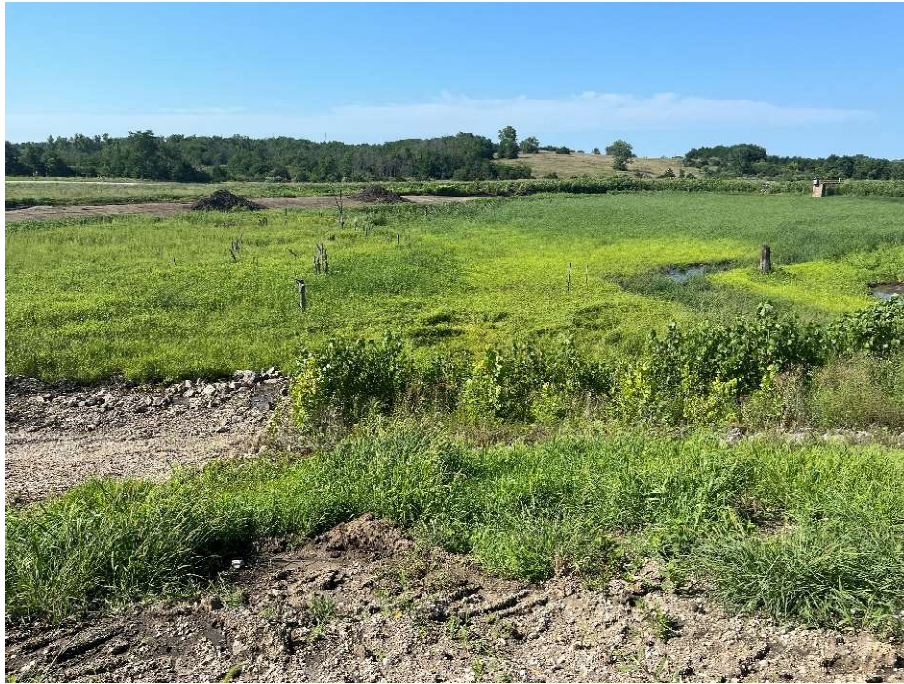
Photo 11: Typical view of the impoundment (looking south)

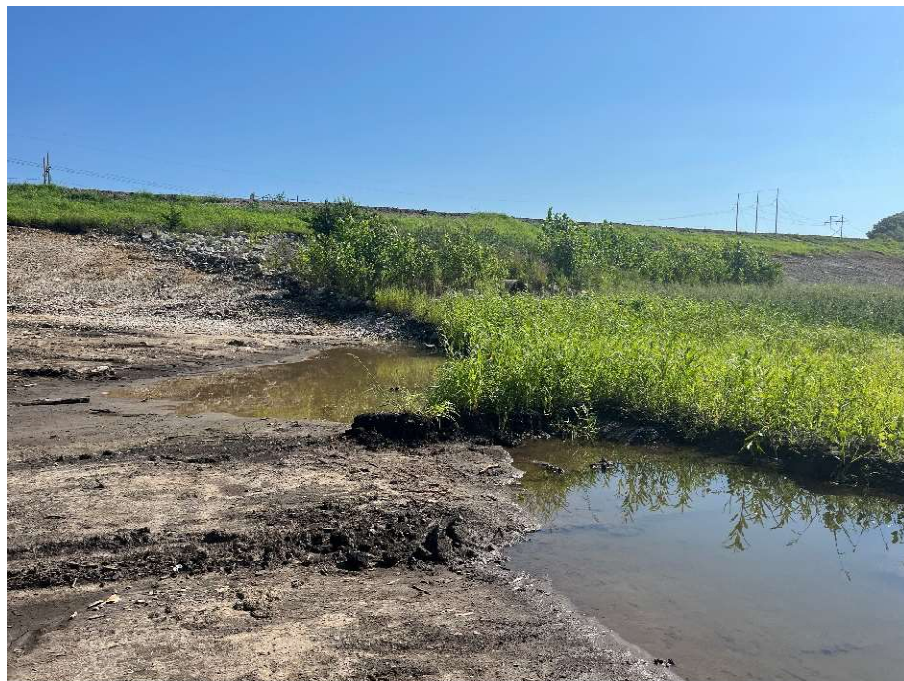
Photo 12: Southern slope of Cell 003 embankment, north side of Cell 004 (looking northeast)

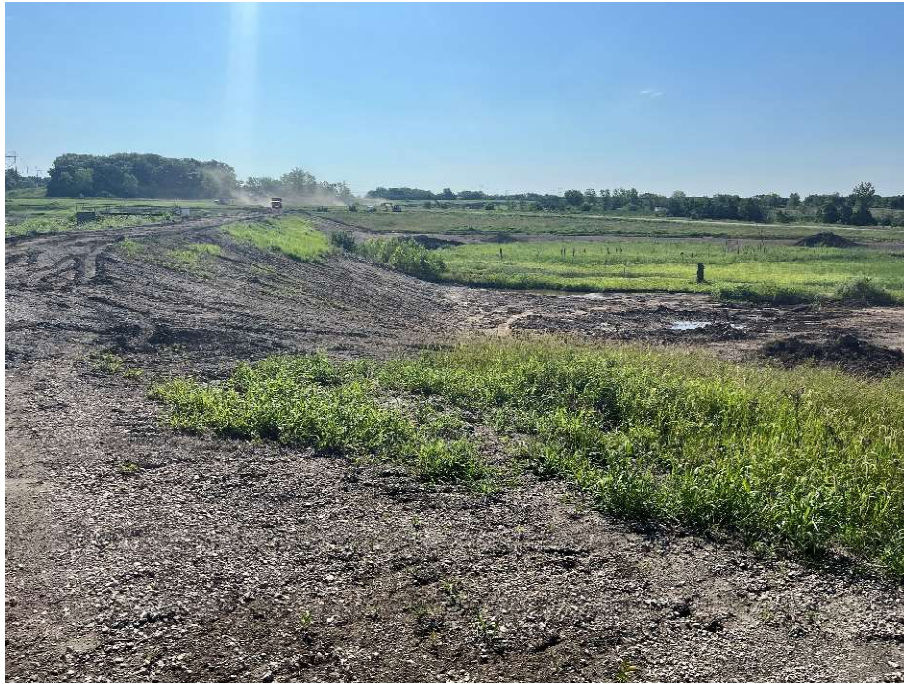
Photo 13: Typical view of the northwestern end of the impoundment from the access road (looking east)

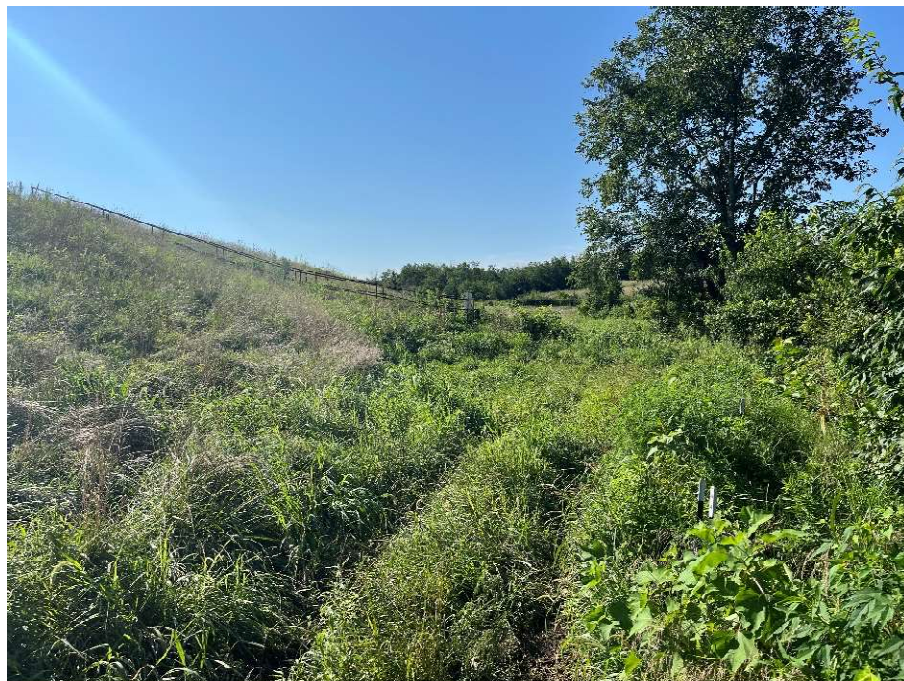
Photo 14: Typical view of the downstream end of the south Cell 004 embankment (looking southeast)
