2018 ANNUAL GROUNDWATER MONITORING
AND CORRECTIVE ACTION REPORT
UTILITY WASTE LANDFILL
NEW MADRID POWER PLANT
NEW MADRID, MISSOURI

by Haley & Aldrich, Inc.
Cleveland, Ohio

for Associated Electric Cooperative, Inc.
Springfield, Missouri

SUMMARY REPORT
APPENDIX III SSI
ALTERNATE SOURCE DEMONSTRATION
FOR THE UTILITY WASTE LANDFILL
NEW MADRID POWER PLANT
NEW MADRID, MISSOURI

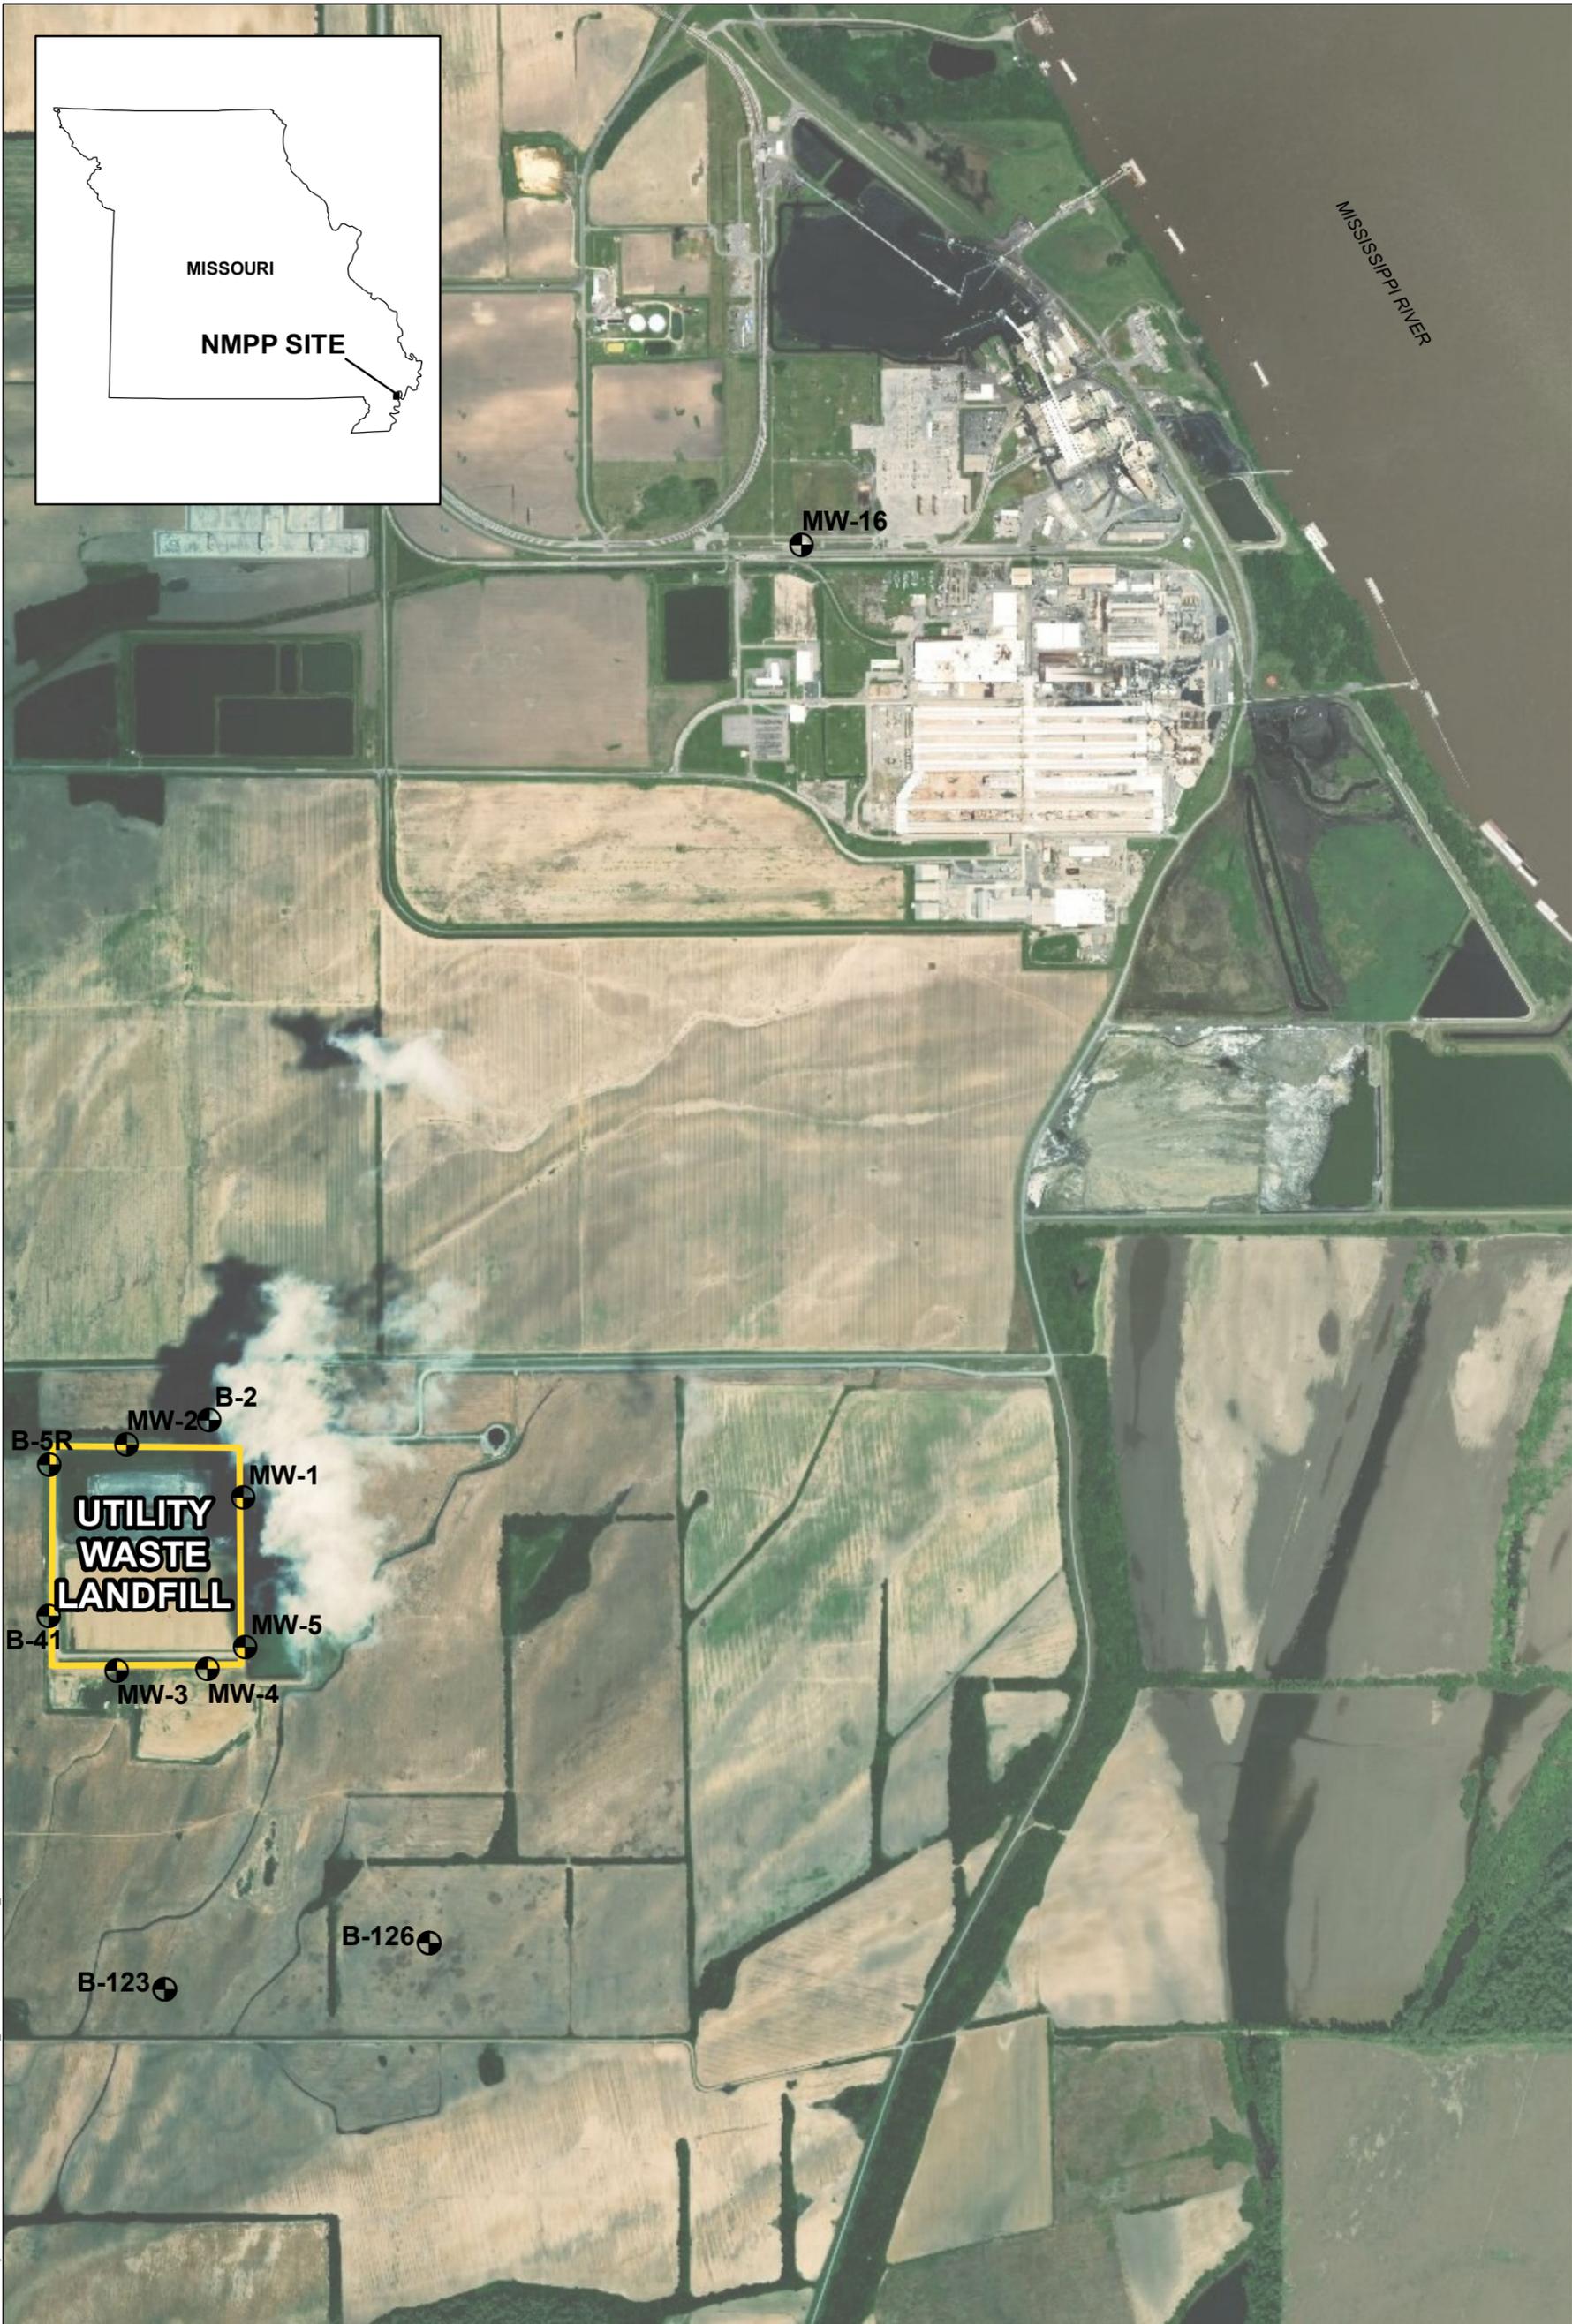
FIGURE

As required by § 257.90(e)(1), a map showing the locations of the CCR unit and associated upgradient and downgradient monitoring wells for the UWL is included in this report as Figure 1. In addition, this information is presented in the CCR Groundwater Monitoring Network Description Report prepared for AECL, which was placed in the facility's operating record by 17 October 2017 as required by § 257.105(h)(2).
