**2022 – 2023 ANNUAL GROUNDWATER MONITORING
AND CORRECTIVE ACTION REPORT**
LINED POND
NEW MADRID POWER PLANT
NEW MADRID, MISSOURI

by Haley & Aldrich, Inc.
Cleveland, Ohio

for Associated Electric Cooperative, Inc.
Springfield, Missouri

File No. 0129342-045
July 2023

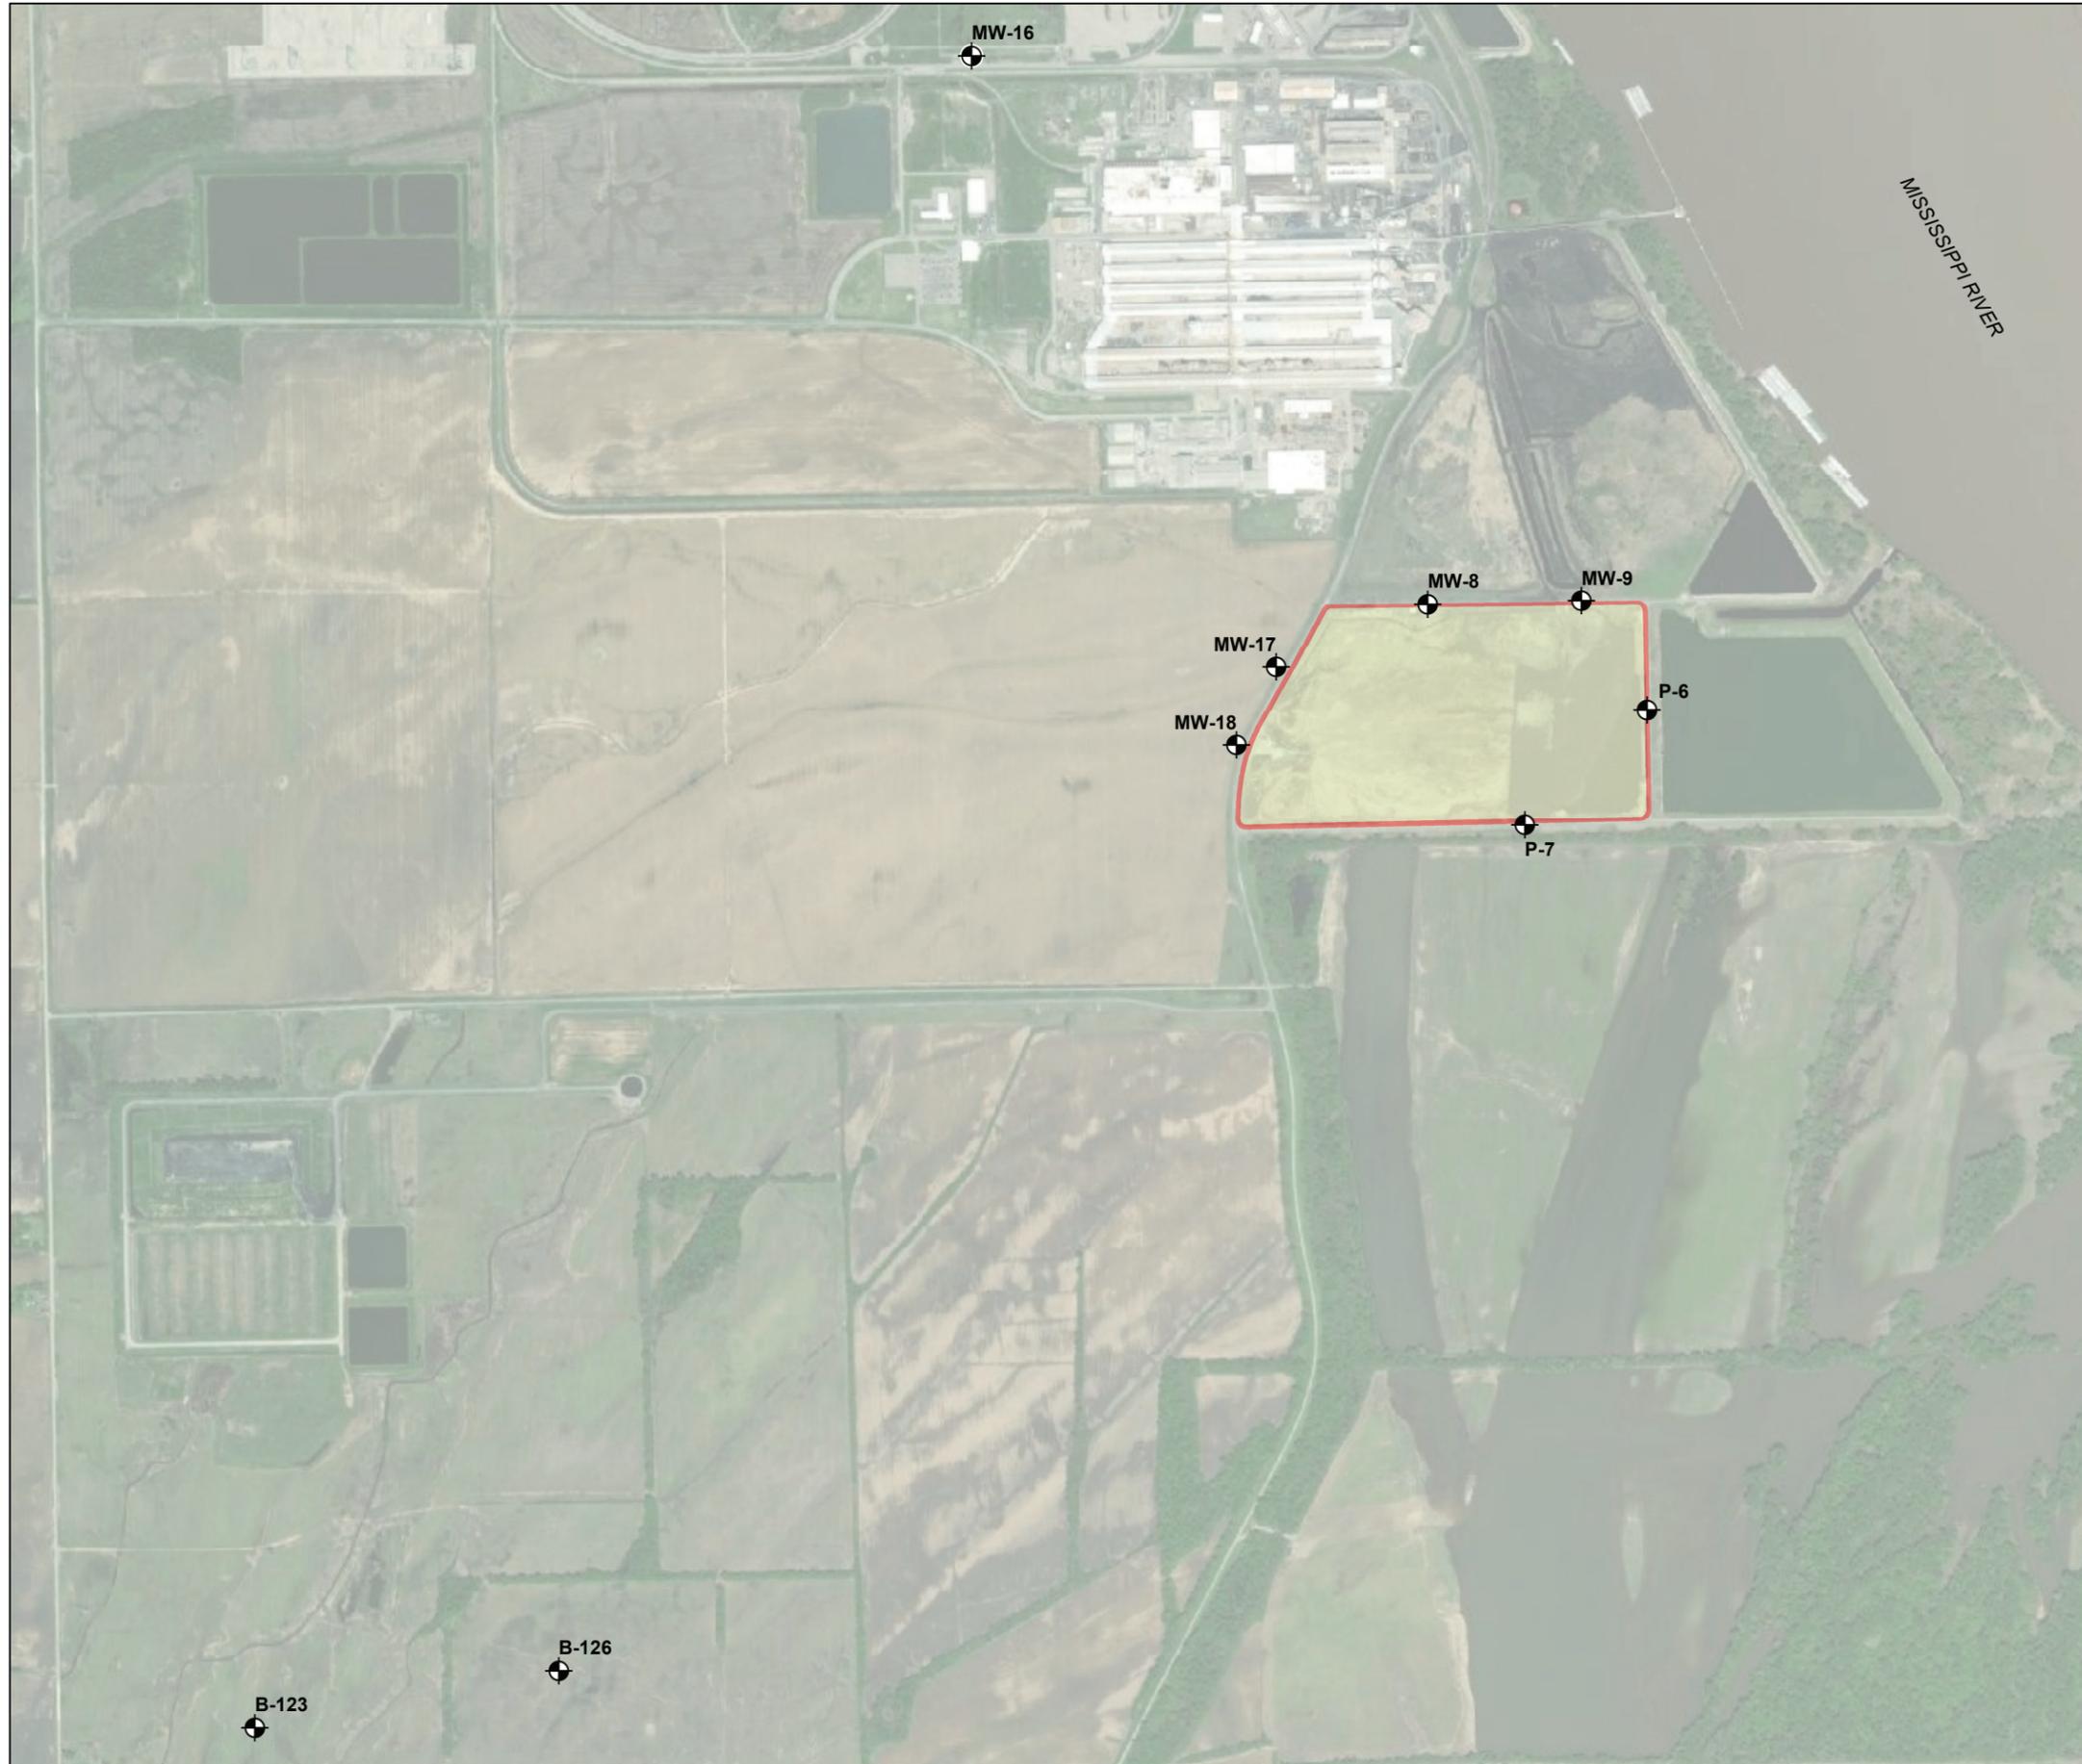
FIGURE

Figure No.	Title
1	Inactive Lined Pond Monitoring Well Location Map

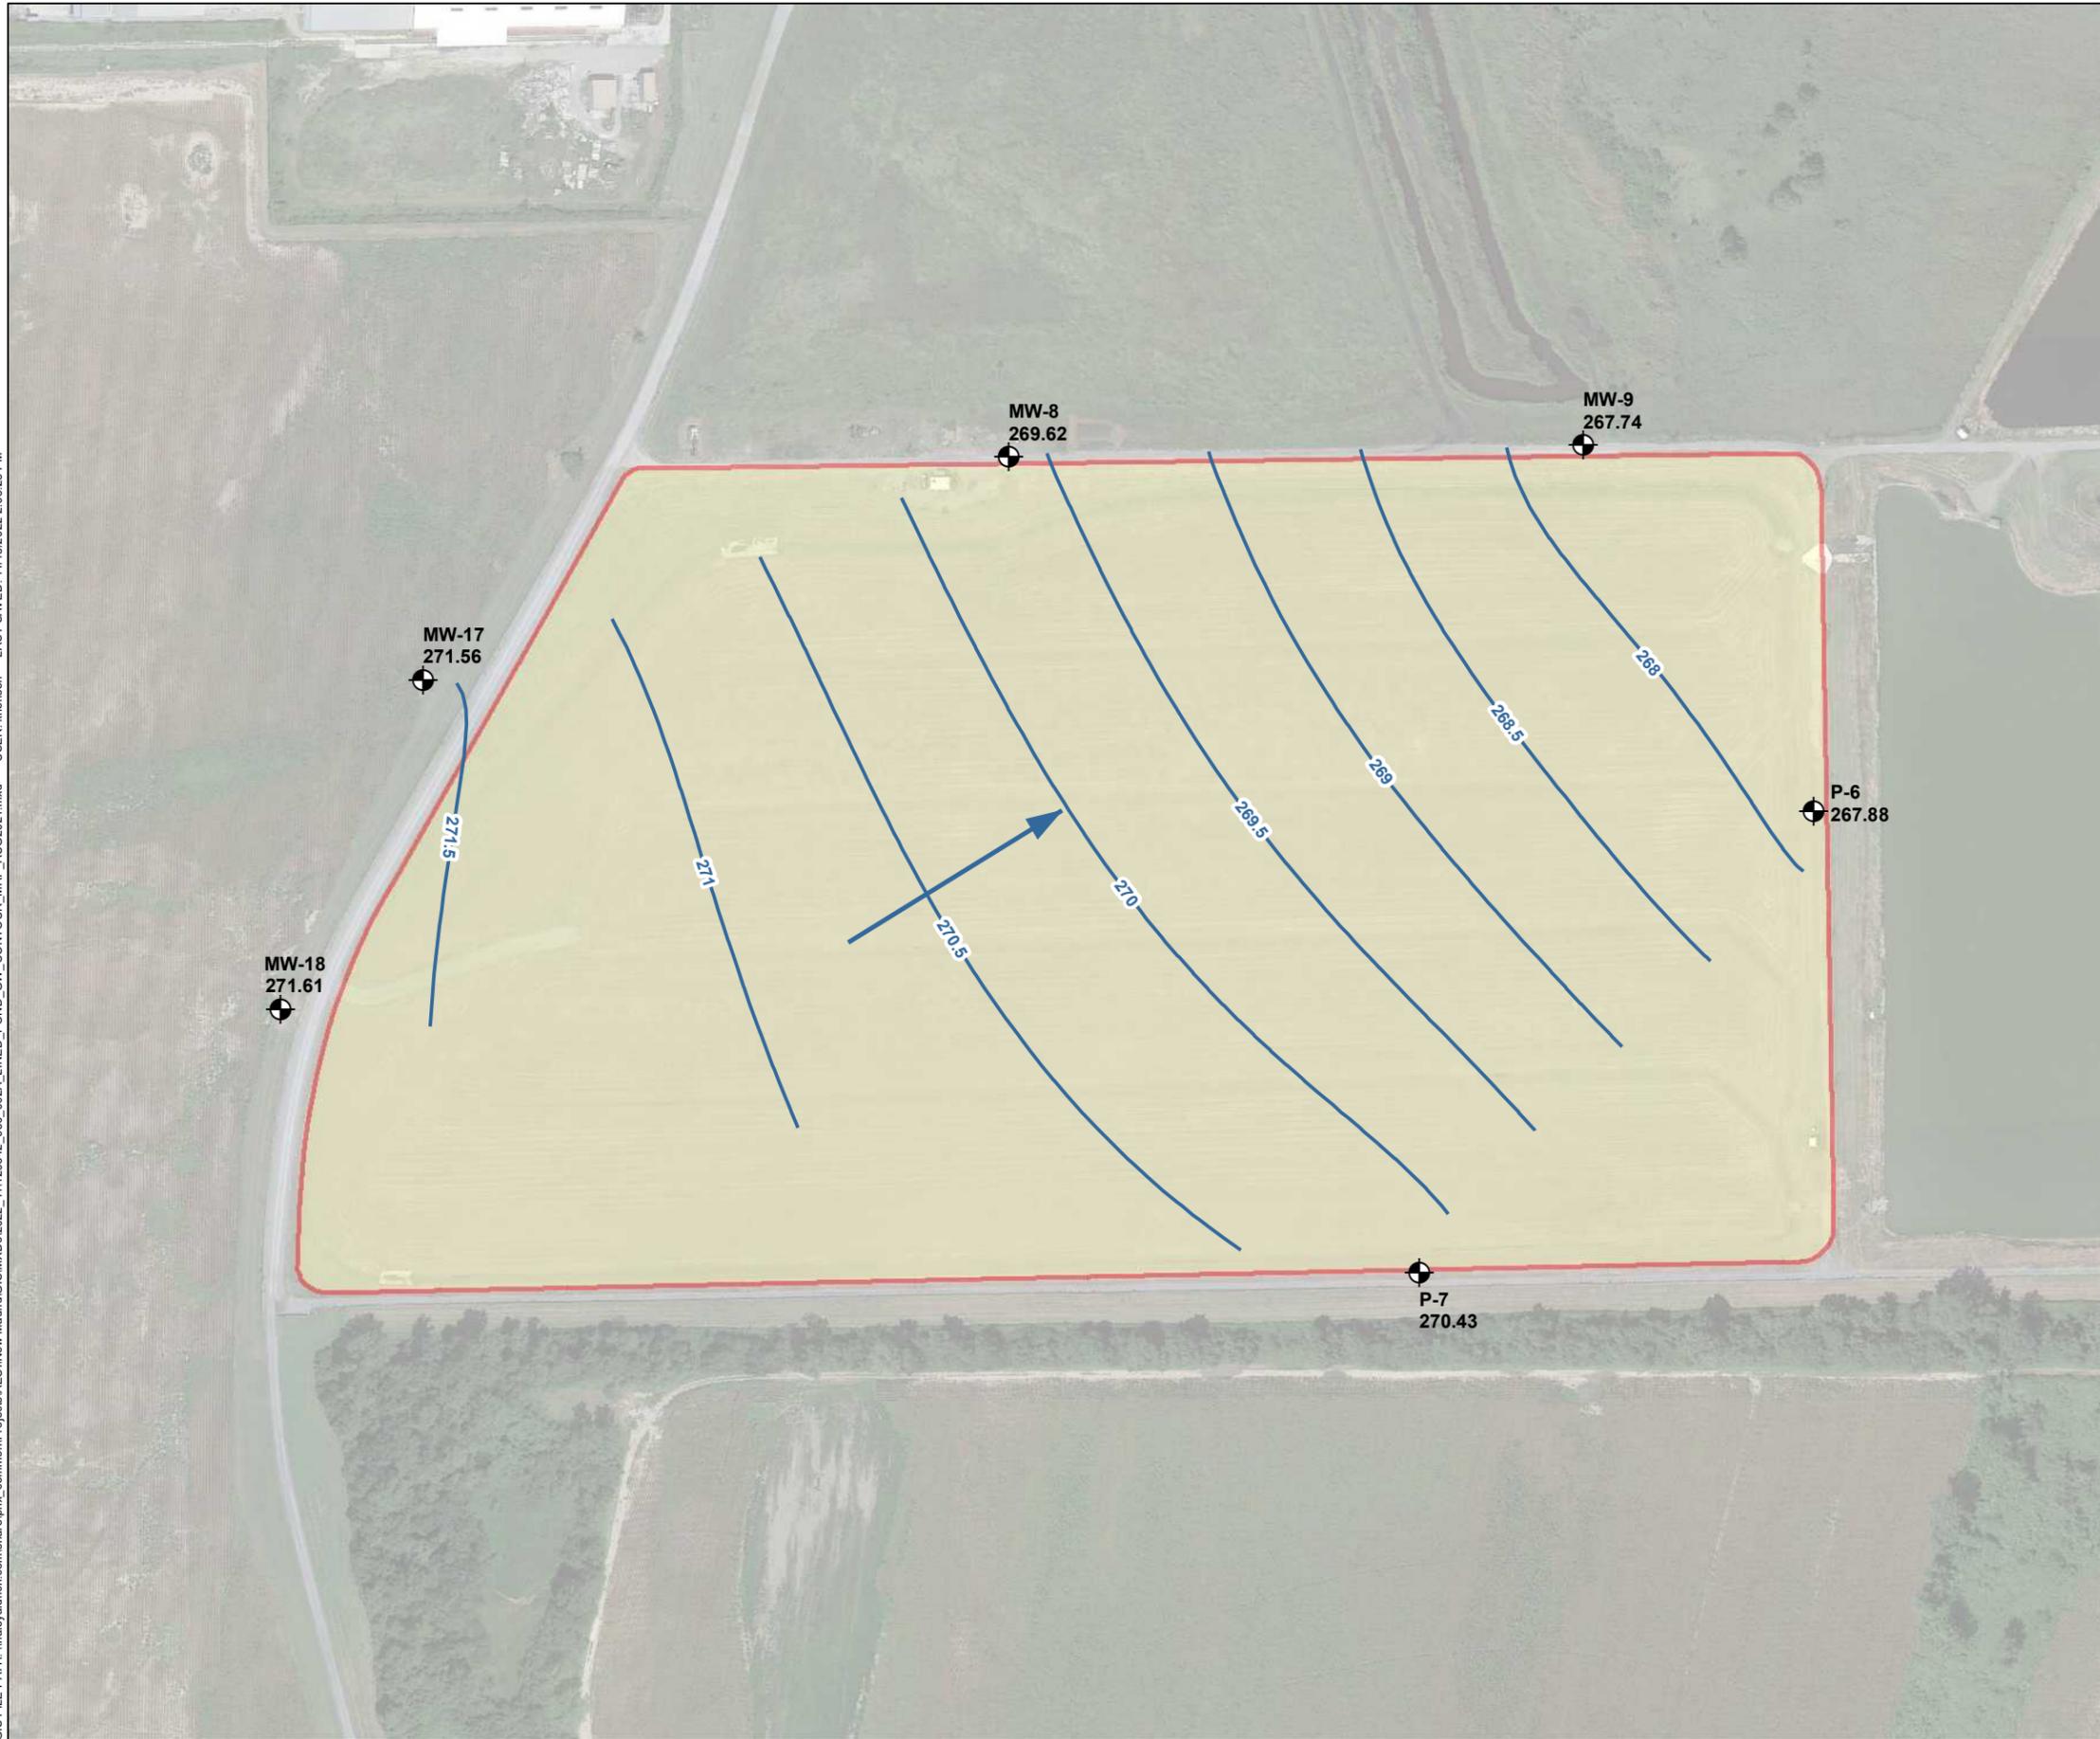
FIGURE 2A

The predominate groundwater flow direction beneath the Lined Pond is to the northeast (Figure 2A and Figure 2B); however, since the Lined Pond lies adjacent to the Mississippi River and the alluvial aquifer within the study area is in communication with the river, seasonal fluctuations in river stage cause the groundwater flow direction to change and occasionally reverse (Figure 2C). During baseflow conditions, when the Mississippi River stage is low, groundwater flow in the alluvial aquifer is generally to the north/northeast. During wet weather conditions, when the Mississippi River stage is high, groundwater flow direction is generally to the southwest.

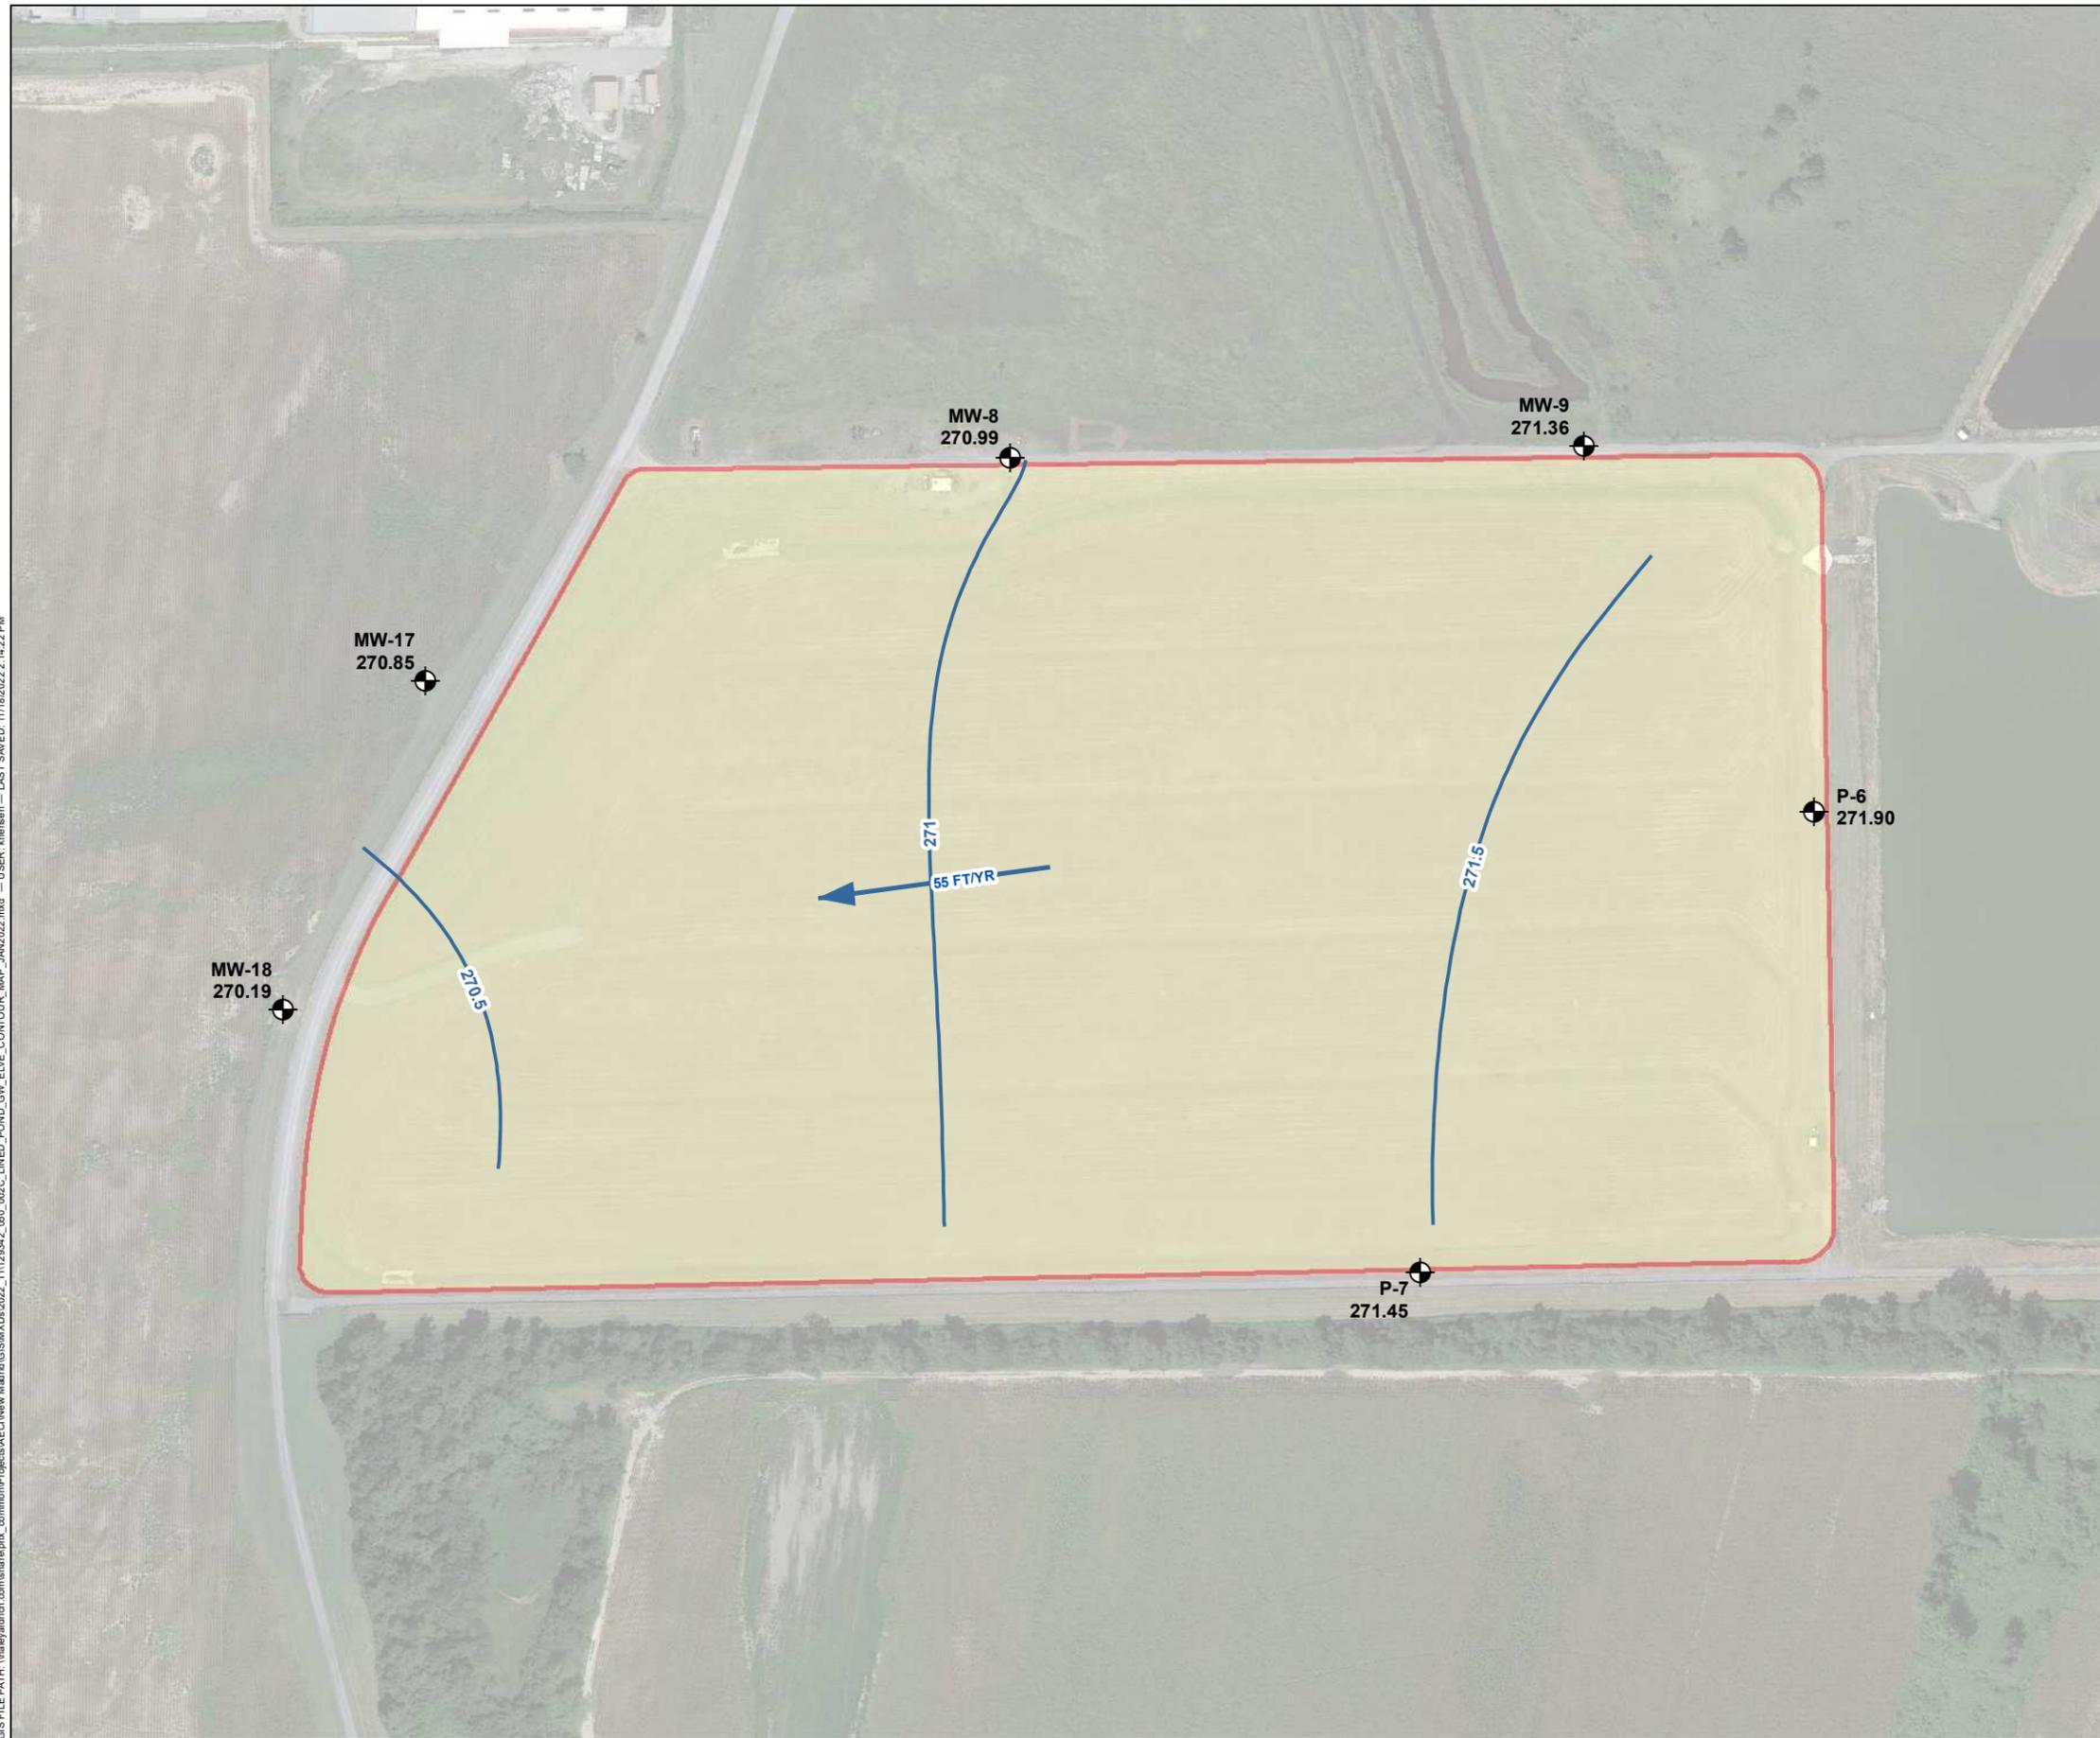
FIGURE 2C

1. ALL LOCATIONS AND DIMENSIONS ARE APPROXIMATE.
2. GROUNDWATER POTENTIOMETRIC ELEVATIONS WERE MEASURED 28 JANUARY 2022.
3. THE GROUNDWATER FLOW RATE WAS APPROXIMATED USING THE HYDRAULIC GRADIENT CALCULATED FROM GROUNDWATER POTENTIOMETRIC ELEVATIONS MEASURED 28 JANUARY 2022. THE HYDRAULIC CONDUCTIVITY VALUES COLLECTED THROUGH SLUG TESTING DURING WELL DEVELOPMENT, AND EFFECTIVE POROSITY VALUES OBTAINED FROM PUBLISHED SOURCES.
4. AERIAL IMAGERY SOURCE: GOOGLE EARTH, 6 SEPTEMBER 2021

LINED POND GROUNDWATER
ELEVATION CONTOUR MAP
JANUARY 28, 2022
