**REPORT ON
INITIAL PERIODIC STRUCTURAL STABILITY ASSESSMENT
POND 003
NEW MADRID POWER PLANT
NEW MADRID, MISSOURI**

by Haley & Aldrich, Inc.
Cleveland, Ohio

for Associated Electric Cooperative, Inc.
New Madrid, Missouri

File No. 40616-300
October 2016

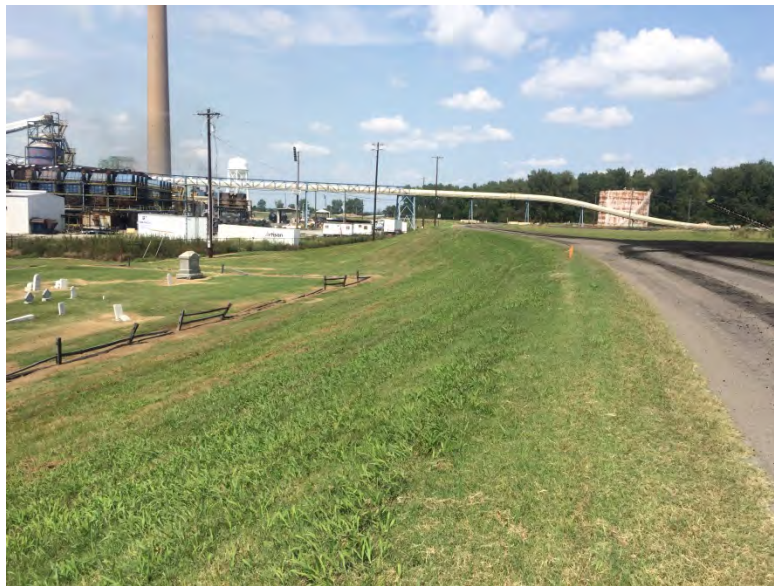
Photograph No. 14

Upstream slope on western embankment

Note vegetation growing on Ash stockpiled above water level to the right.
