## **New Madrid CCR Surface Impoundment**

# **Pond 003**

# **Emergency Action Plan**

**18 April 2022**

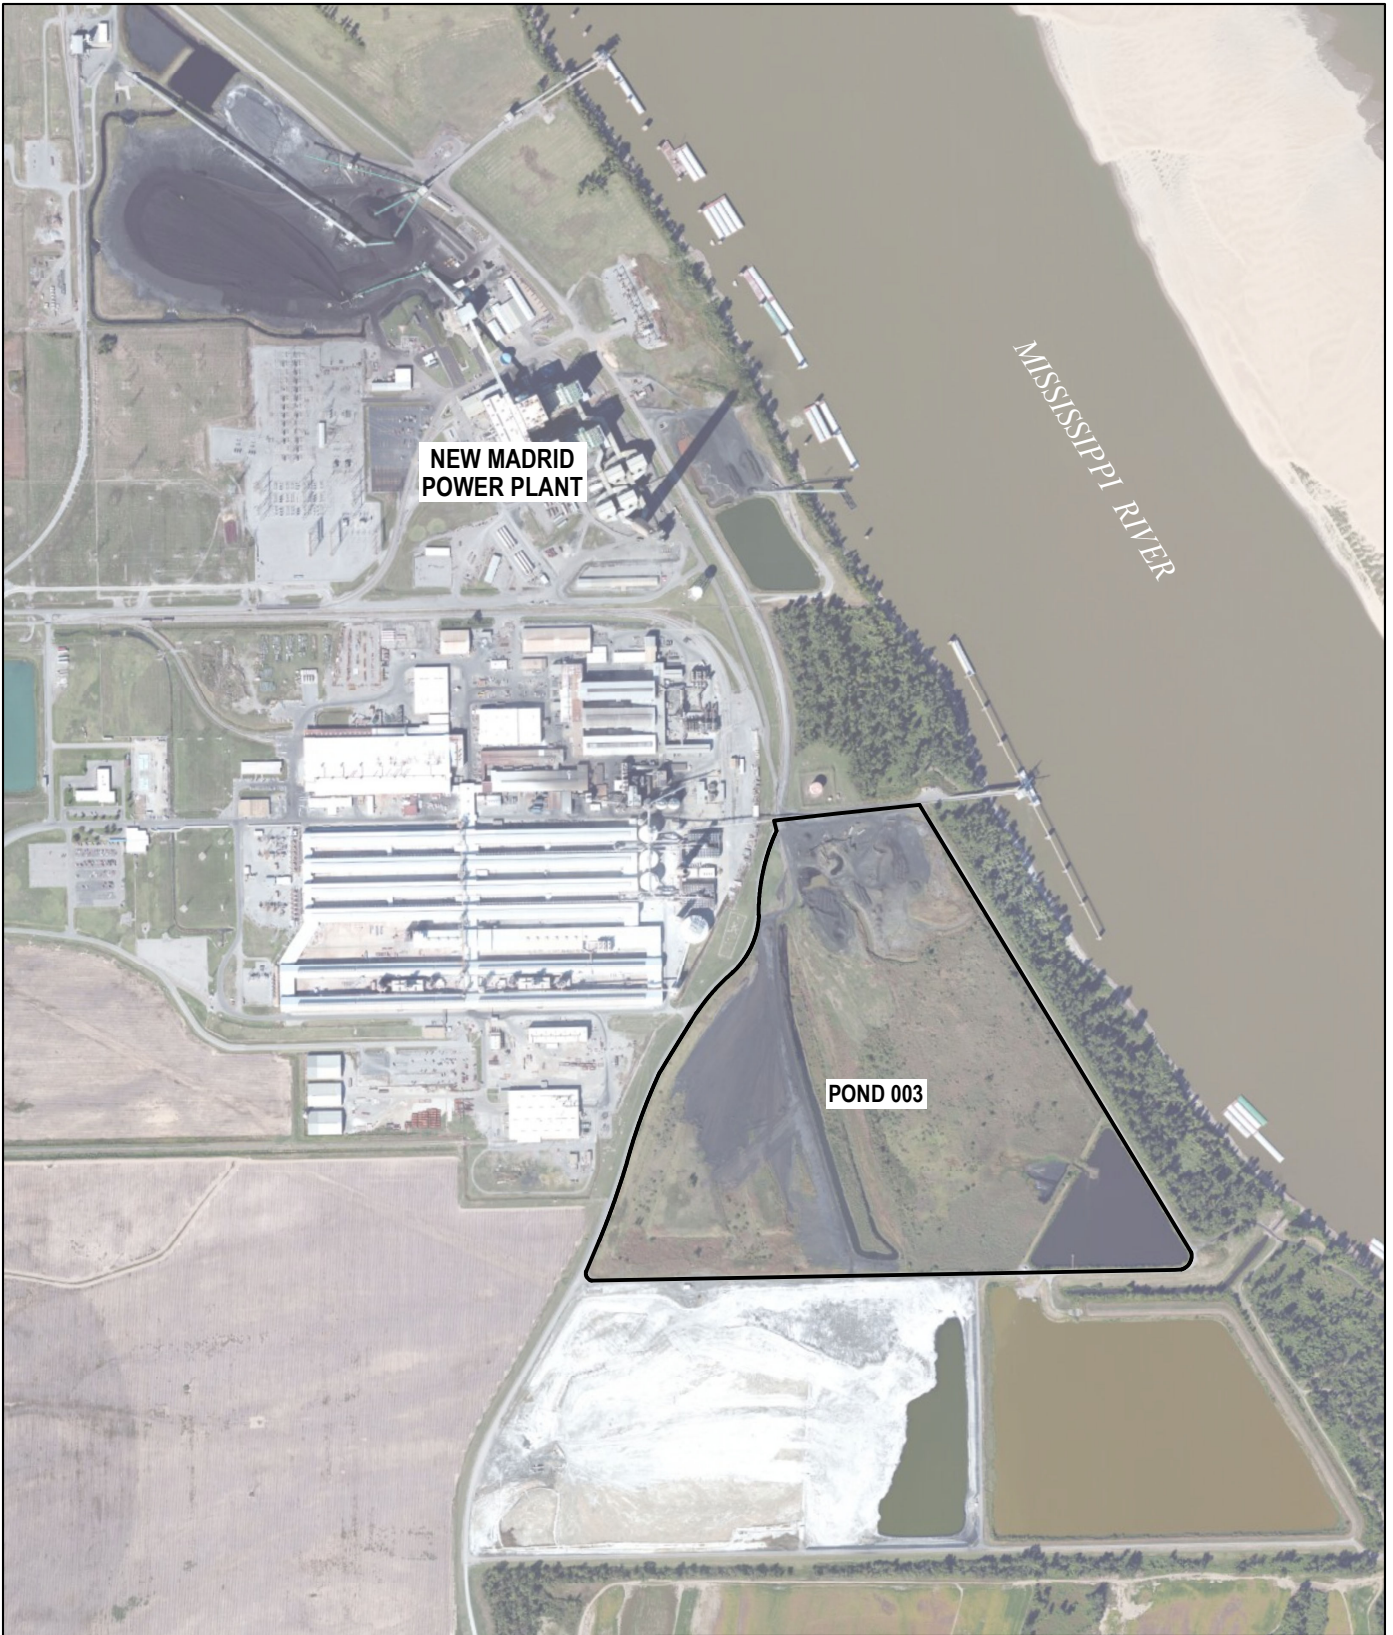
**FIGURE 1**

**AERIAL PHOTO MAP OF THE AECI  
NEW MADRID POWER PLANT AND  
POND 003**

AECI has developed and will implement this EAP in the event an impoundment failure occurs at their NMPP CCR Surface Impoundment – Pond 003 (Pond 003) (see Figures 1 and 2). In addition, this Plan is written in accordance, and to comply, with 40 CFR §257.73(a)(3)(i). This EAP provides step-by-step instructions to those individuals at the NMPP level on how to respond to an emergency situation. The Plan includes notification lists, maps of the CCR surface impoundment, and emergency response procedures. The main goal of this EAP is to offer a quick and effective reference for personnel at the facility in case such an emergency should occur.

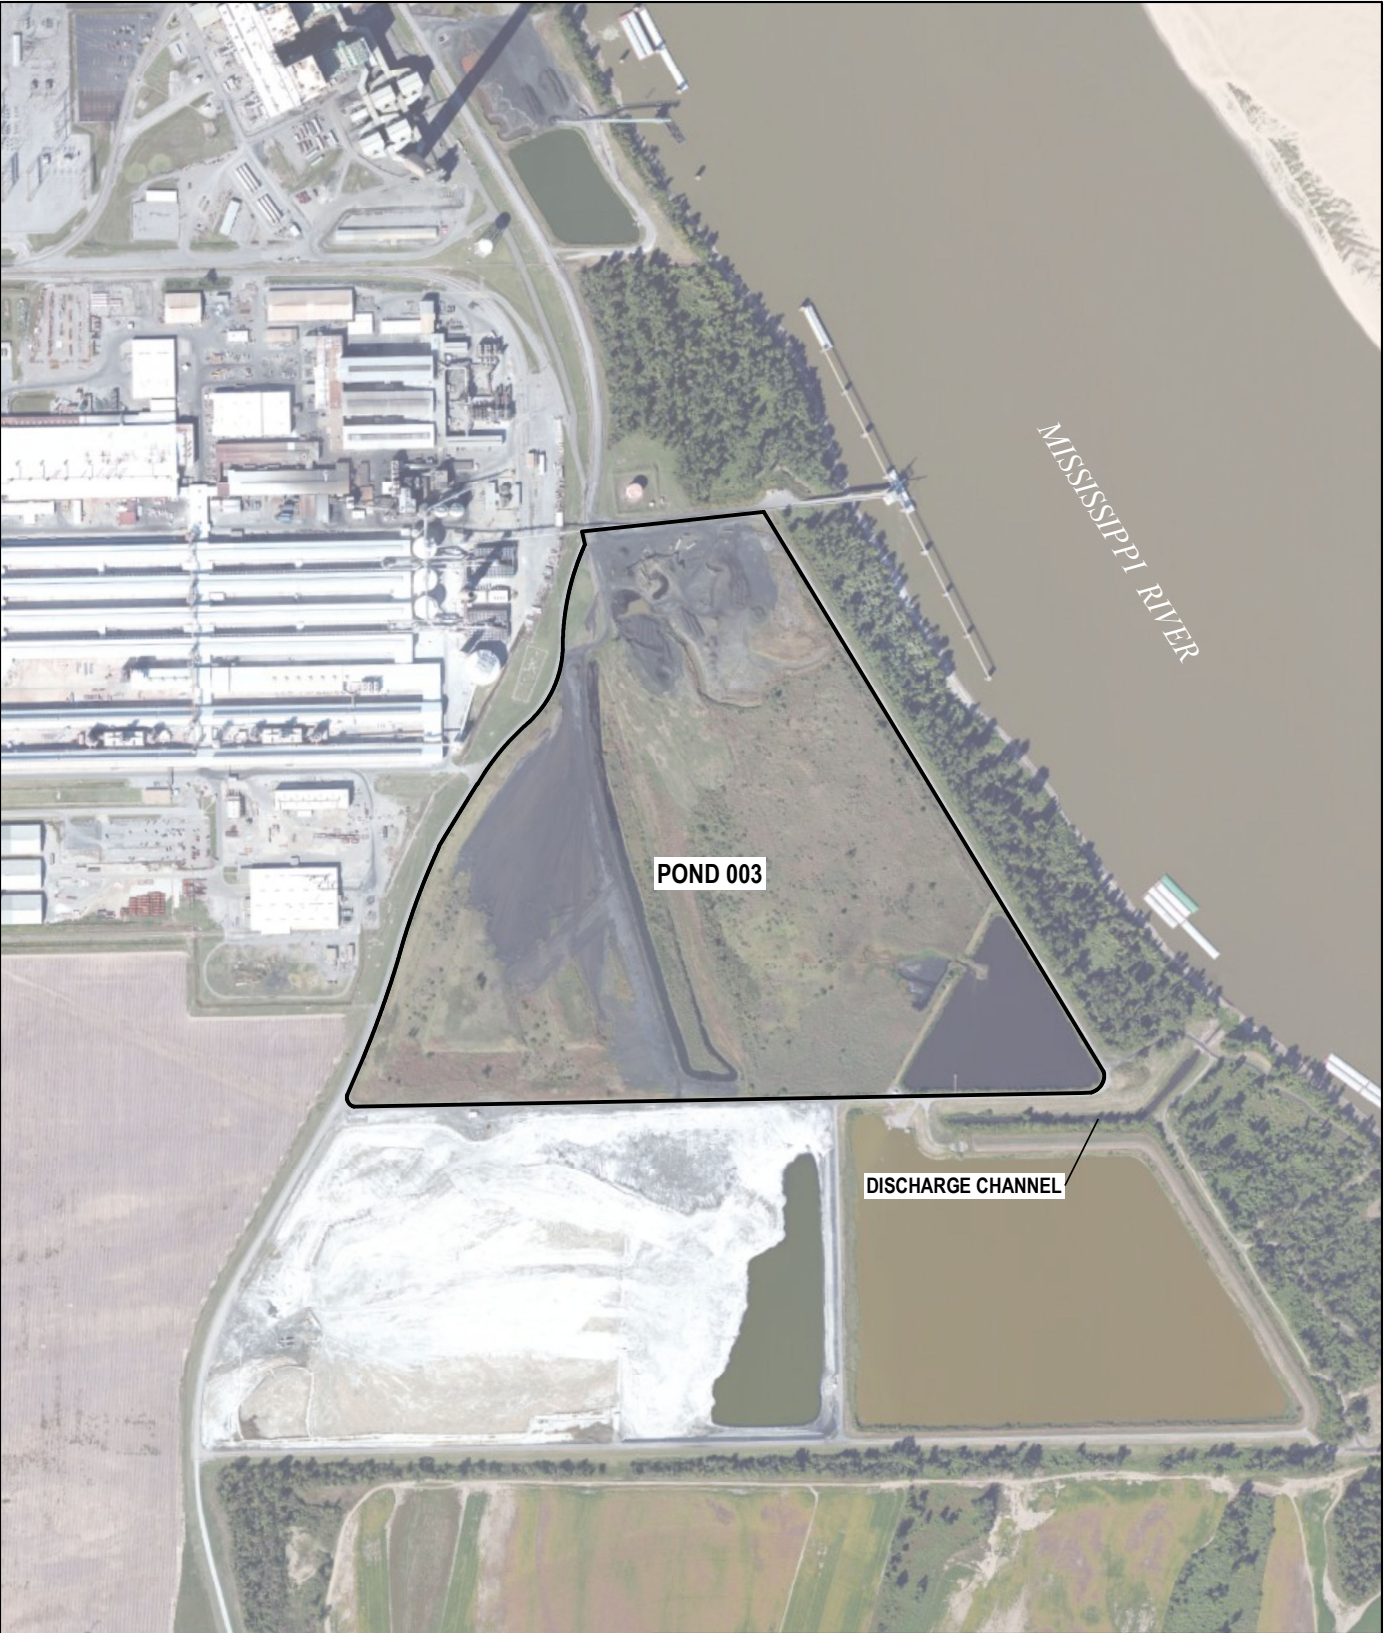
**FIGURE 2**

**AERIAL PHOTO MAP OF POND 003**

The watershed in which Pond 003 is located is the Little River Ditches Watershed (USGS No. 08020204) that is approximately 2,608 square miles in size. Pond 003 is an above-grade ring dike and does not receive any overland flow from the surrounding areas. Discharges from the impoundment flow to a concrete drip inlet structure with concrete stoplogs located in the southeast corner of Pond 003. A discharge pipe directs water through the dike and into a discharge channel that flows to the Mississippi River as shown on Figure 2.

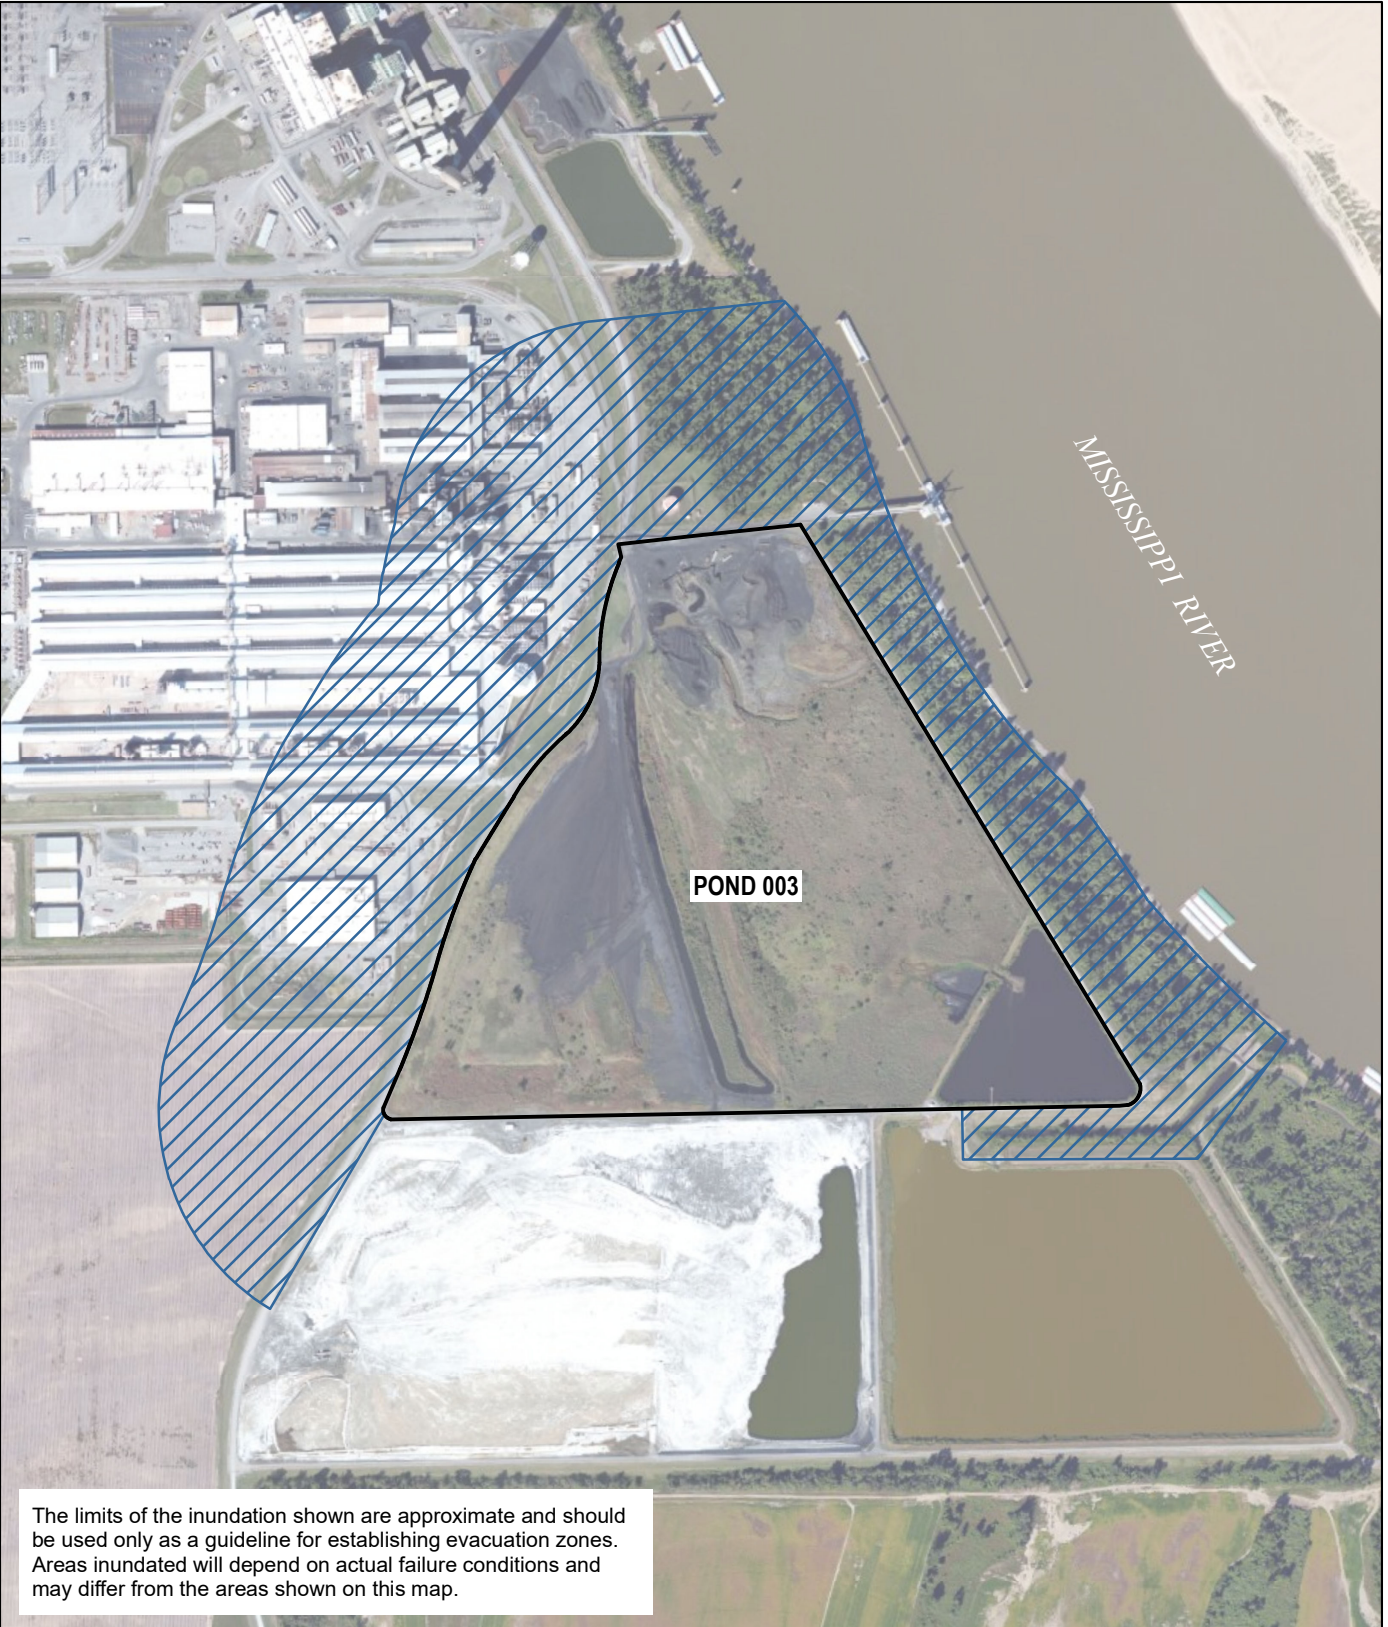
**FIGURE 3**

The limits of the inundation shown are approximate and should be used only as a guideline for establishing evacuation zones. Areas inundated will depend on actual failure conditions and may differ from the areas shown on this map.

**POND 003 FLOOD INUNDATION MAP**

The Flood Inundation Map for Pond 003 (Figure 3) indicates the potential areas that may be affected if the impoundment should fail. Based on the flood inundation mapping, the potentially affected areas include uninhabited farmland to the south and southwest, the AECI NMPP property to the northwest, and other industrial facilities to the west. No other structures or buildings have been identified in this inundation area.
