2022 ANNUAL GROUNDWATER MONITORING AND
CORRECTIVE ACTION REPORT
ASH POND SYSTEM
THOMAS HILL ENERGY CENTER
CLIFTON HILL, MISSOURI

by
Haley & Aldrich, Inc.
Cleveland, Ohio

for
Associated Electric Cooperative, Inc.
Springfield, Missouri

File No. 128064-014
January 2023

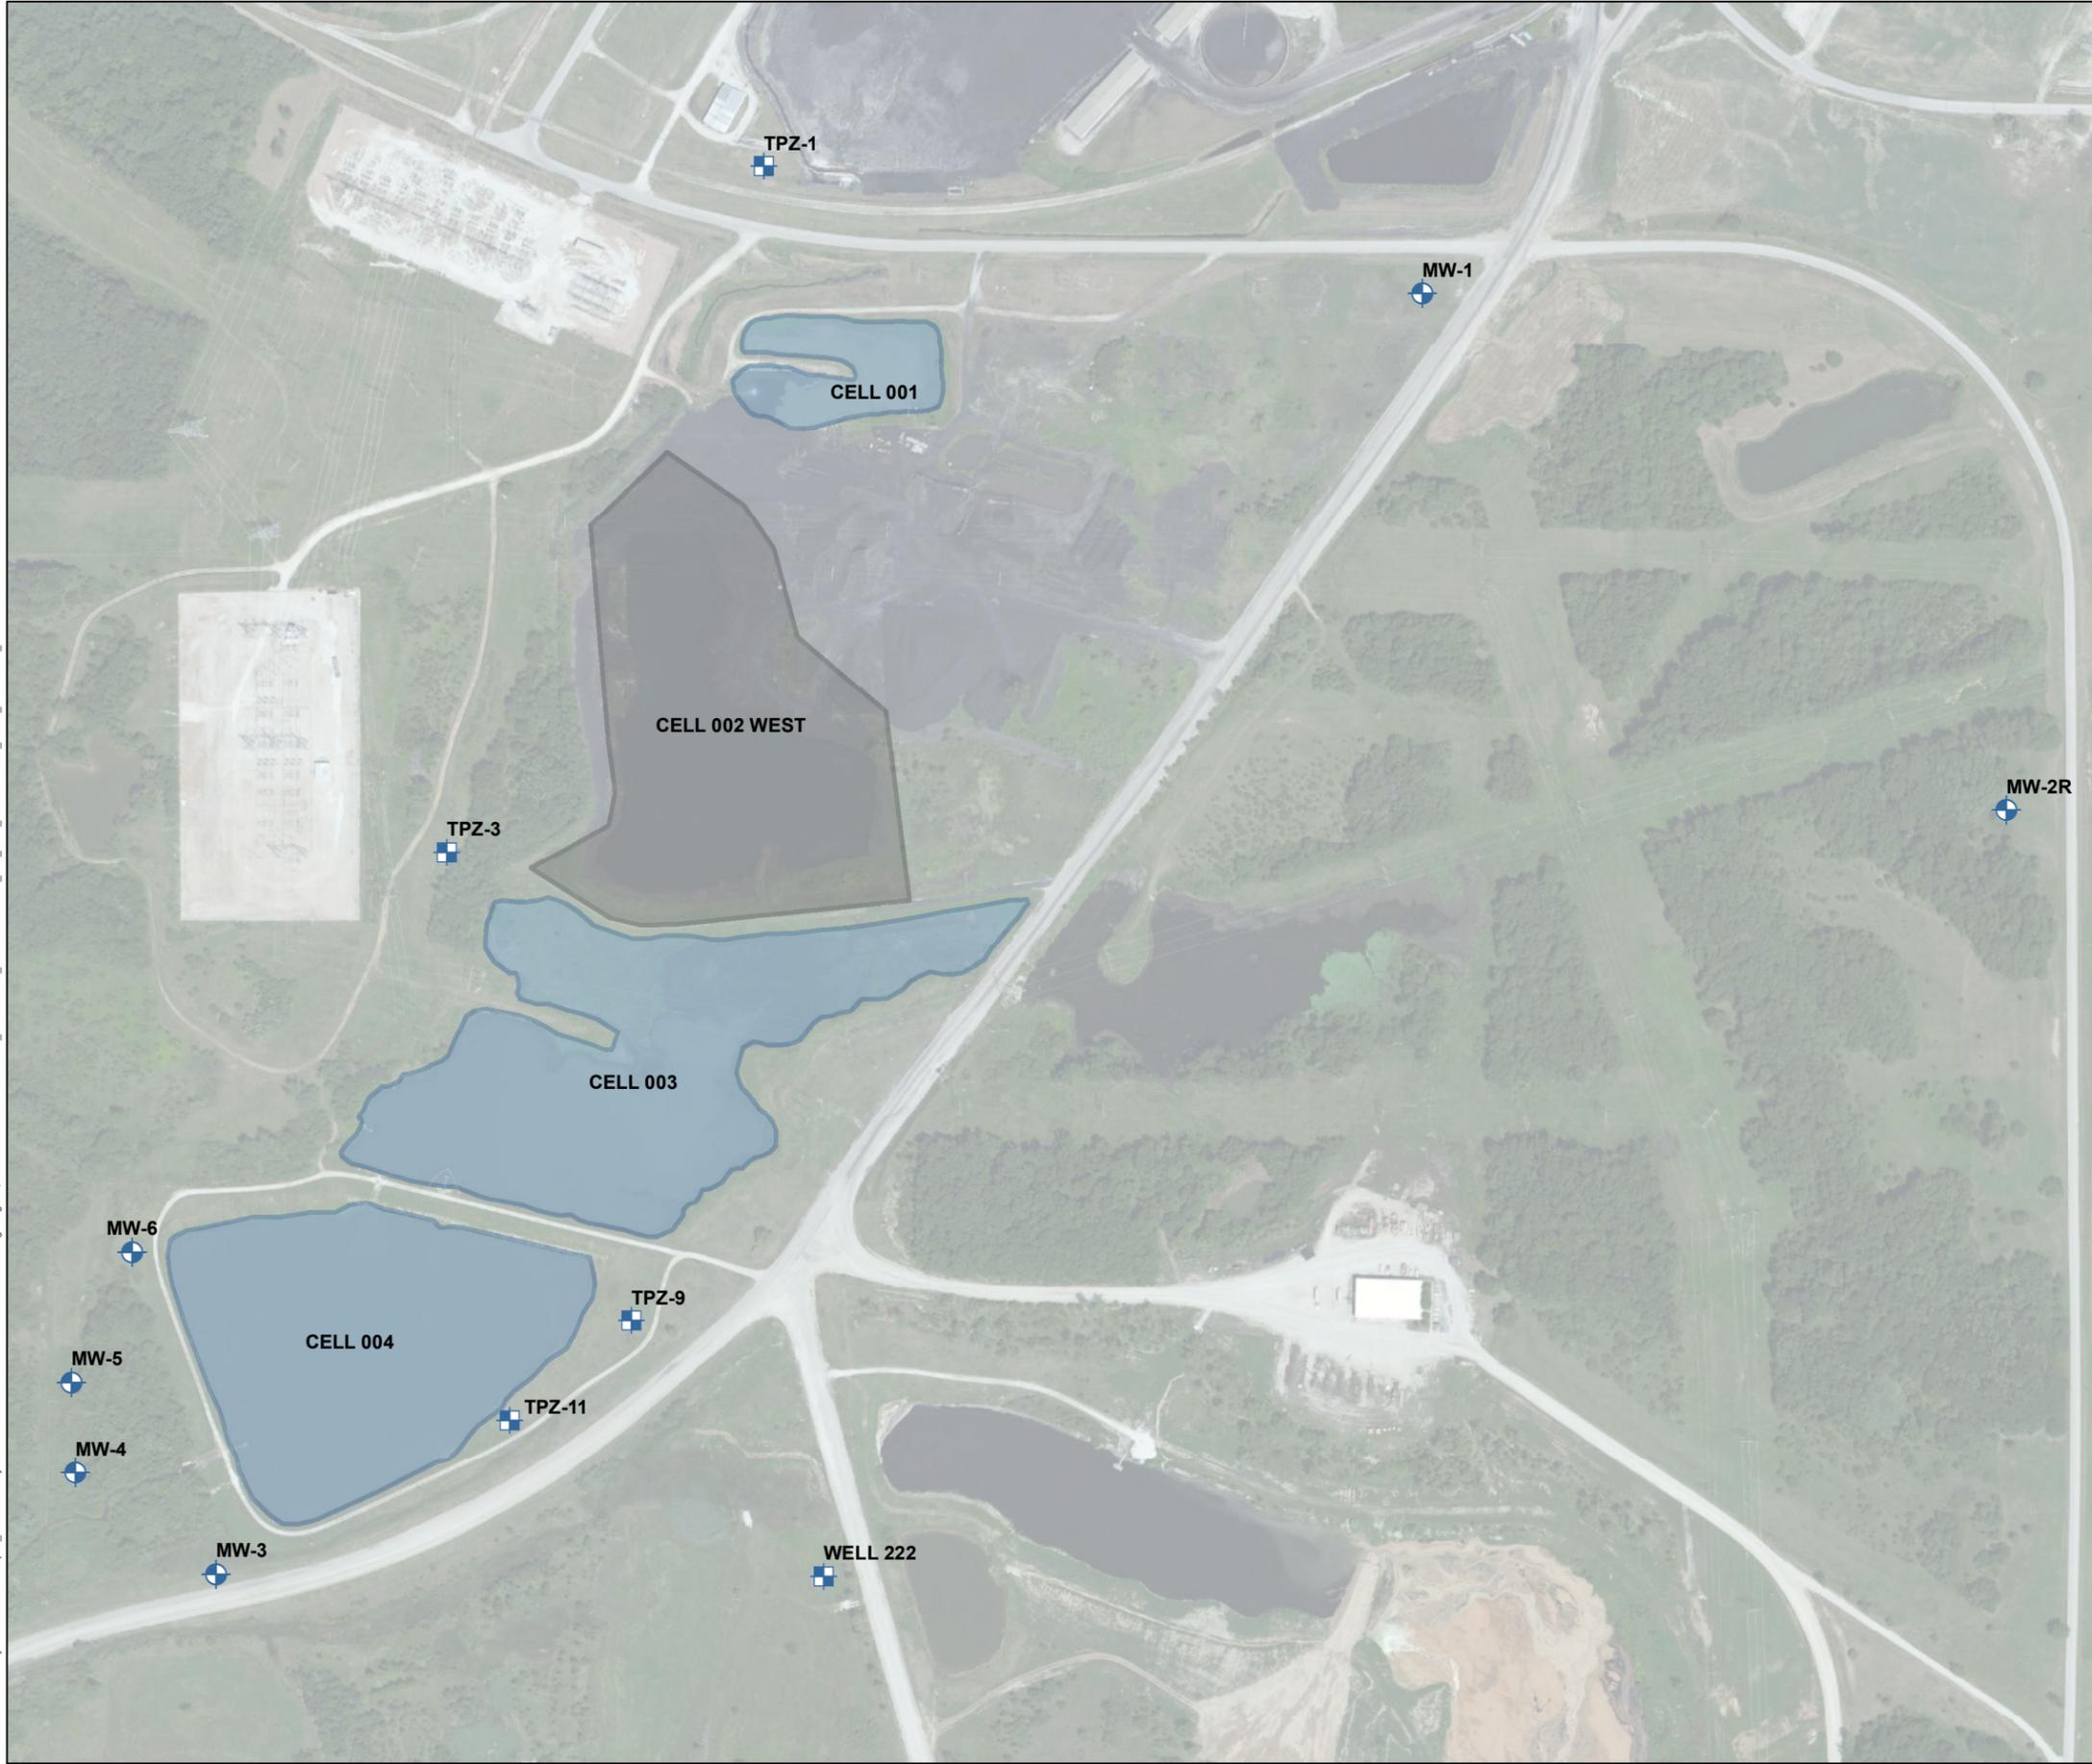
FIGURE

Figure No.	Title
1	Ash Pond System Monitoring Well Location Map

As required by § 257.90(e)(1), a map showing the locations of the CCR unit and associated upgradient and downgradient monitoring wells for the Ash Pond System is included in this report as Figure 1. In addition, this information is presented in the CCR Groundwater Monitoring Network Description Report prepared for AECl, which was placed in the facility's operating record by 17 October 2017 as required by § 257.105(h)(2) and revised in April 2019.
